**Ministry of Economy and Sustainable Development of Georgia
Civil Aviation and Maritime Transport Accident Incident
Investigation Bureau**

**Final Report on accident to Bell 505 helicopter in Kazbegi municipality,
Georgia on 6 June 2019**

Helicopter type	BELL-505
Nationality and registration marks	4L- ADJ
Operator	“Aviator+” LLC
Time and date of the accident	10:57 (local time) 06.06.2019
Accident location	“Kazbegi” municipality settlement “Stepantsminda” (Georgia).
Geographical coordinates	N 42°38' 59'' E 44°38' 49''

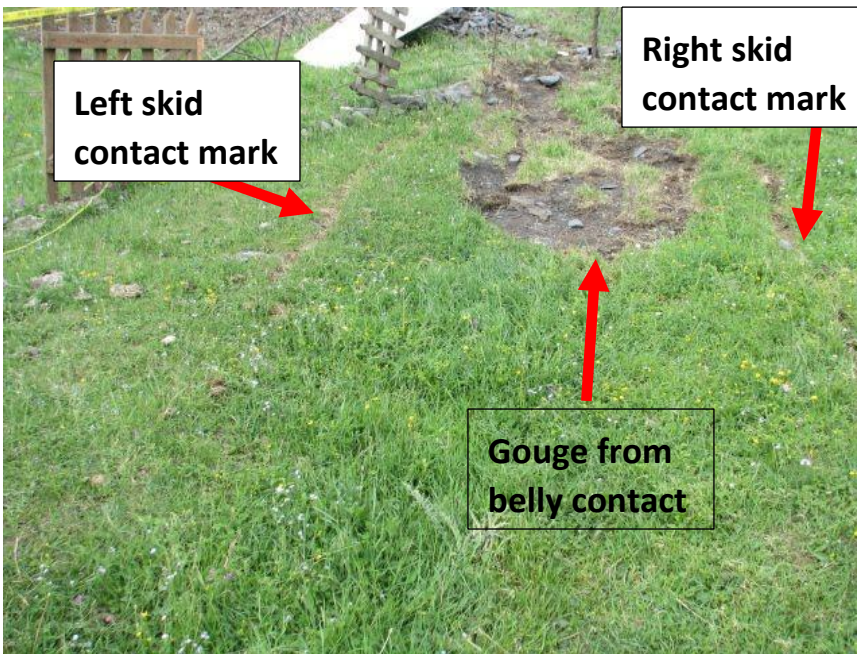
Photo 1
Forward fuselage and skid gear impact marks

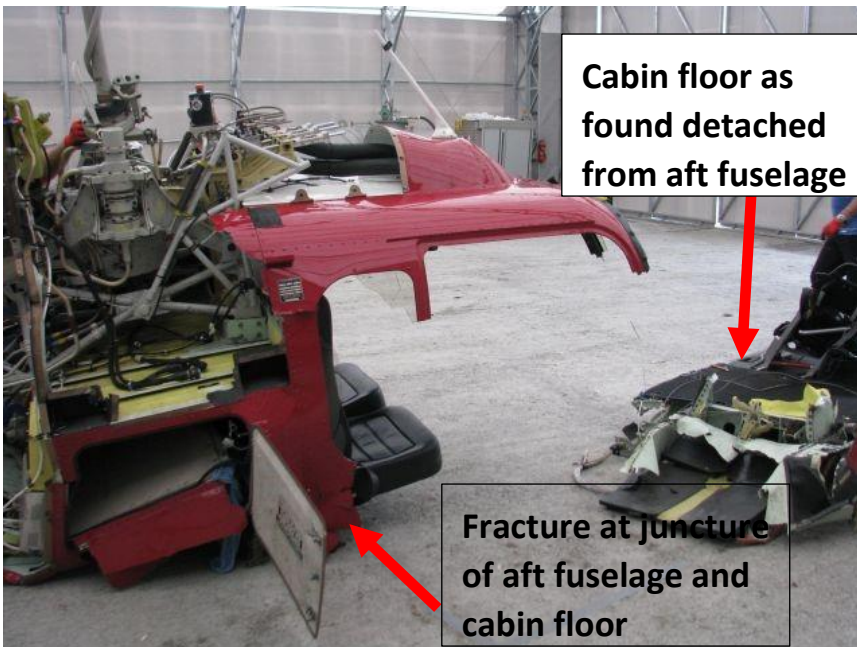
The cockpit and cabin floor fractured at its attachment to the aft fuselage consistent with impact overload forces (See Photo 2). The top of the helicopter was intact. The aft fuselage steel truss was relatively intact but exhibited bent structure at both the aft crosstube mounting locations consistent with a hard ground impact (See Photo 3). The right bottom side of the steel truss was more damaged than the left bottom side. Bottom surfaces of the airframe exhibited impact damage. Additionally, the truss exhibited a fracture just aft of the aft crosstube. No evidence of wirestrike was observed on the helicopter.

Photo 2
Right side of fuselage with fracture of cabin floor from aft fuselage

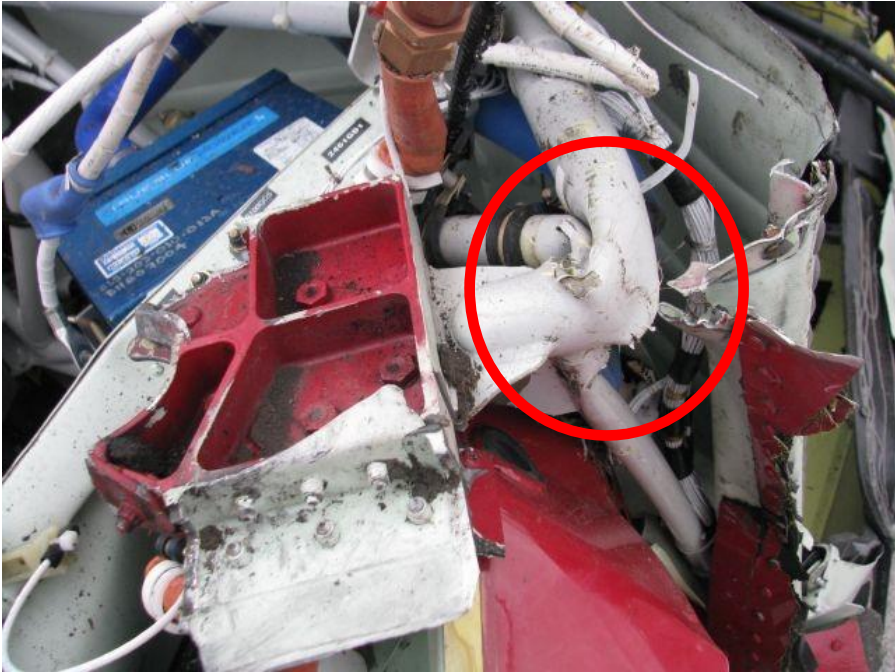
Photo 3

Right bottom side of truss was bent from hard impact of rear crosstube

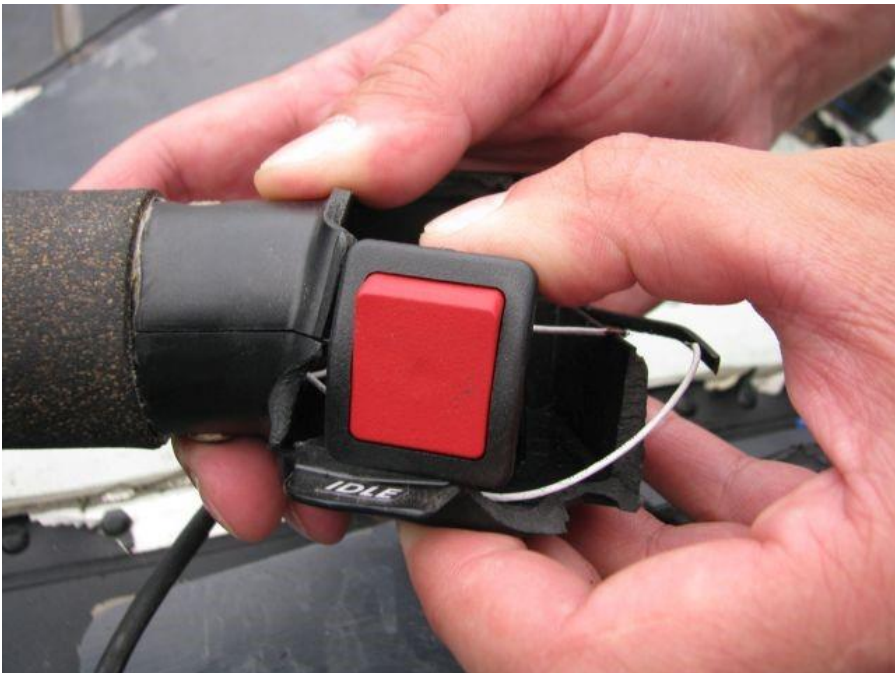
The Fly/Idle throttle switch on the collective head was found in the Idle position when observed (See Photo 4). The engine selector switch on the console was found in the Start/Run position (See Ph5).

Photo 4 Fly/Idle throttle switch (fractured, but held in place) on collective head was found in Idle position

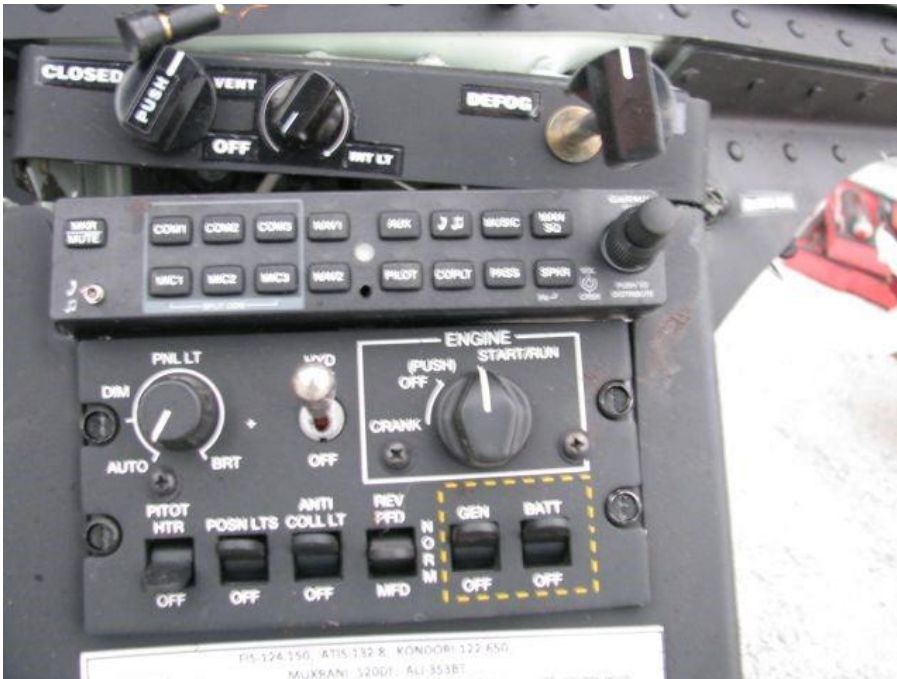
Photo 5
Engine selector switch found in Start/Run position

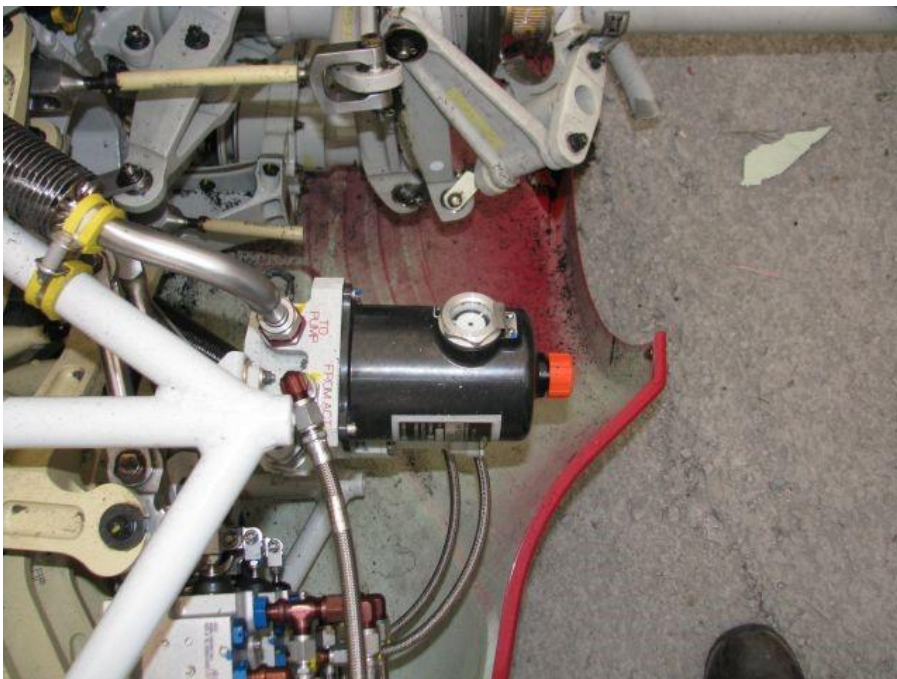
All observed hydraulic lines were intact. A small amount of red colored fluid up to the refill line on the hydraulic reservoir sight glass, consistent with hydraulic fluid, was observed in the hydraulic reservoir and filter module. Leakage evidence of red colored fluid was observed near the hydraulic reservoir and filter when the helicopter was examined resting on its left side (See Photo 6).

Photo 6
Red colored fluid found on cowling was consistent with hydraulic fluid. Hydraulic reservoir intact.

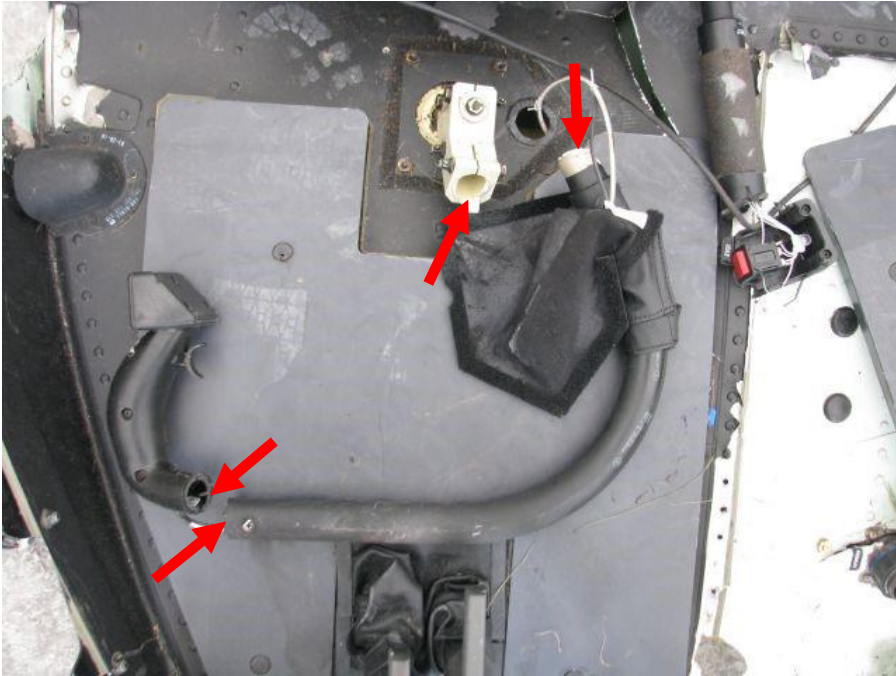
Photo 7

The cyclic stick fractured consistent with overload forces at its base (See Photo 7). The cyclic hand grip also fractured consistent with overload forces away from the cyclic stick. A screwdriver was placed at the fractured base and was moved longitudinally and laterally by hand. Movement to the cyclic mixer was observed. Both cyclic vertical control tubes fractured near the bottom of the tubes consistent with overload forces from separation of the cabin floor from the aft fuselage (See Photo 8). The upper

Cyclic stick fractured due to overload at its base and at the hand grip (red arrows)

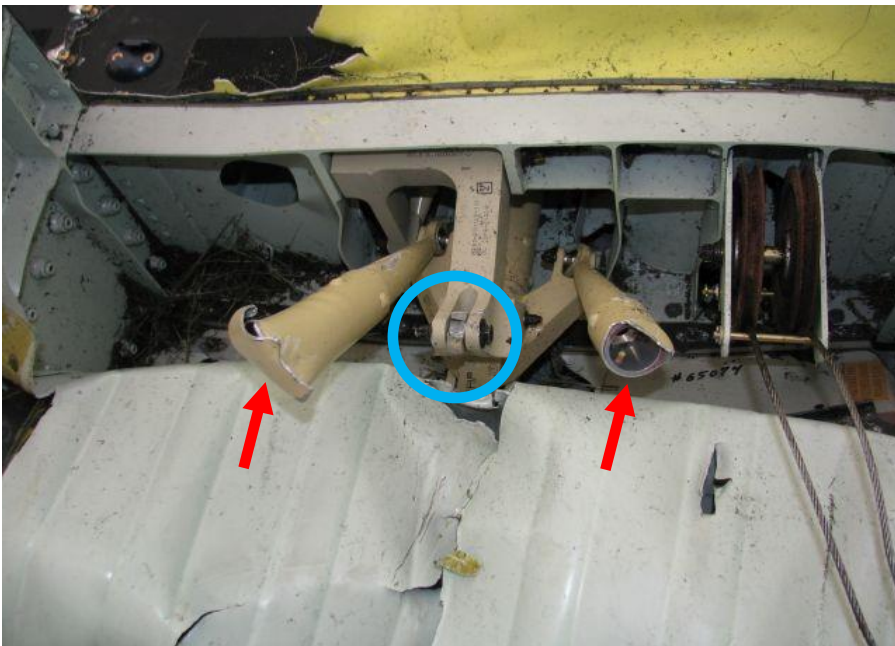
Photo 8. Vertical cyclic (Red) and collective (blue) control tubes fractured consistent with overload forces

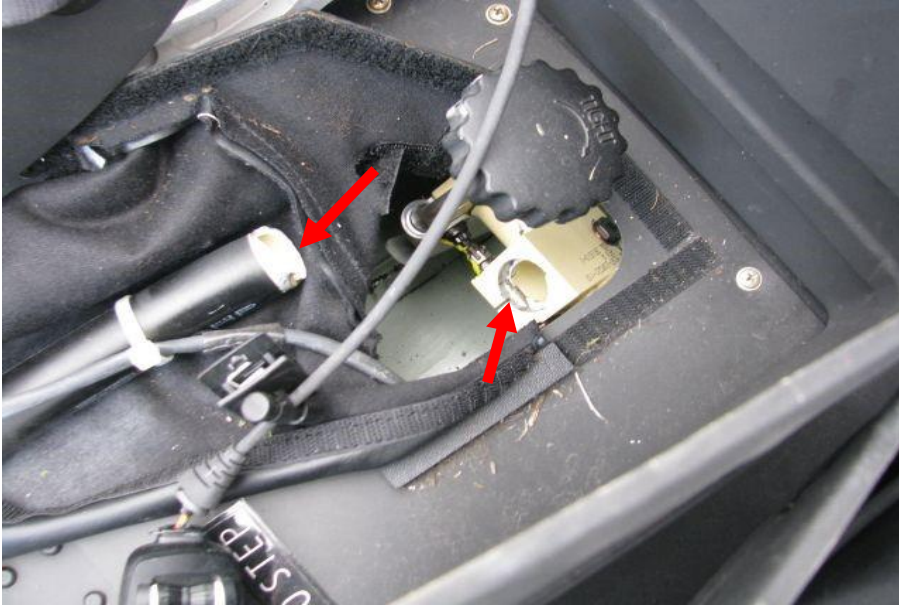
The collective stick was fractured at its base consistent with overload forces at impact (See Photo 9). The collective head was also fractured consistent with overload forces at impact (See Photo 10). A screwdriver was inserted into the fractured base and up and down collective movement was applied. Control movement was observed to the overload fractured collective control tube at the cyclic mixer. The collective vertical control tube to the servos exhibited a fracture consistent with overload forces in the bottom rod end near the mixing unit where the cabin floor and aft fuselage separated during impact (See Photo 8—Blue Circle).

Photo 9
Collective stick fractured at its base consistent with overload forces

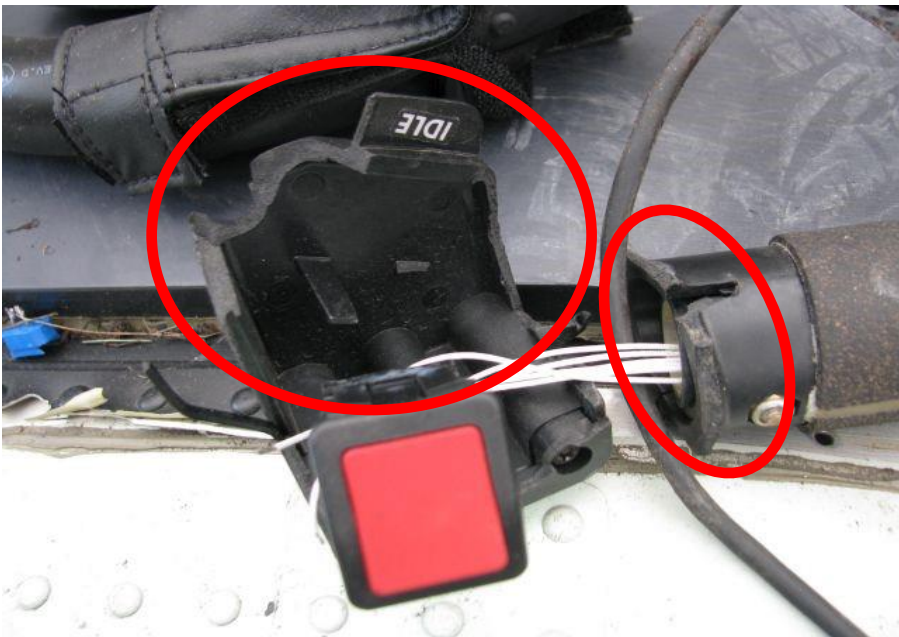
Photo 10
Collective head fractured consistent with overload forces at impact

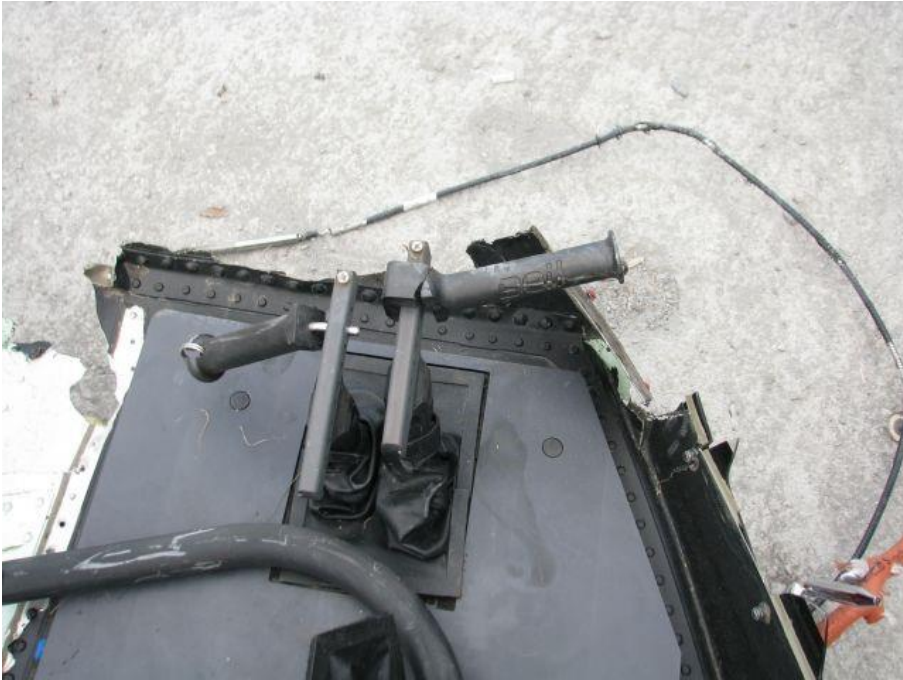
The tail rotor pedals exhibited damage consistent with impact forces (See Photo 11). The pedals moved freely by hand and movement was observed in the steel tail rotor cables through the forward pulley at the rear of the cabin floor. Tail rotor cable fractures were observed in two areas of airframe fracturing. First, the aft fuselage between the mid upper and aft pulleys and just aft of the turnbuckles, the left and right pedal cables were observed fractured as result of separation of the main cabin floor from the aft fuselage (See Photo 12). Second, the aft tailboom area at the location of the tailboom fracture from main rotor strike, both left and right tail rotor pedal cables were fractured. Free pitch change was demonstrated from the slider tube through the tail rotor mast to the tail rotor hub.

Photo 11
Damage to pilot tail rotor pedals consistent with impact forces

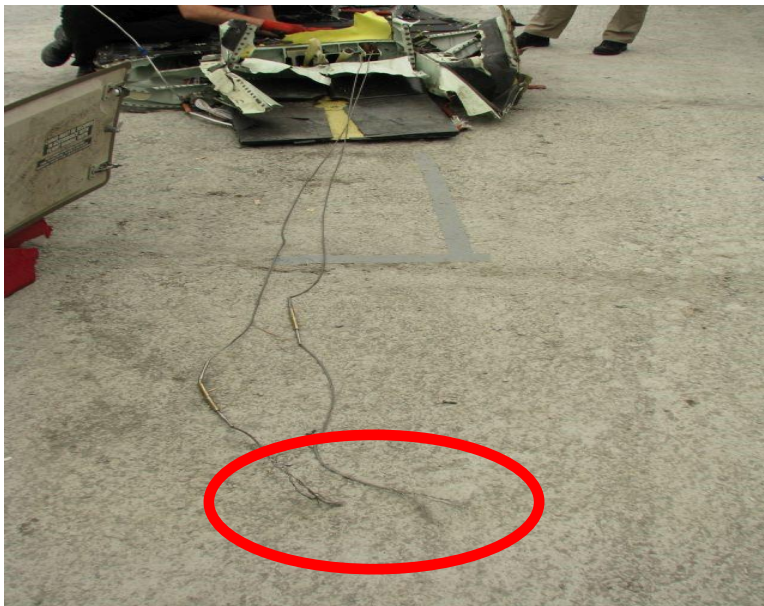
Photo 12 Fractured tail rotor control cables as result of separation of cabin and aft fuselage at impact

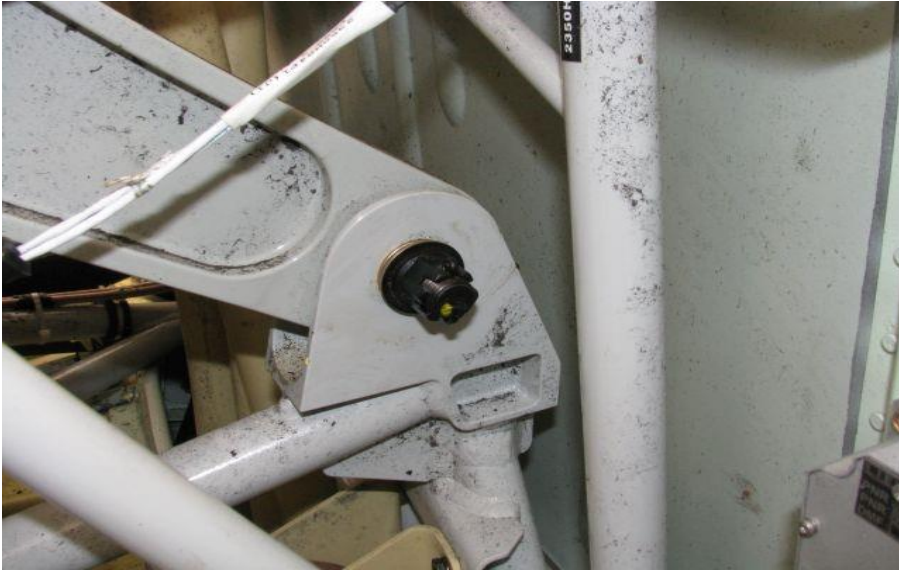
Photo 13

For the left and right LIVE mounts, all four LIVE support arm connections to the airframe were connected to airframe truss structure (See Photo 13). Two studs on the inboard right LIVE transmission adaptor exhibited stripped threads and the nuts were missing (See Photo 14). The load direction to strip the threads of the studs is consistent with a heavy downward and lateral impact force. The fore/aft elastomeric restraints, located aft of the transmission mounts, were intact.

Intact nut and bolt securing RH forward LIVE support arm to truss. Other three corners also intact.

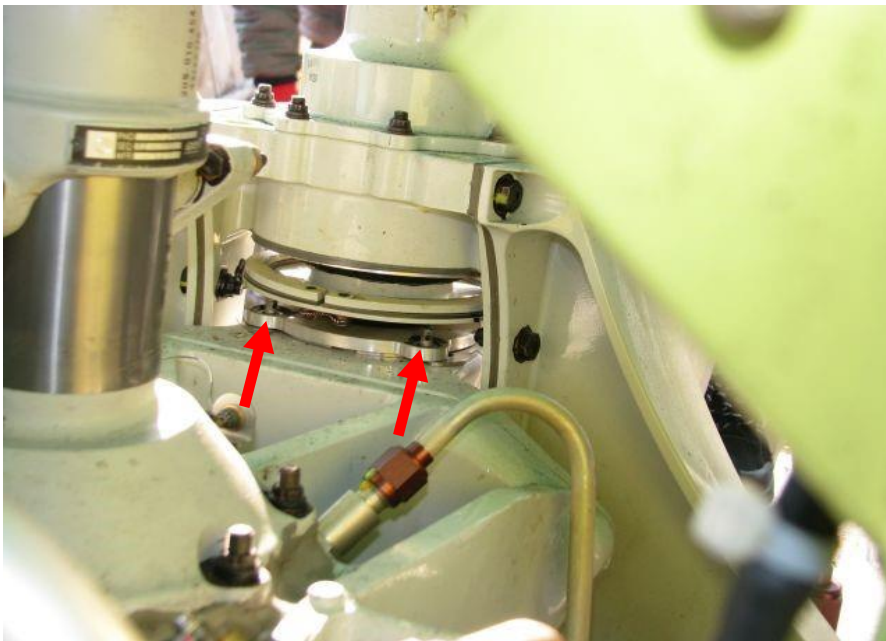
Photo 14

Two studs on RH inboard LIVE transmission adaptor were found stripped and nuts missing

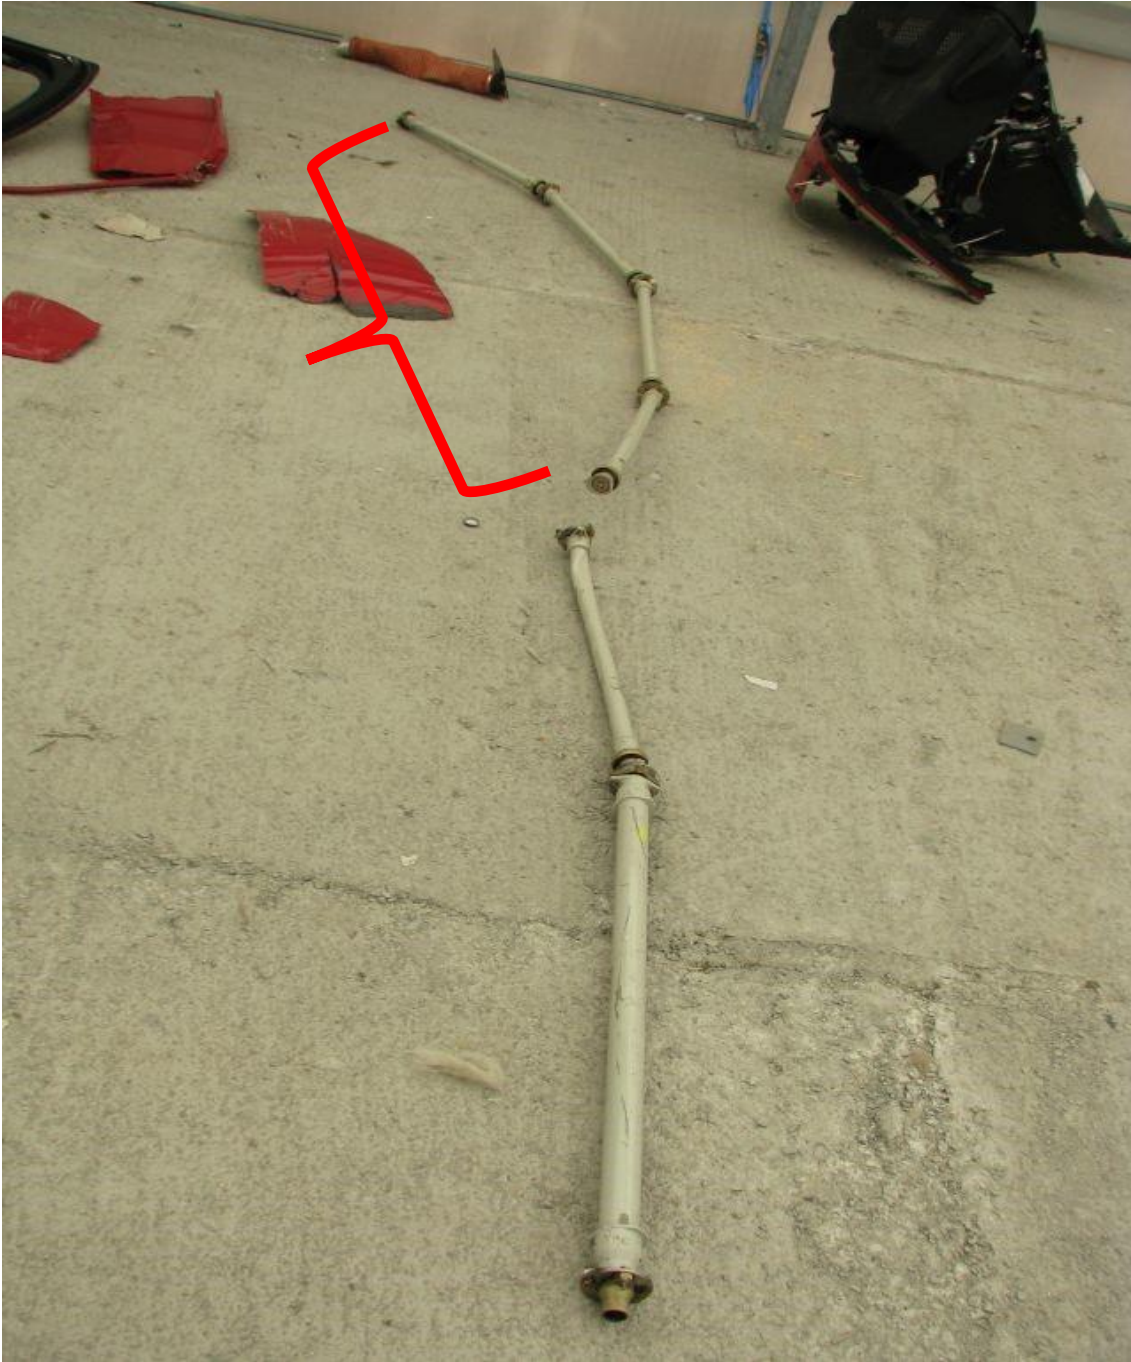
Photo 15

Four aft tail rotor driveshafts found approx. 150 m from wreckage consistent with main rotor strike

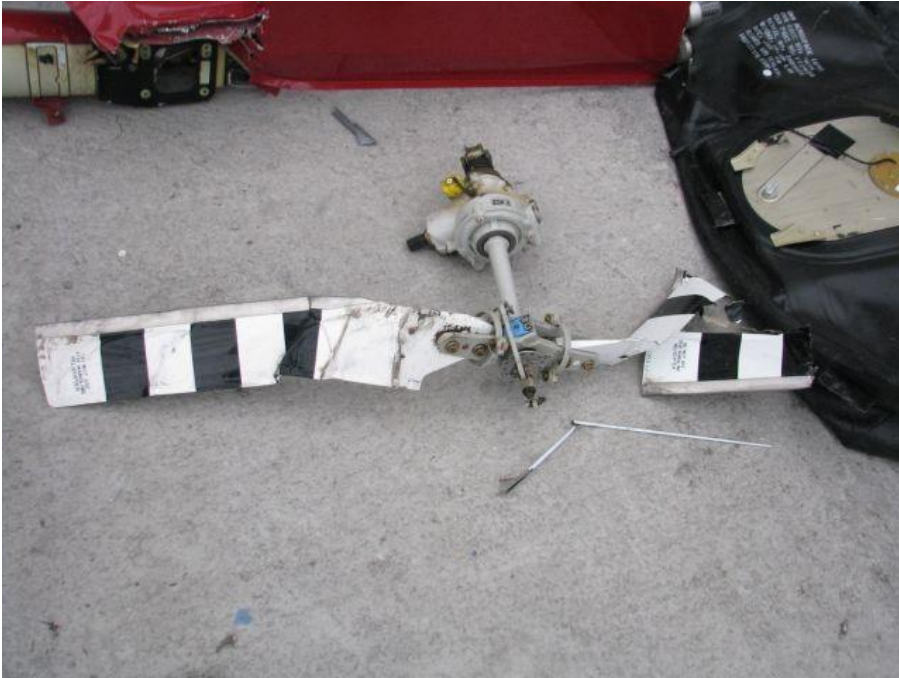
Photo 16
Both blades exhibited impact damage

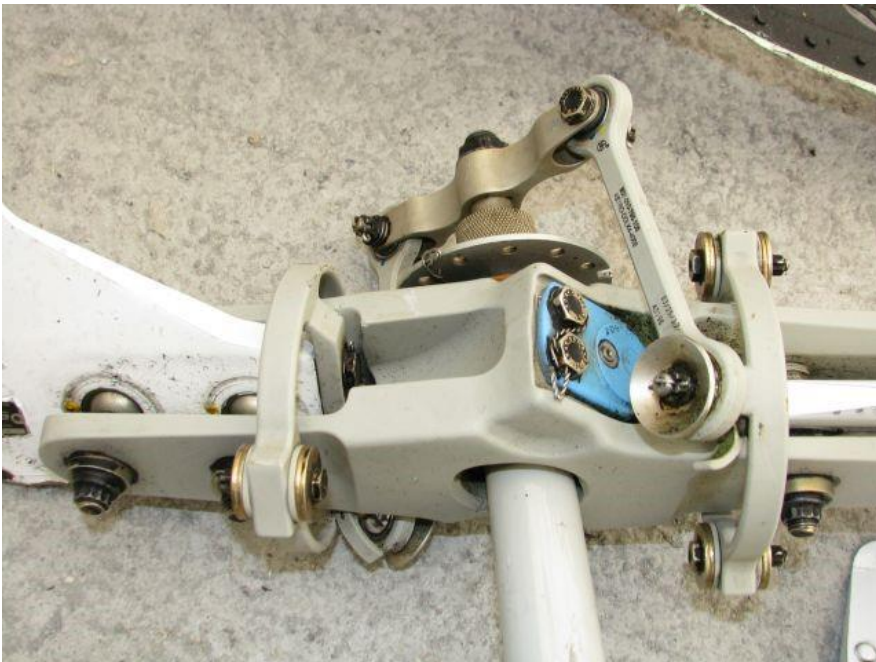
Photo 17
Tail rotor hub with intact connections at pitch change links and blades

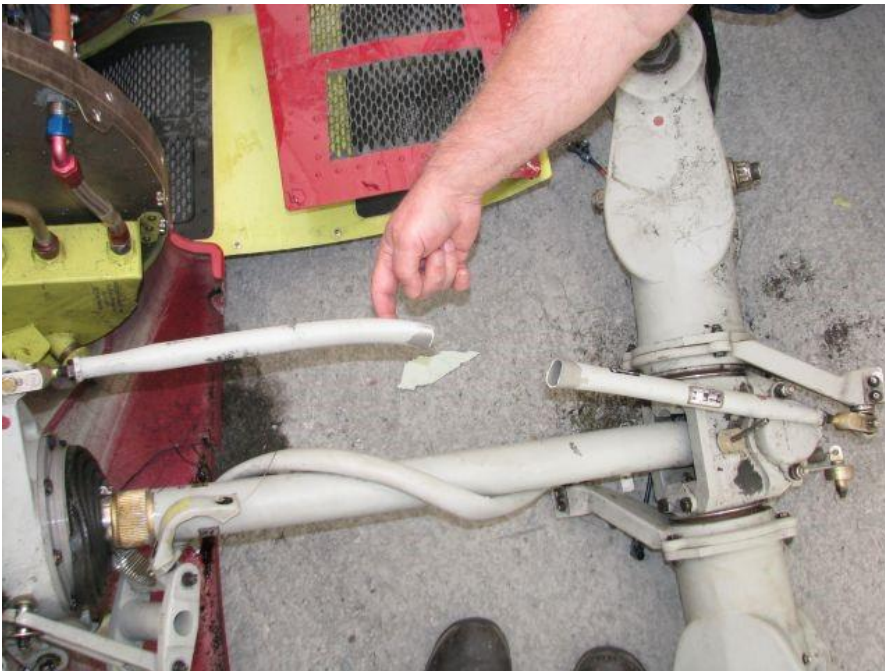
Photo 19

Red pitch change link (PCL) fractured near center of tube consistent with impact overload force

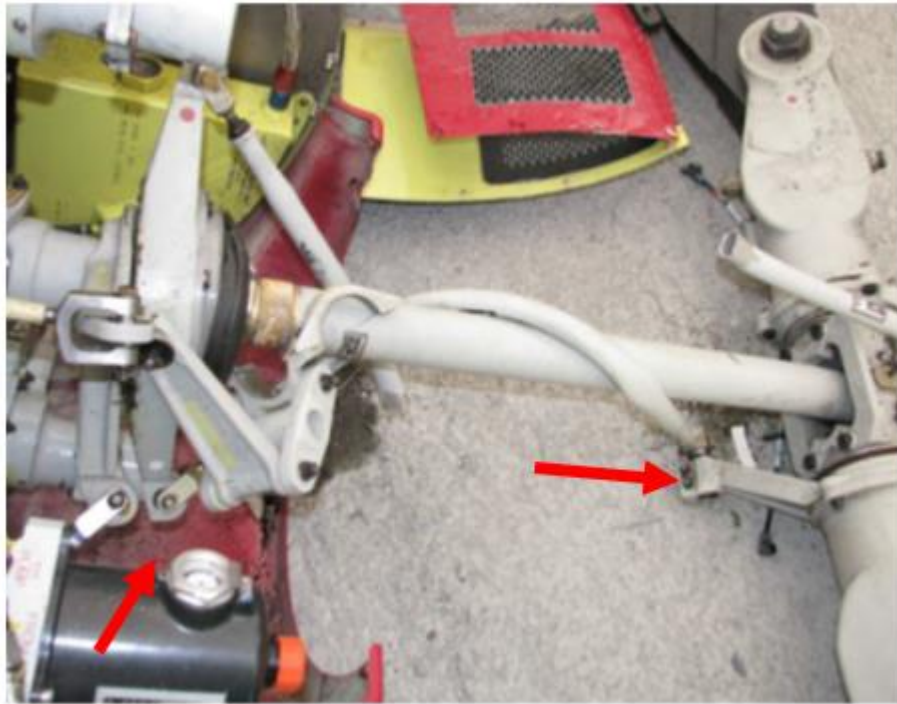
photo 20

White PCL wrapped around mast with intact connections to swashplate (bottom) and pitch horn (top)

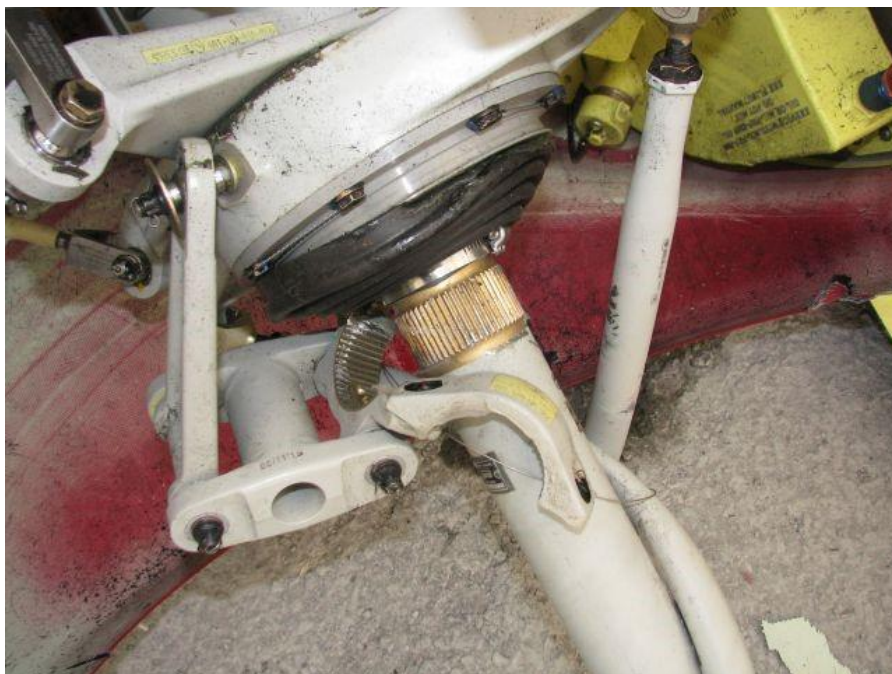
Photo 21

Splined drive collar found disconnected from mast splines consistent with impact forces

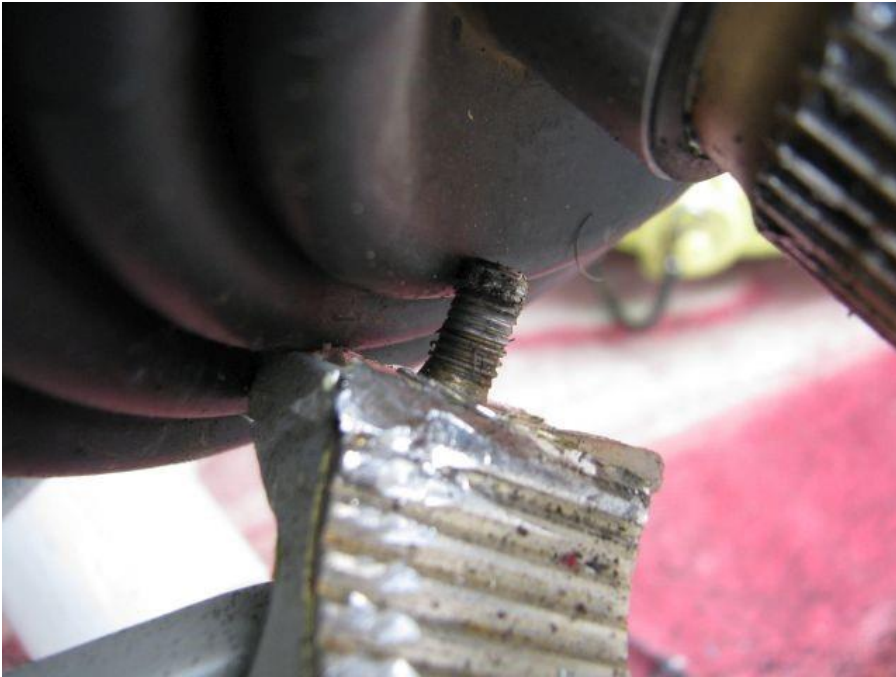
Photo 22

Missing nut and partially stripped bolt threads on retention bolt for splined drive collar

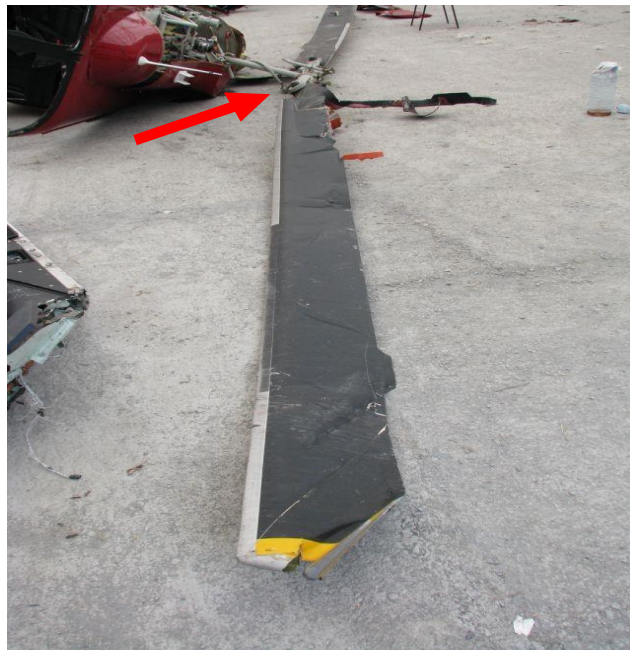
Photo 23

White main rotor blade fractured at inboard location consistent with overload

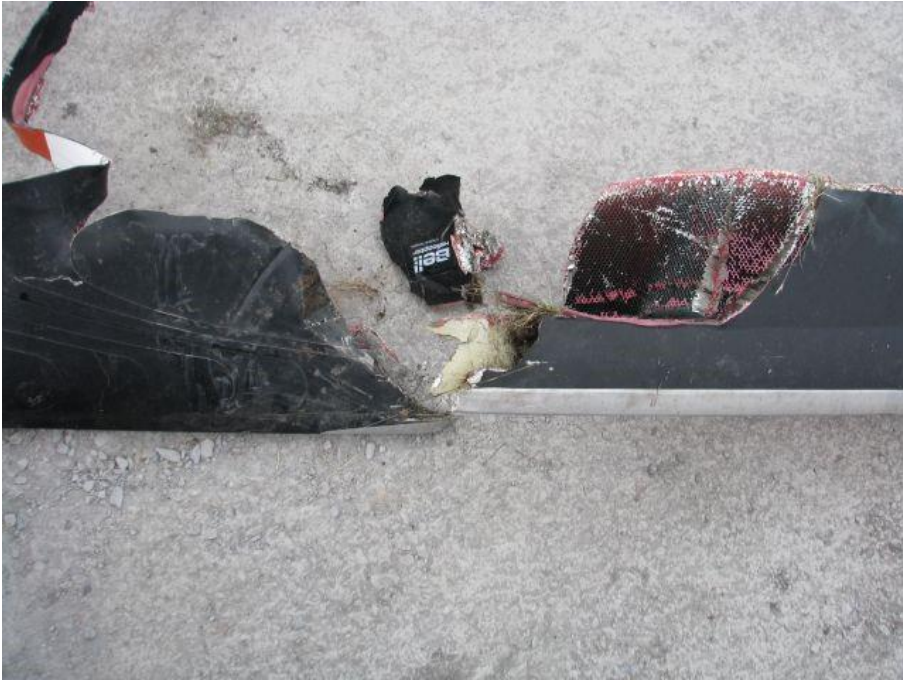
Photo 24

White blade fracture through spar and afterbody near most outboard doubler

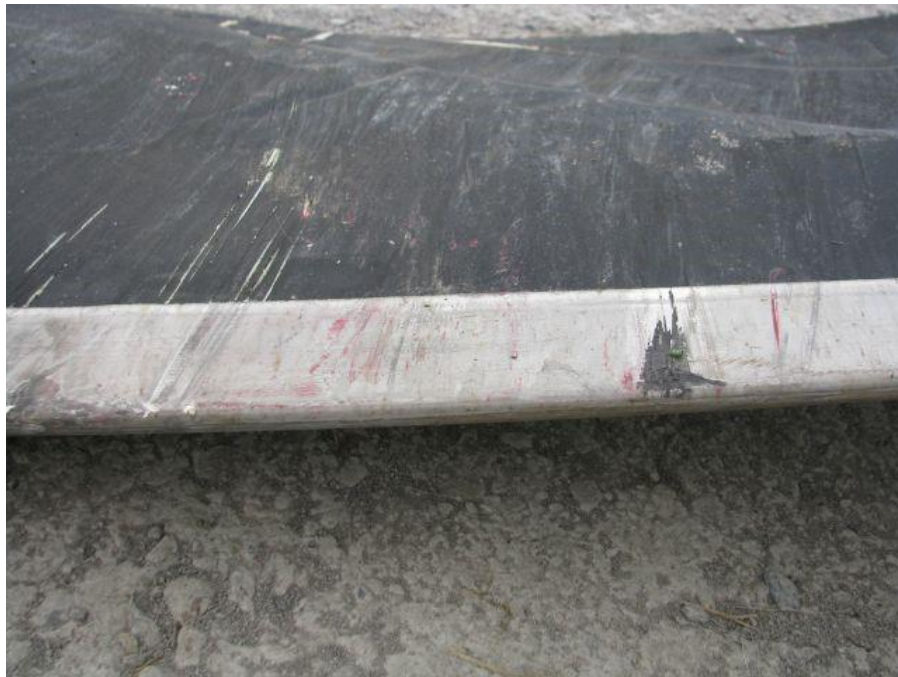
Photo 25

Red paint transfer on White blade leading edge consistent with tailboom color

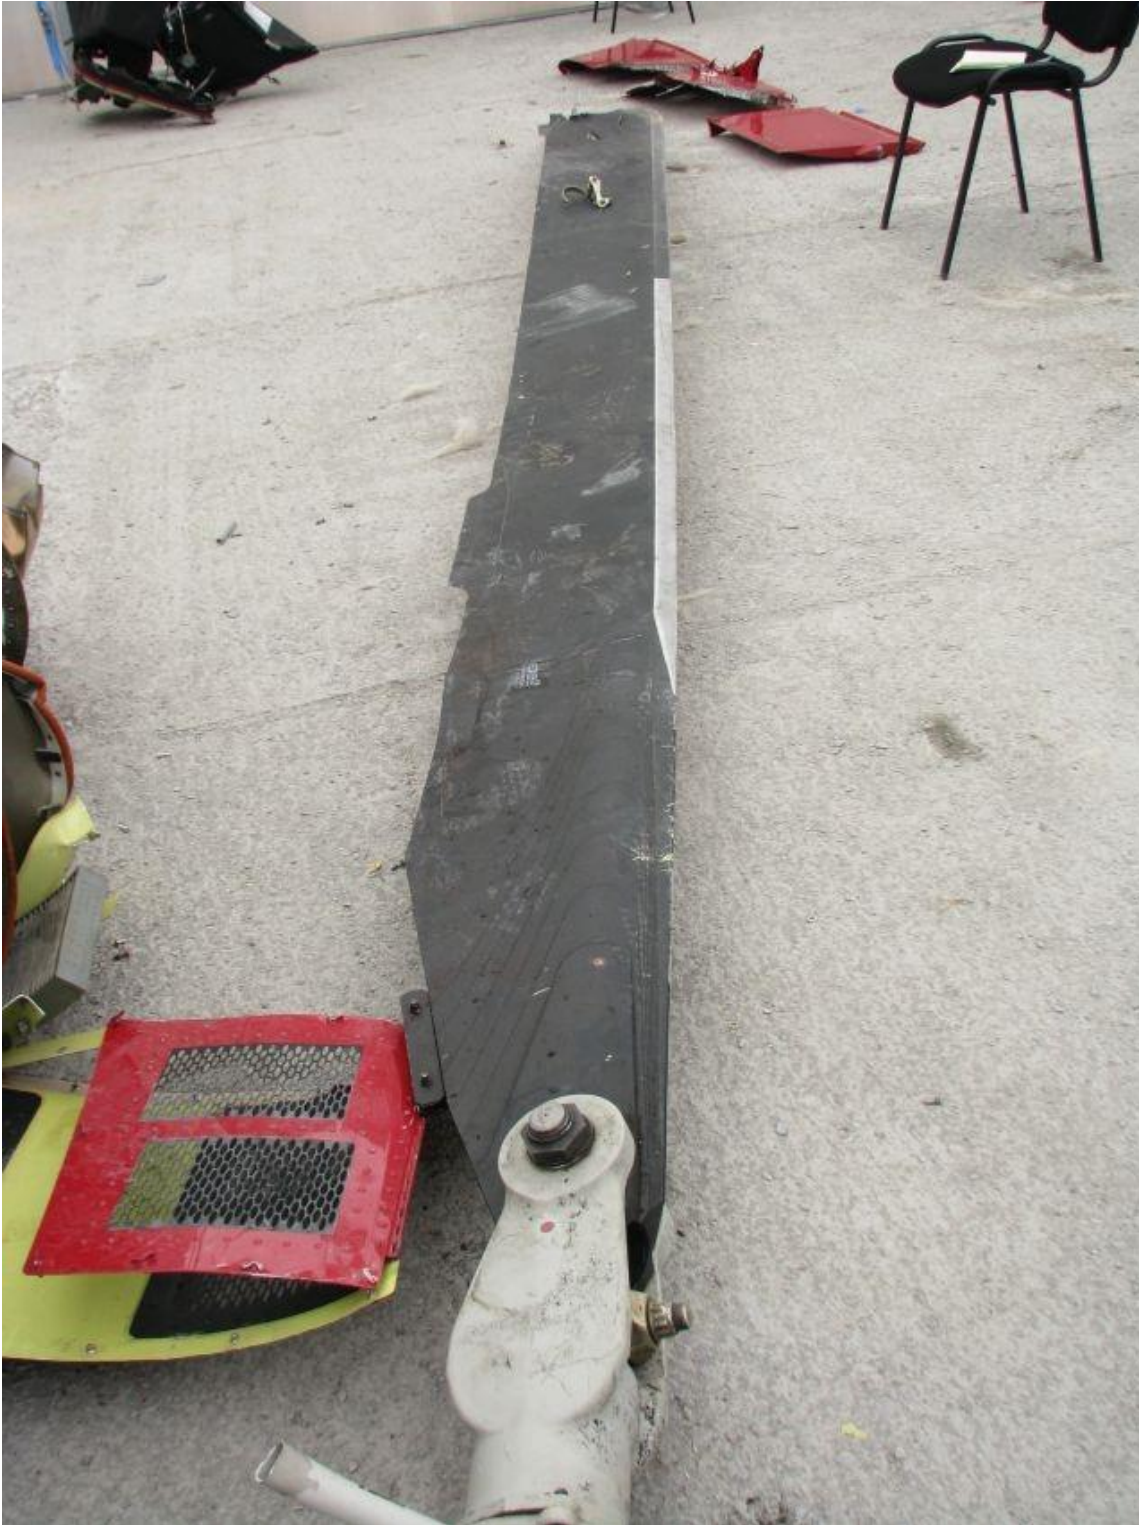
Photo 26

Red main rotor blade was relatively intact with no spar fractures

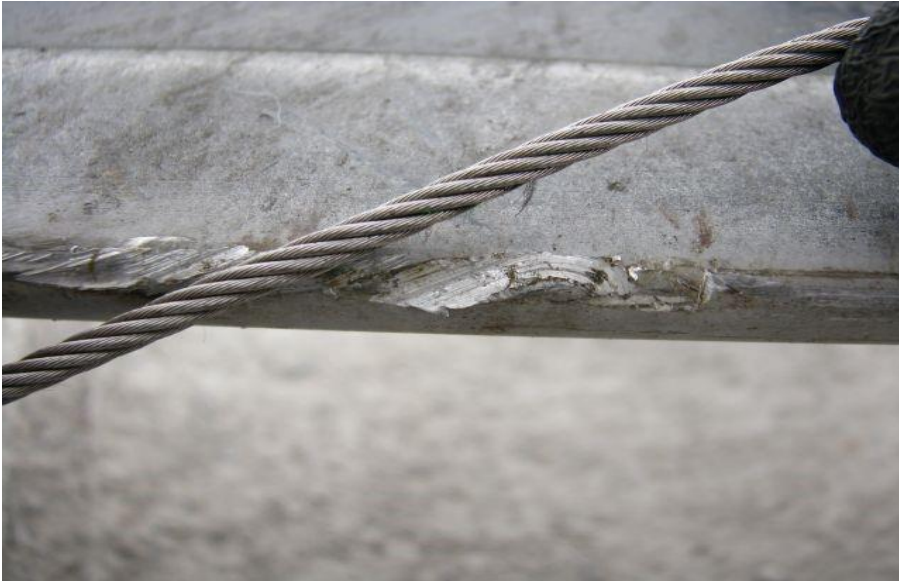
Photo 27

Markings on the Red main rotor blade leading edge were consistent with contact with tail rotor cable

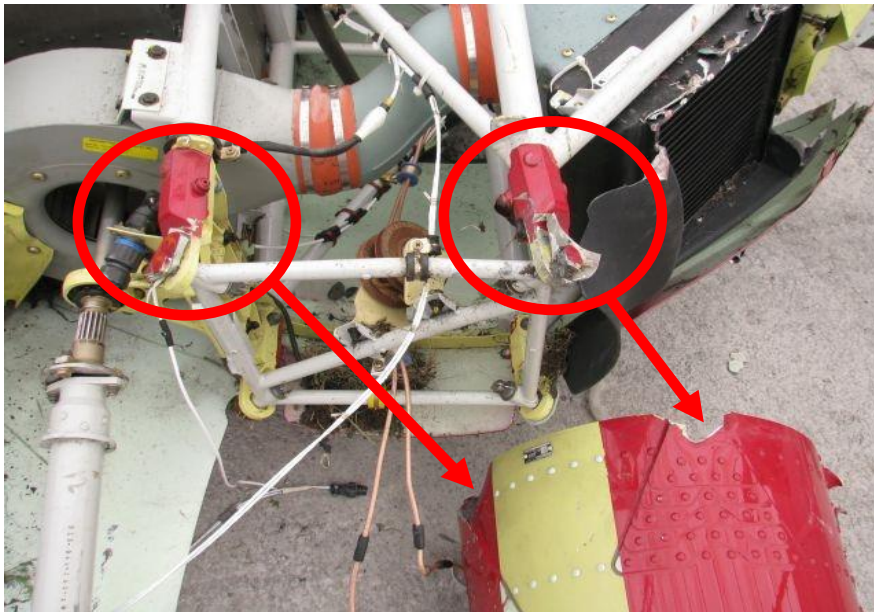
Photo 28

Tailboom separation from aft fuselage with doubler fractures consistent with impact overload forces

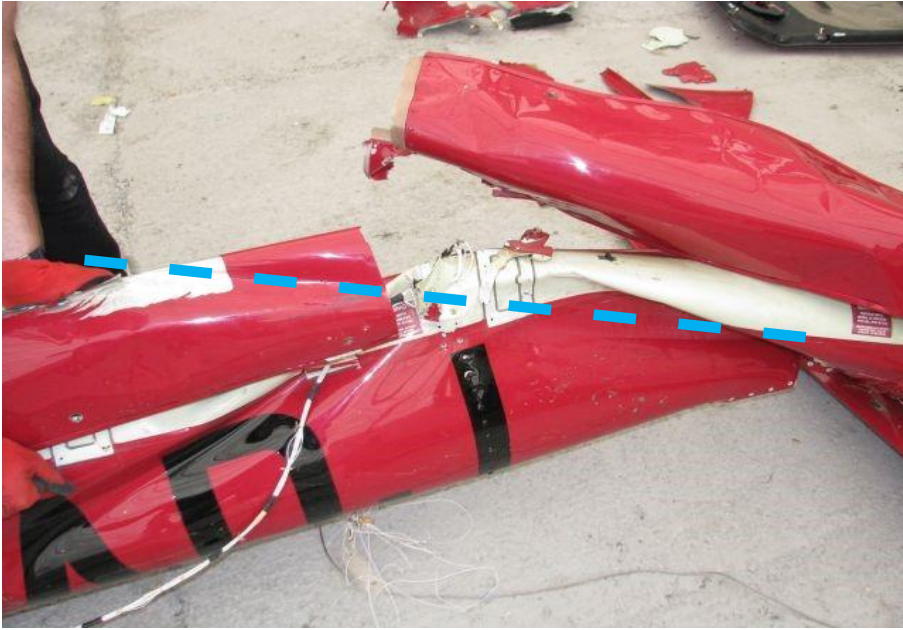
Photo 29
Linear strike mark on left side of tailboom consistent with main rotor strike

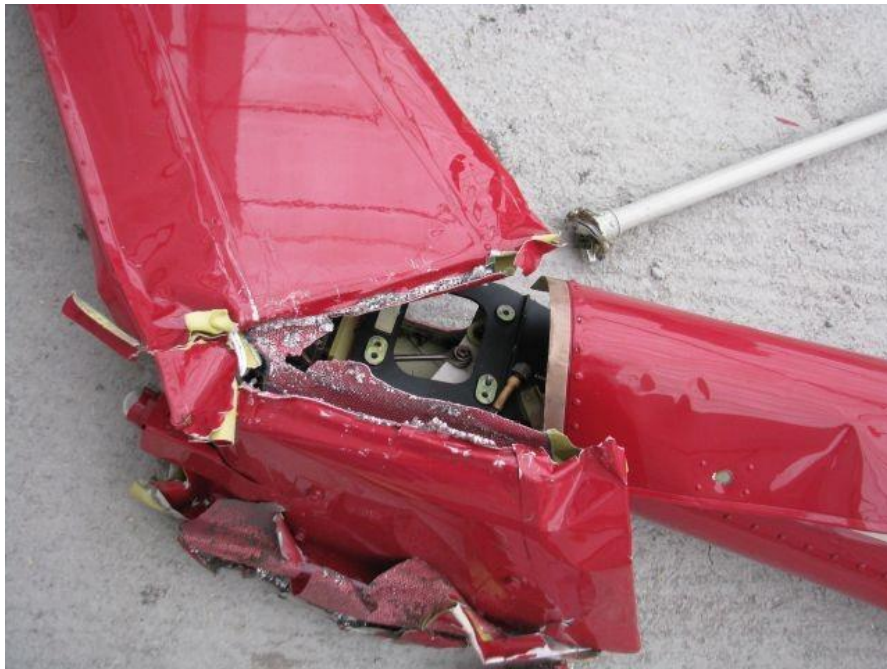
Photo 30
Fracture in middle of vertical fin from cable strike and mud on bottom fracture

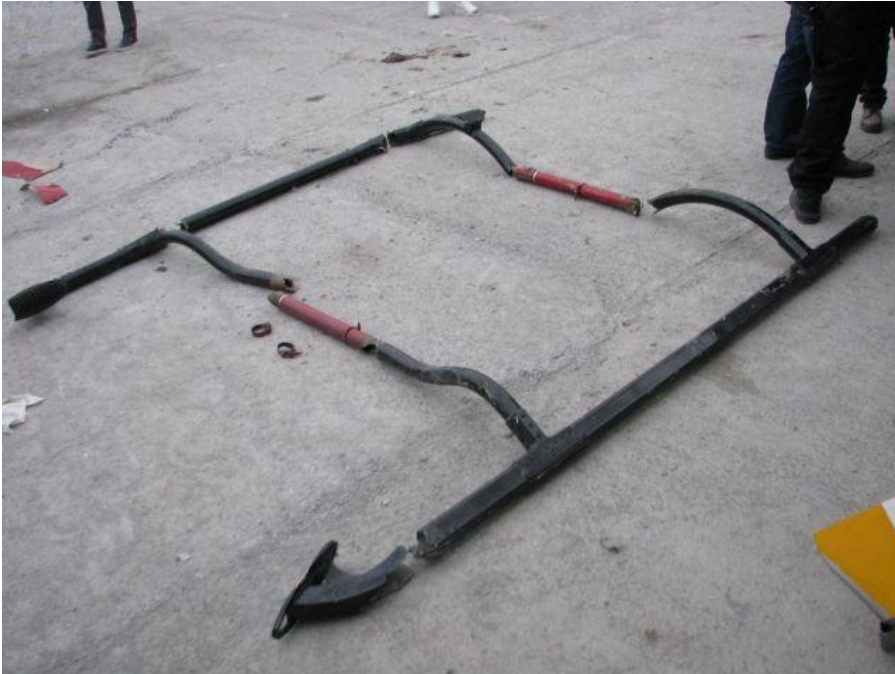
Photo 31

Both cross-tubes spread out with slightly more spread on right side

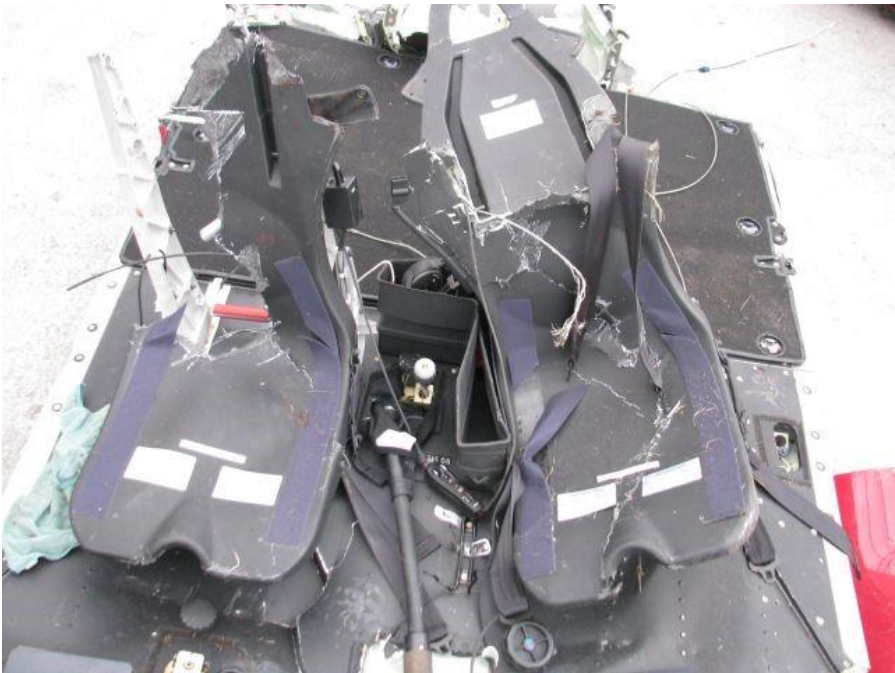
Photo 32

Pilot and copilot seats displaced to the right and exhibiting fractured back supports

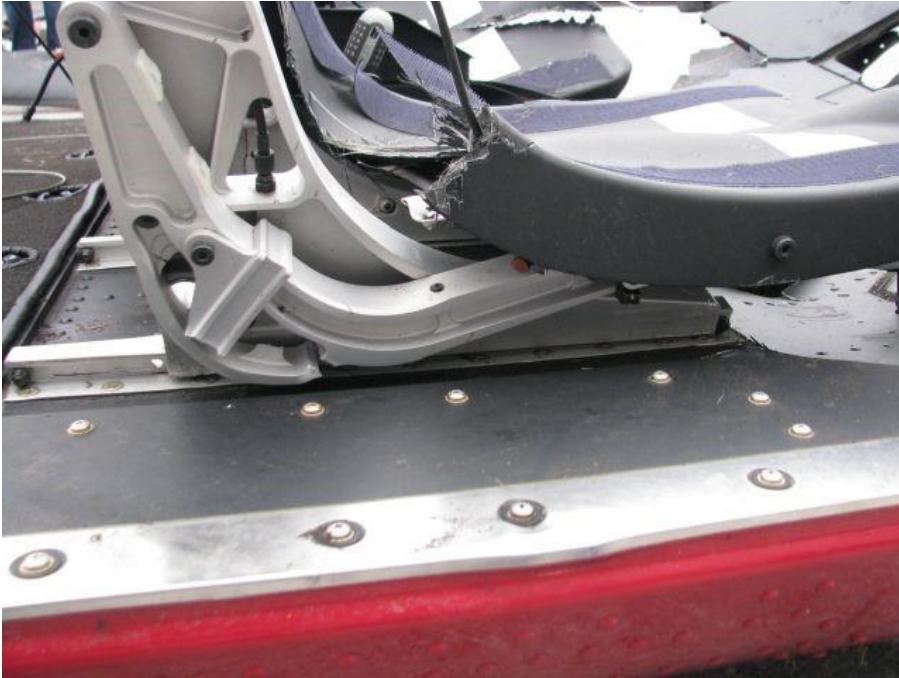
Photo 33

Pilot (right front) seat was stroked and exhibited fractured support

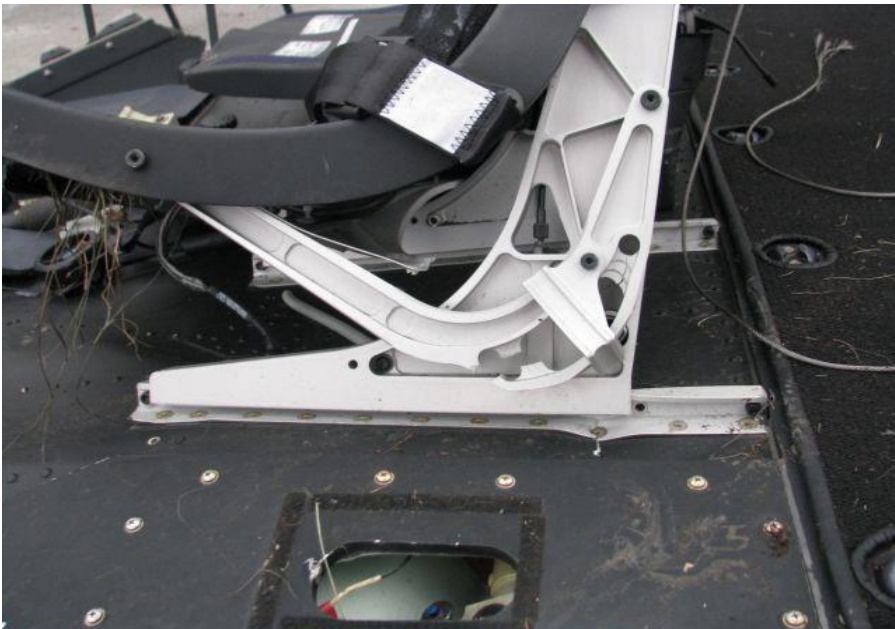
Photo 34

Copilot (left front) seat was stroked and exhibited fractured support
