**Ministry of Economy and Sustainable Development of Georgia
Civil Aviation and Maritime Transport Accident Incident
Investigation Bureau**

**Final Report on accident to Bell 505 helicopter in Kazbegi municipality,
Georgia on 6 June 2019**

Helicopter type	BELL-505
Nationality and registration marks	4L- ADJ
Operator	“Aviator+” LLC
Time and date of the accident	10:57 (local time) 06.06.2019
Accident location	“Kazbegi” municipality settlement “Stepantsminda” (Georgia).
Geographical coordinates	N 42°38' 59'' E 44°38' 49''

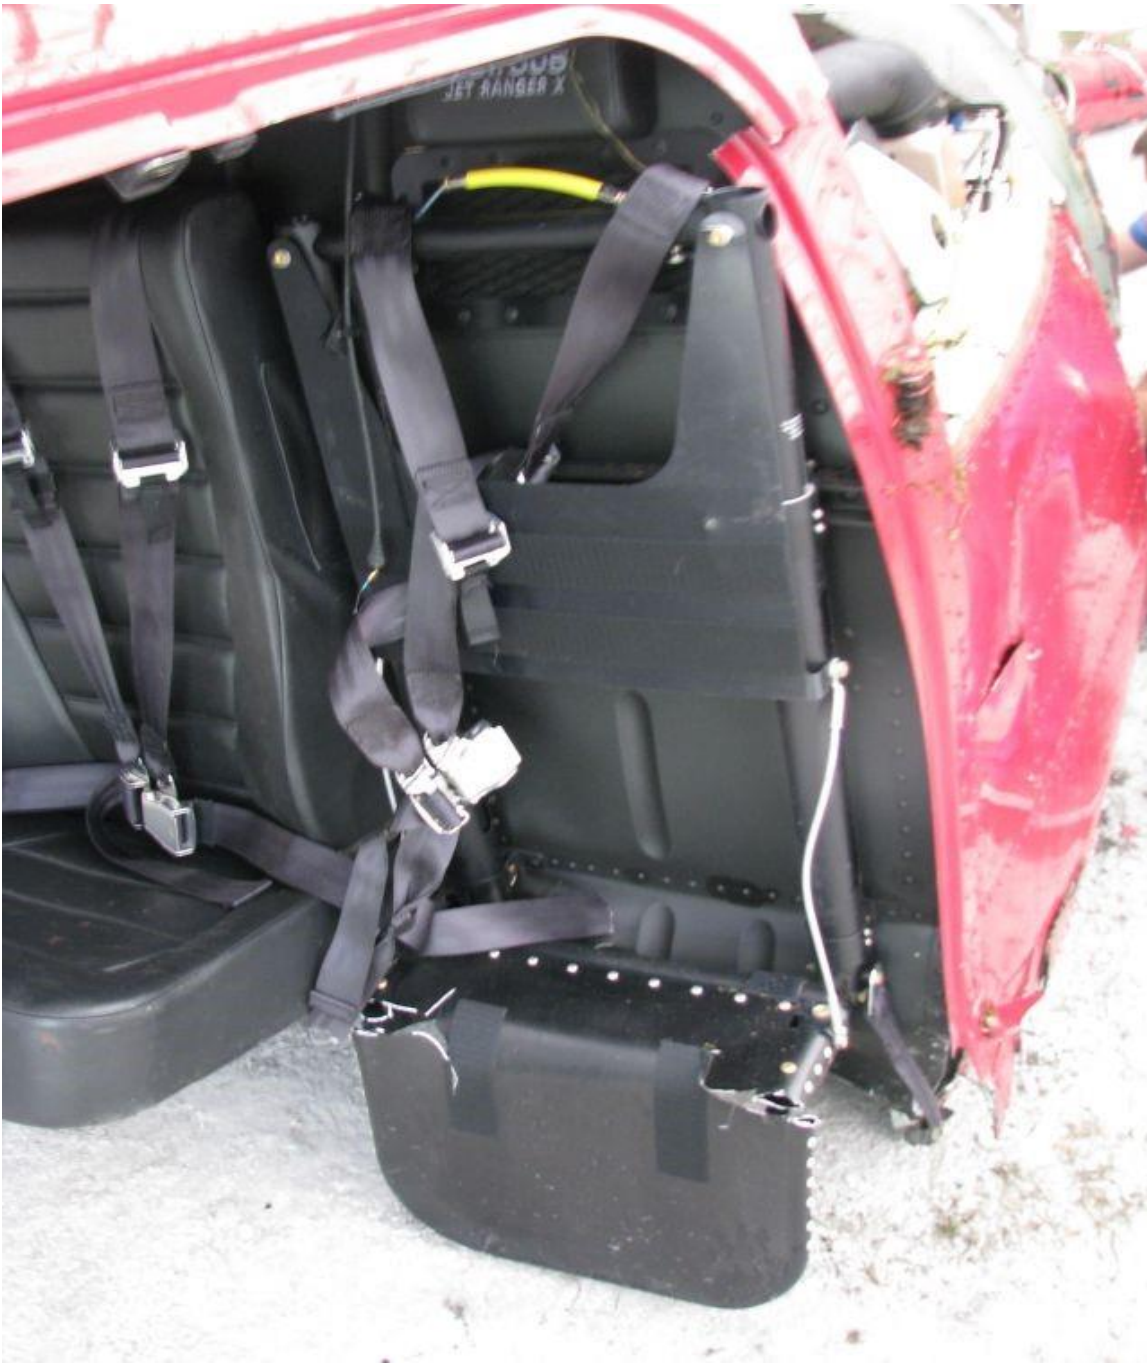
Photo 35

Left passenger seat with seat structure fractured down

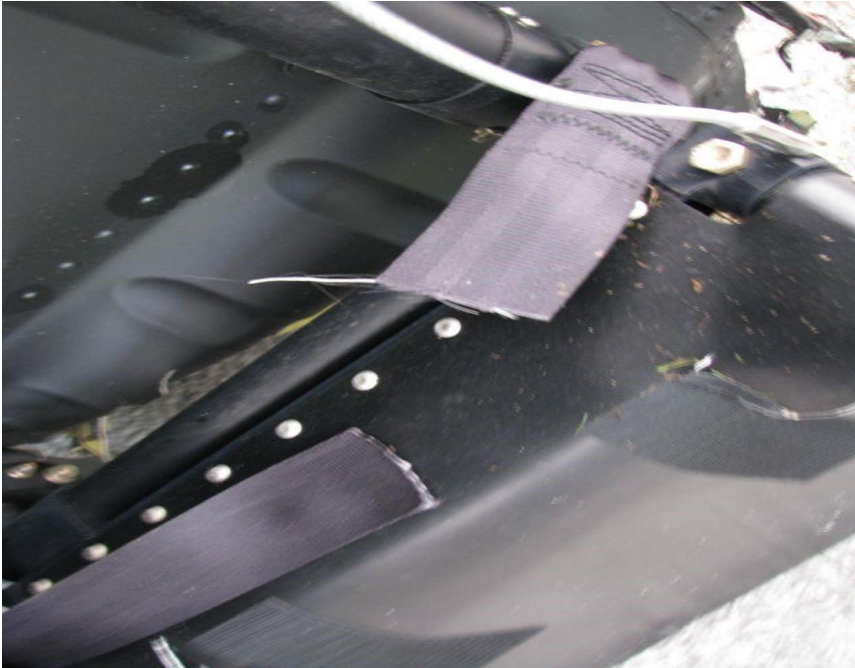
Photo 36

Passenger seat lap belt was reportedly cut by a first responder

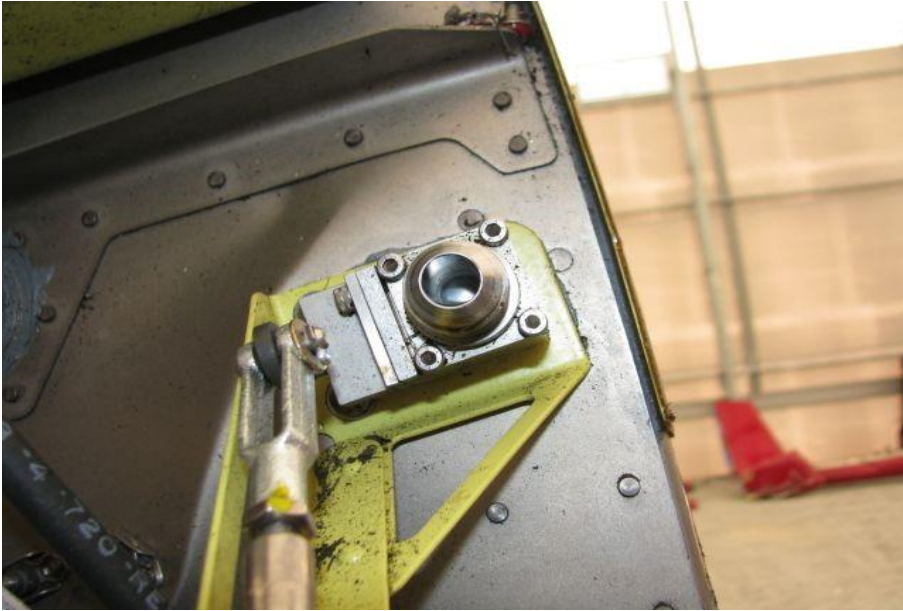
Photo 38
Emergency fuel shutoff valve was found in Off position

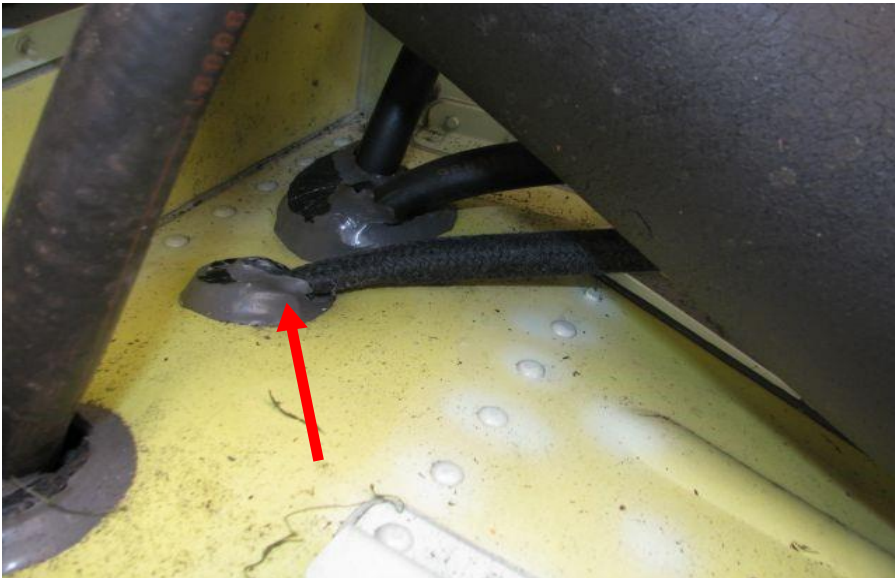
Photo 39
Fuel line was found crimped at location where it makes 90° turn at aft fuselage deck

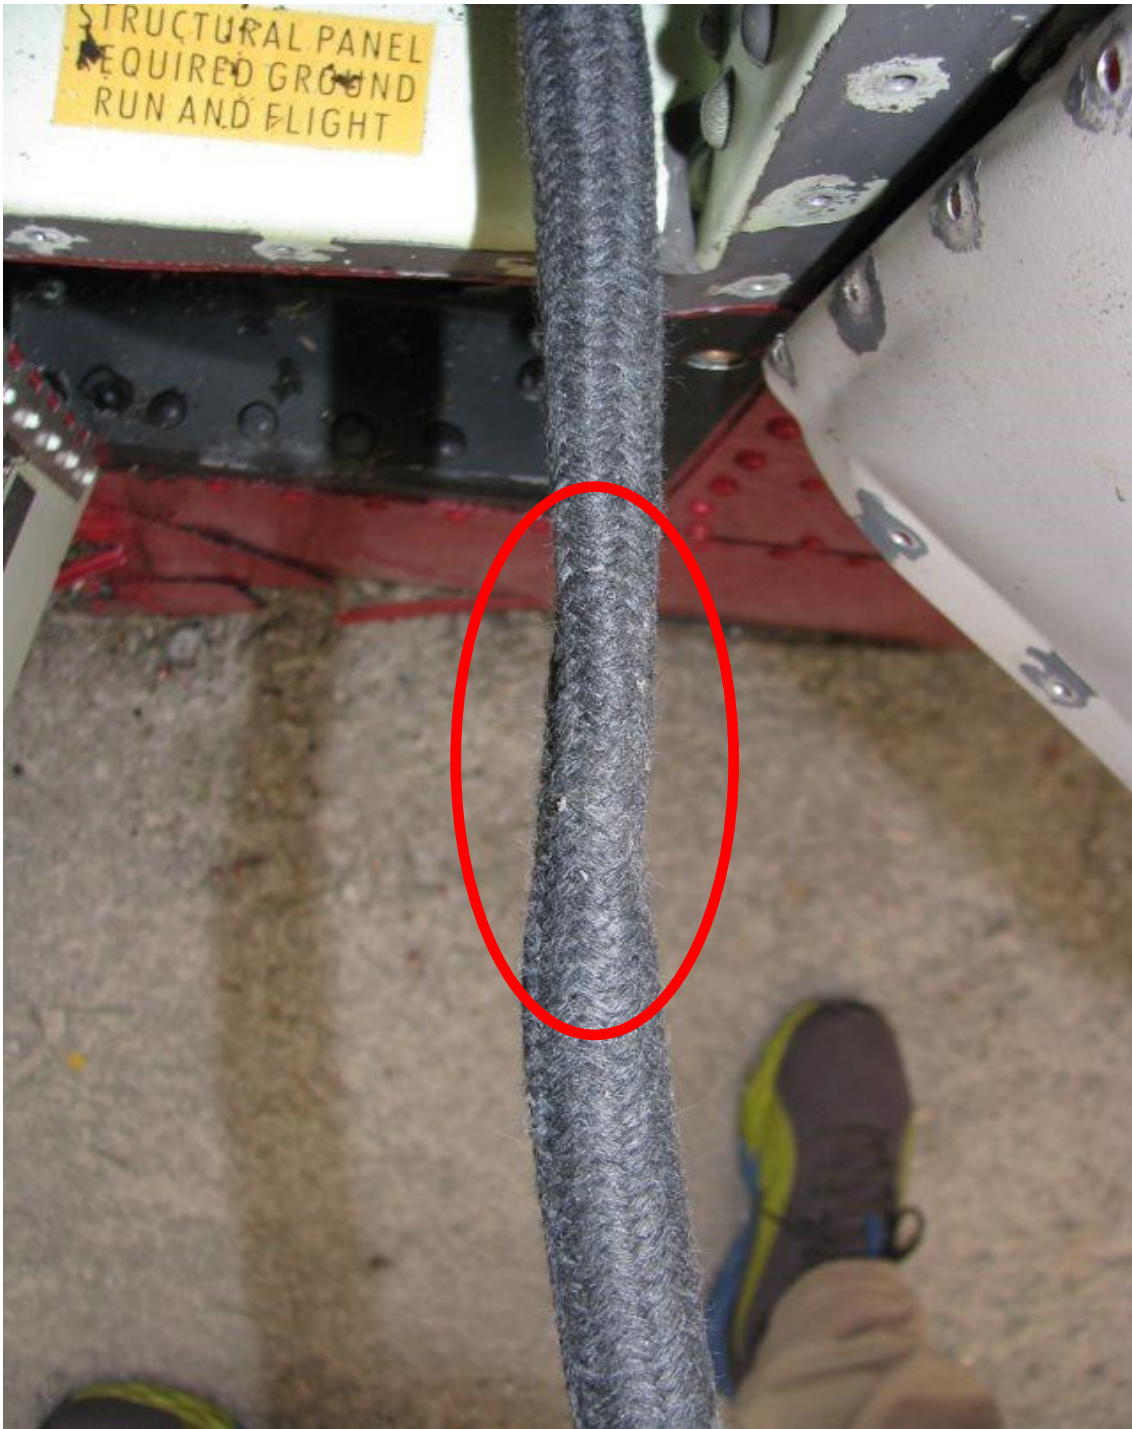
Photo 40
When fuel line was removed, crimped section was observed at area of 90° turn

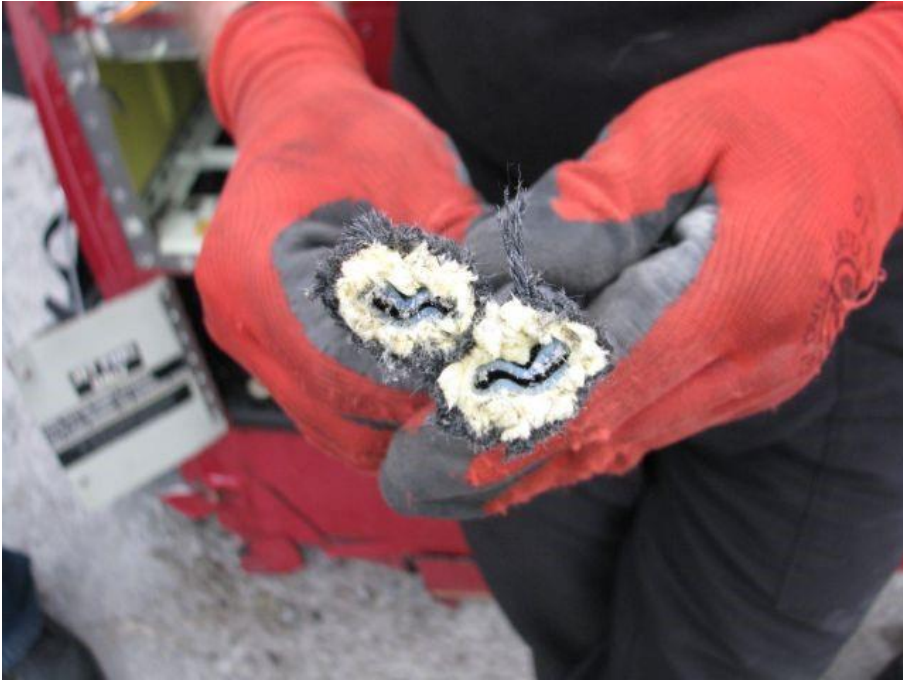
Photo 41

Fuel line was cut in area of reduced cross section and crimped area was observed

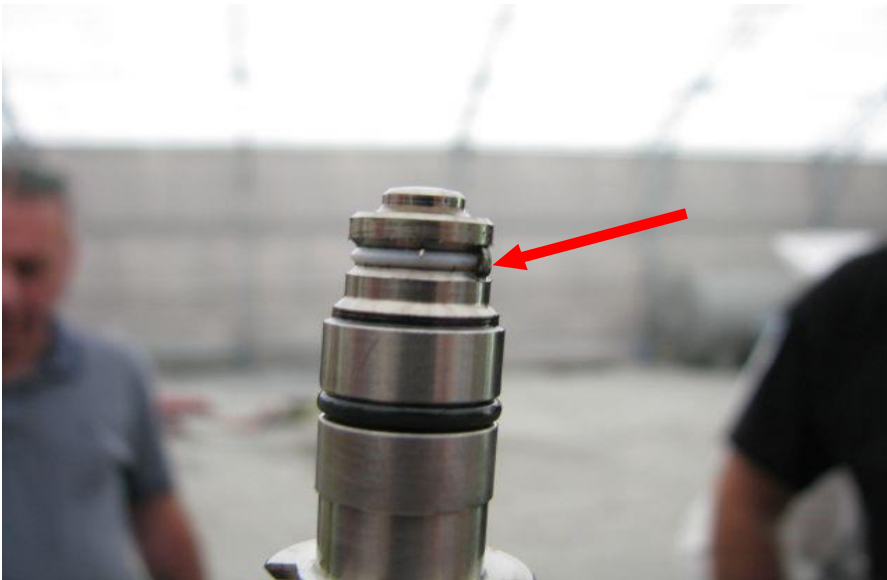
Photo 42

Engine module 01 chip detector with tab type chip found (arrow)

The engine exam revealed that tab-type chips were found on the engine lower chip detector (See Photo 42) although no chips were observed on the rear upper chip detector. The Ng and Np turbines rotated freely by hand. The engine was later removed from the helicopter by “Aviator +” personnel and shipped to Safran Helicopter Engines facilities at France for future examination. Inspections of the engine, of the airpath and its rotating parts were performed, as well as checks and tests on the electrical magnetic plugs and on the igniters. The removal of the accessory gearbox (module M01) was then operated to control the state of the drive train.

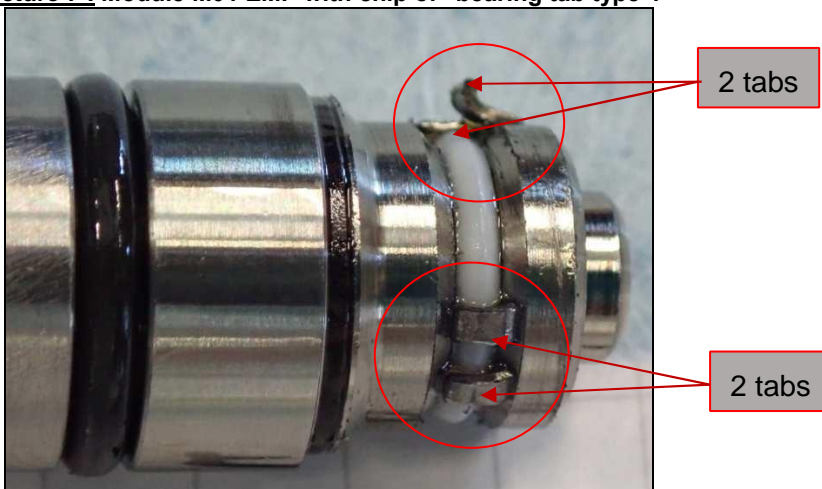
Picture 8 : Module M01 EMP with 4 chip of “bearing tab type”.

An electrical continuity test was performed with the tabs left as they were found: the resistance measured (60kOhm) confirmed that, in the tabs position, no current goes between the two heads of the EMP.

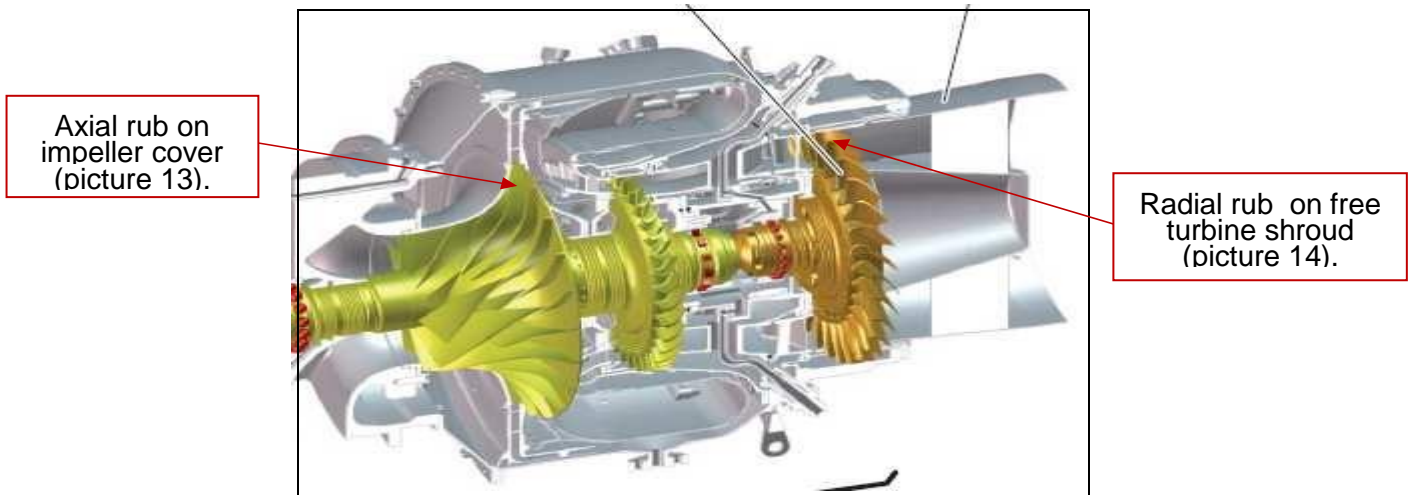
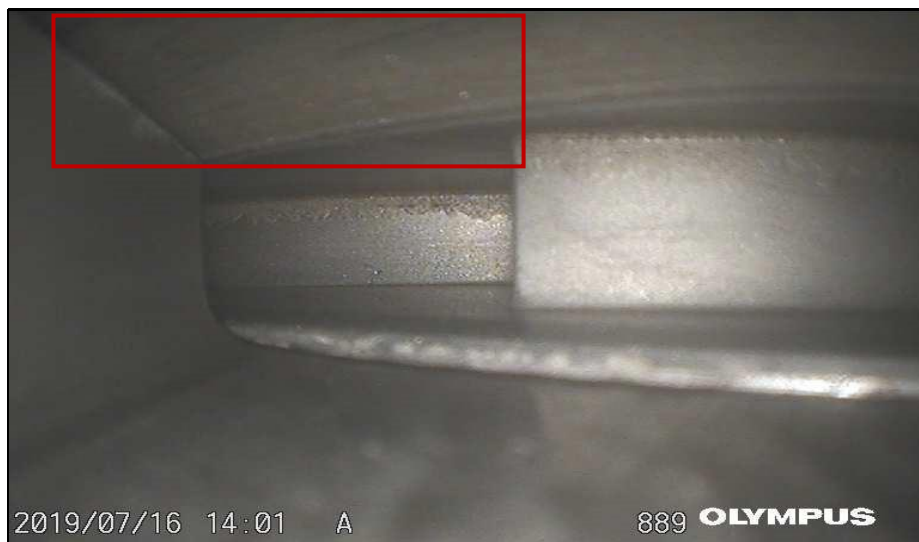
As the parts are not touching the rubbed zone anymore, it means it is likely that these rubs occurred at impact.

Picture 13 : light rub of compressor cover, at impeller trailing edge (red rectangle).

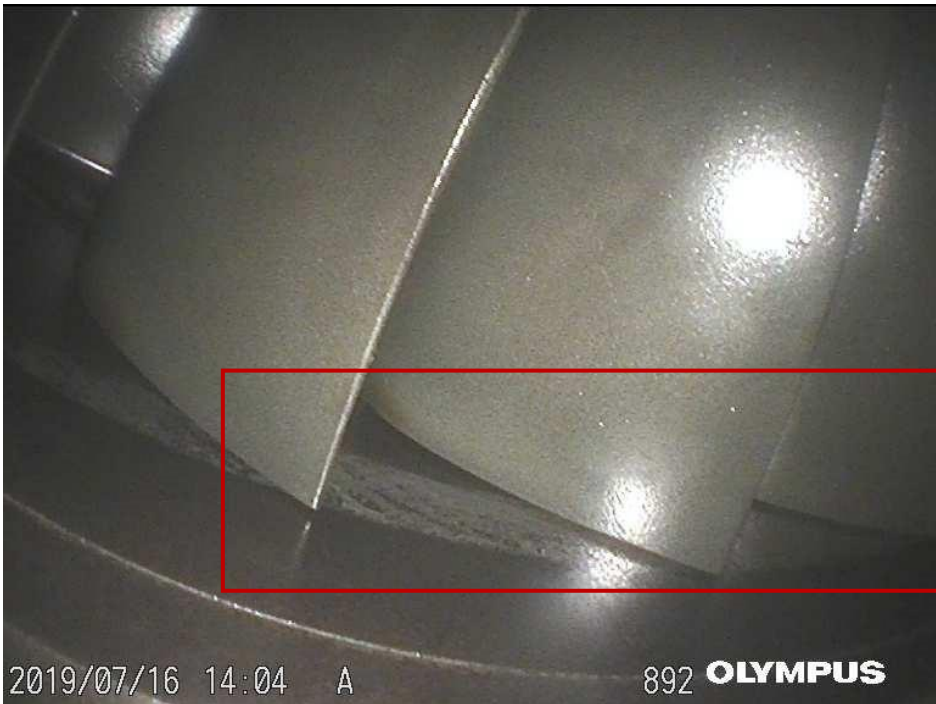
Picture 14 : light rub of free turbine shroud, at free turbine blade tips (red rectangle).

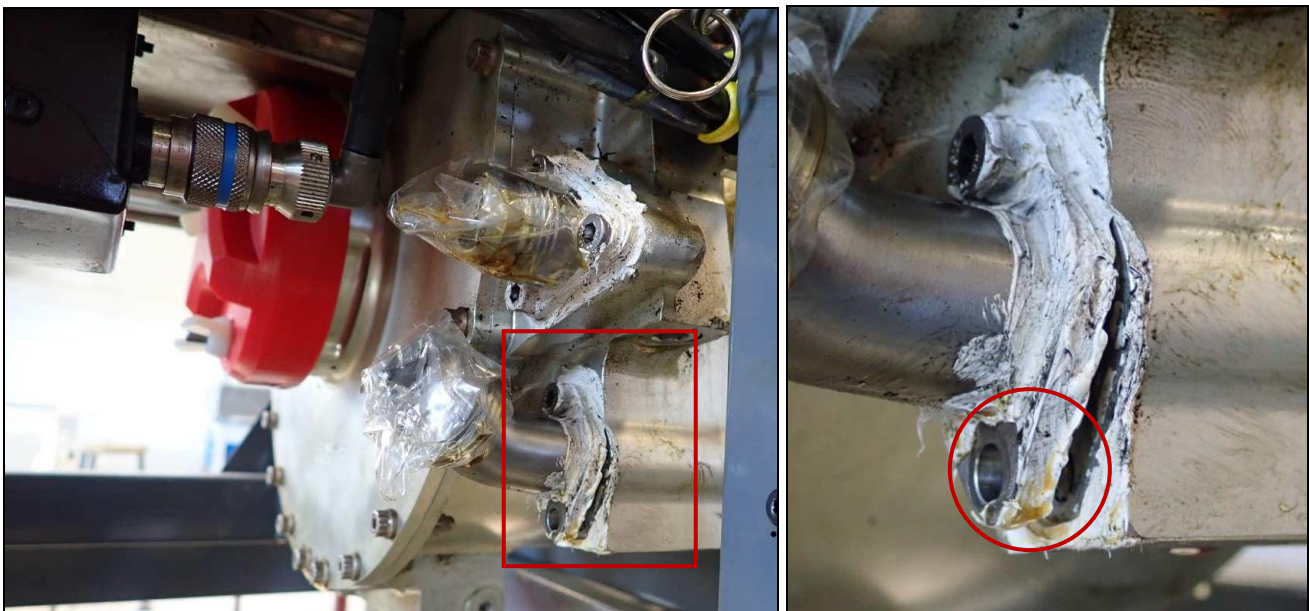
A visual statement is made that the oil connection from the oil tank to the module M01 casing was found partially unplugged. One of the two screws of the flange of the plug was also missing. This may explain why the oil tank was found empty on the accident site.

Pictures 15&16 : oil supply of Module M01 is unplugged and a screw is missing.

This kind of damage is repairable in the perspective of an engine run trial.

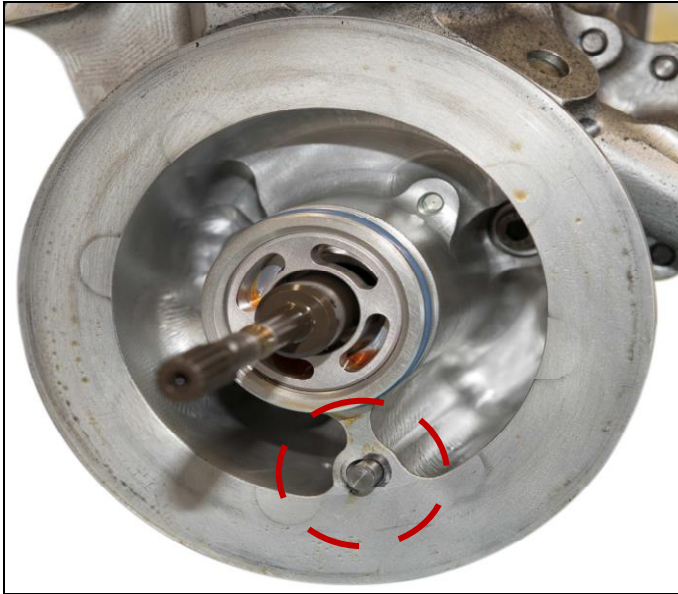
The HMU is removed from module M01. The positioning pin sets the angular position of the HMU on the module M01 casing. A masting of this positioning pin on the module M01 casing was detected. This statement was relevant with the induced metal beading and the ovalization of the drilling on the module M01 casing side. No other traces of displacement were found on the two cover flanges. These findings allow to conclude that the damage of the positioning pin was due to impact forces at the moment of the crash.

Picture 18 : positioning pin of the HMU below the centering bore and its rubber seal.

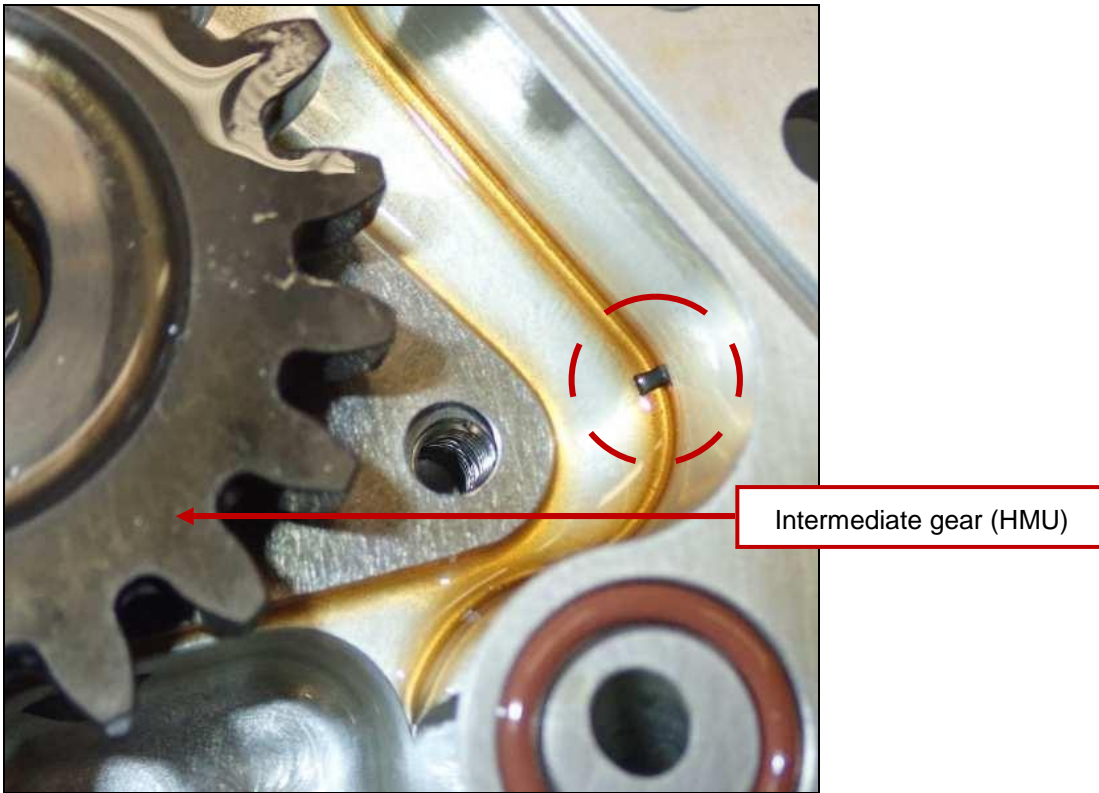
Picture 26 : Bearing tab located in the red circle, in the intermediate gear housing.

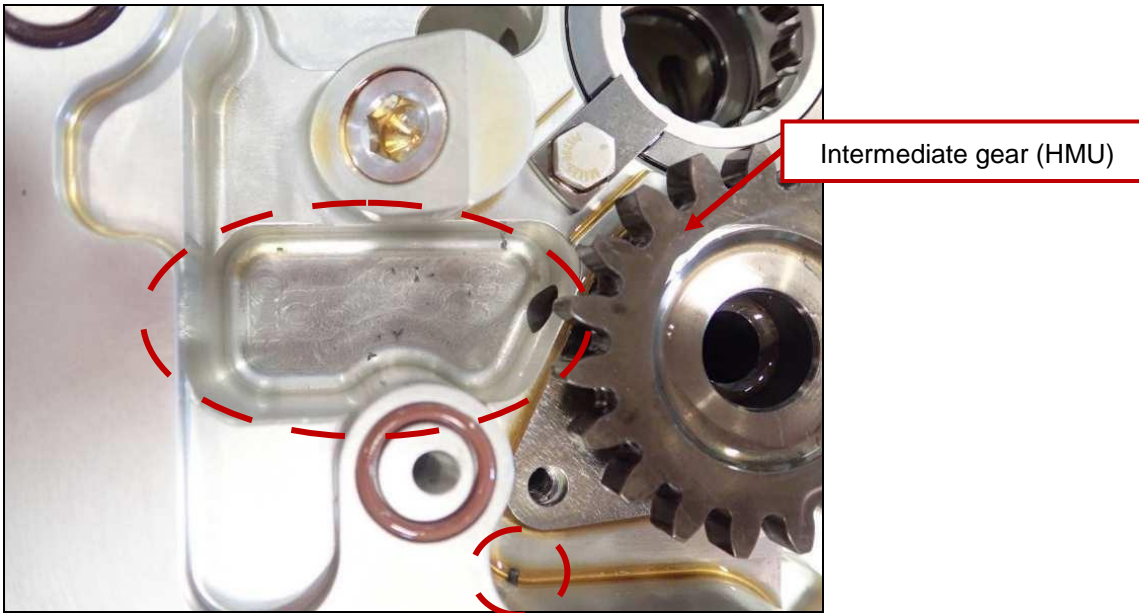
Picture 27 : Dust of unknown material was detected in one housing next to the intermediate gear housing. It was put into a dedicated plastic packet along with the tab found into the casing (previous picture).
