**Service Letter No. 3017/18/ARS2**

**Subject: Arrius 2R engine  
Module M01 (reduction gear). Chip events related to a  
bearing separating cage.**

# ARRIUS 2R ENGINE REDUCTION GEAR BOX BEARING TAB RUPTURE

19th of March 2021

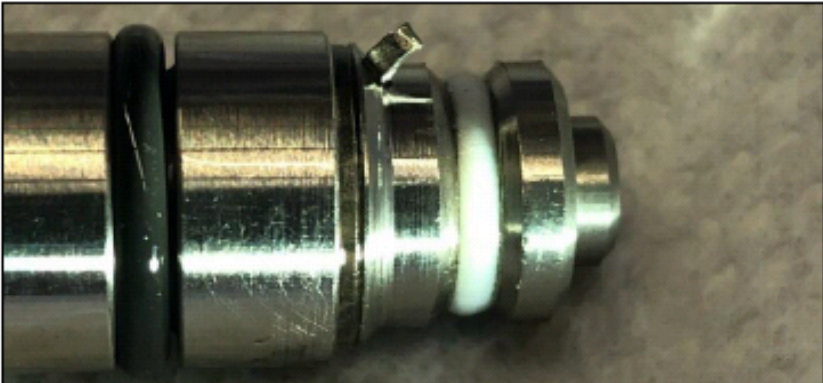
The pilots were notified by an "ENGINE CHIP" **ENGINE CHIP** or "ENG CD INOP" **ENG CD INOP** CASE message. After landing without any other incident, "ENG CHIP 1" **ENG CHIP 1** or "ENG CD 1 INOP" **ENG CD 1 INOP** messages were displayed. The inspection of electrical magnetic plug #1 showed the presence of one or several metal particles (XC material), that measure 2mm in length and 1mm in width. They are fragments of the stamped separating cage of the front bearing from the intermediate gear of the fuel pump drive gear in the module 01.

Bearing cage fragment on the electrical magnetic plug #1

Once chips are detected, you are required to do task 71-02-07-280-803 (refer to the Arrius 2R engine Maintenance Manual). For particles that are fragments of the separating cage fragment, (see photos in the APPENDIX), Safran Helicopter Engines requires the removal of module 01. Information on how to identify this type of material and the request of material removal will be incorporated in the April 2019 update of the Arrius 2R Maintenance Manual.

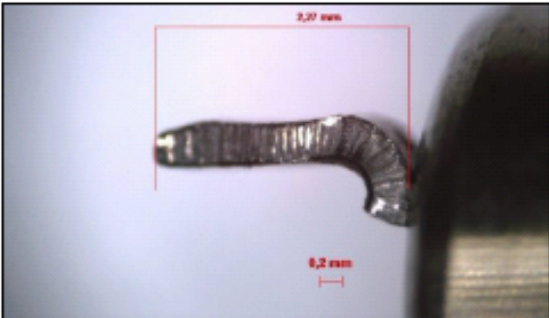
Bearing cage fragment under binocular microscope

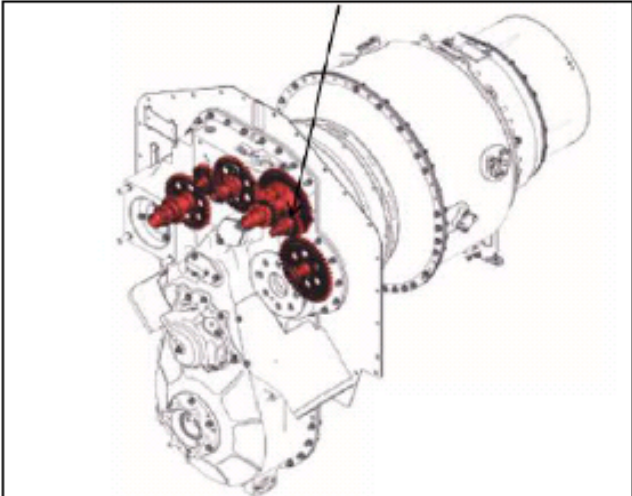
Location of the intermediate fuel pump drive gear

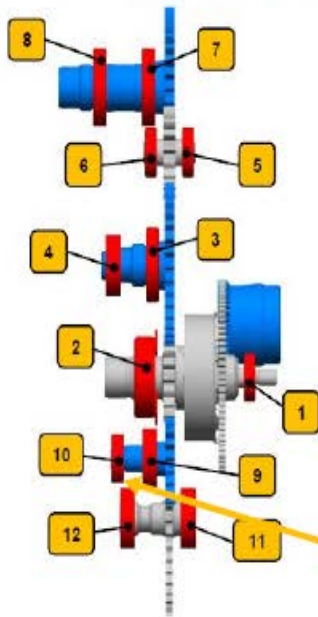
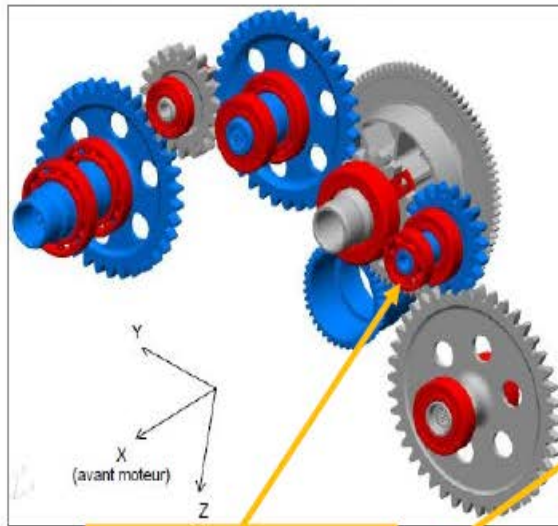
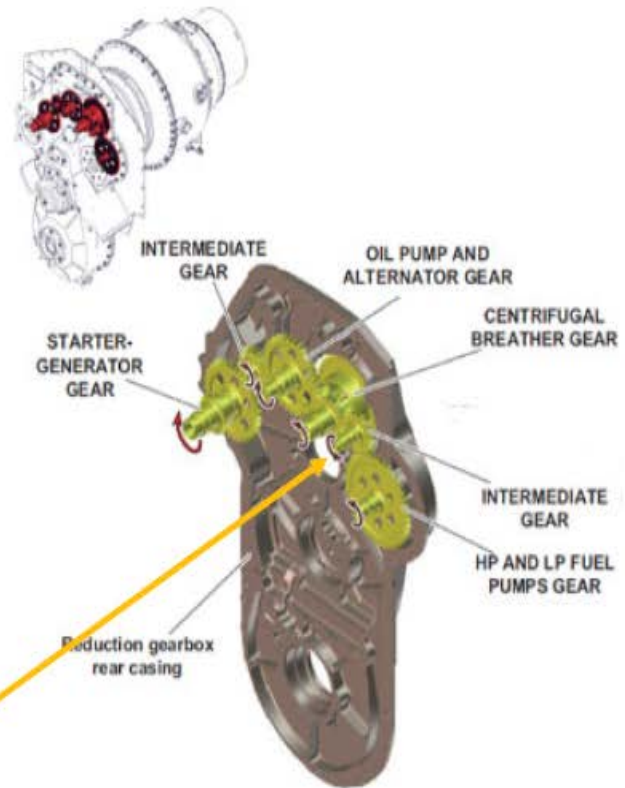
All cases are originated from the fuel pump intermediate gear front bearing

Front bearing  
intermediate gear

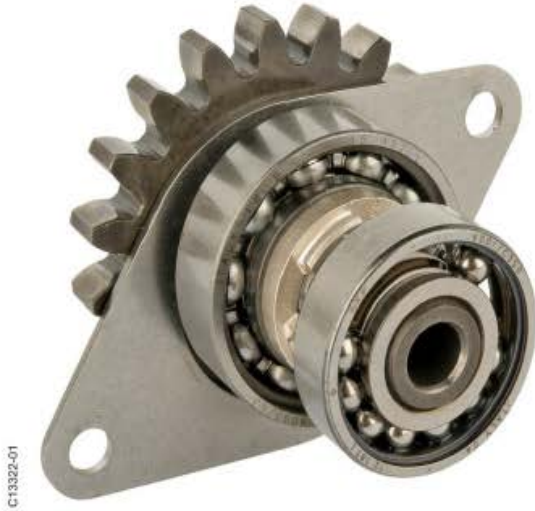
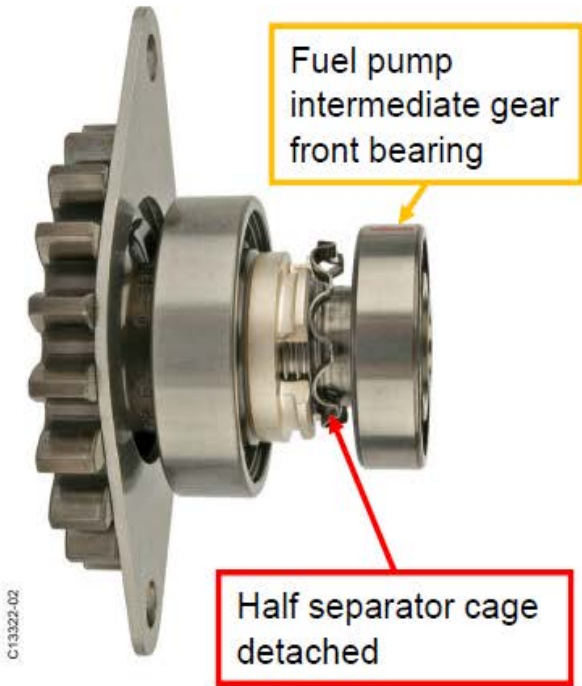
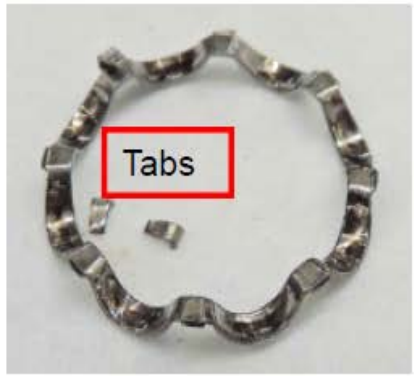
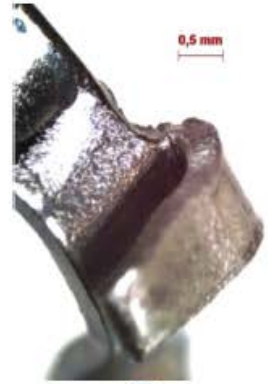
## Tab rupture – exemple of damage seen in service

All cases were detected through chip light illumination or during maintenance (visual inspection of chip detector)

**Tab rupture is due to fatigue leading to cracks**

**Origin/source of the fatigue phenomenon could not be identified**
