**Ministry of Economy and Sustainable Development of Georgia
Civil Aviation and Maritime Transport Accident Incident
Investigation Bureau**

**Final Report on accident to Bell 505 helicopter in Kazbegi municipality,
Georgia on 6 June 2019**

Helicopter type	BELL-505
Nationality and registration marks	4L- ADJ
Operator	“Aviator+” LLC
Time and date of the accident	10:57 (local time) 06.06.2019
Accident location	“Kazbegi” municipality settlement “Stepantsminda” (Georgia).
Geographical coordinates	N 42°38' 59'' E 44°38' 49''

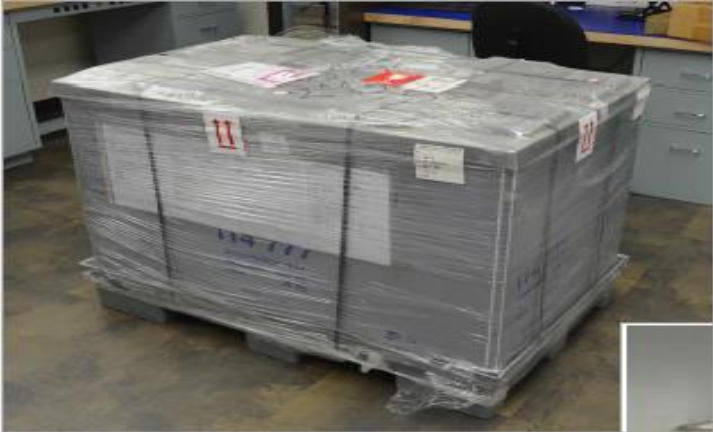
Pilot's collective stick

The collective stick was received with the head fractured off as shown in Figure 11. It was reported that the fly/idle switch was found in the “idle” position at the accident scene. Electrical continuity of the switch was evaluated in the lab by using a multimeter at connector pins 1 and 2. As required, when switched from “Fly” mode (open circuit) to “Idle” the circuit became closed. While simulating vibration by hitting the switch against the table in the lab, a wire fractured from a terminal and the switch still operated as required (redundant circuit). There were no exposed wires at the grommet location at the base of the collective stick. The base of the collective stick fractured via overload. The head of the collective stick fractured via overload with the head fracturing in the upward direction relative to the collective stick.

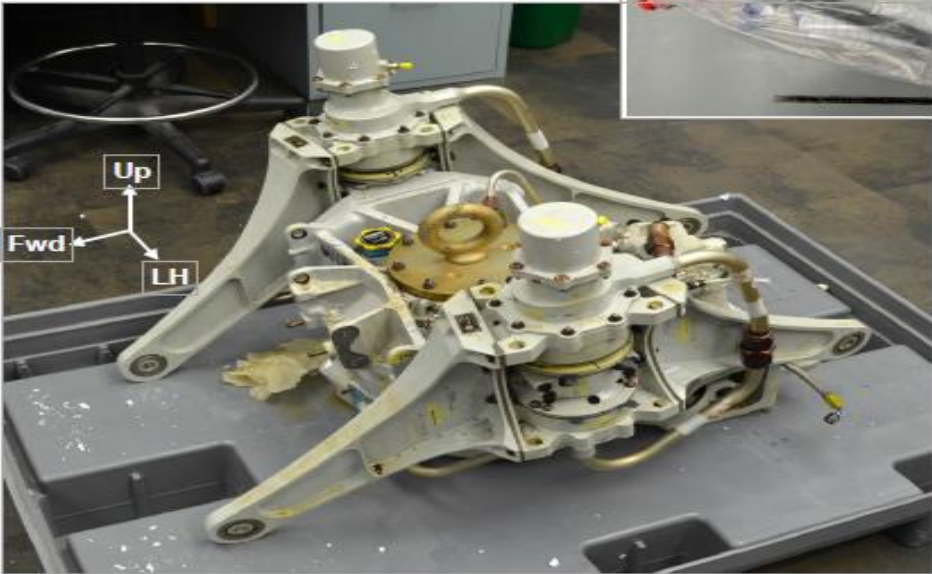
Figure 1: Overall view of the shipping container and of the main transmission assembly with the LIVE mounts attached as-received. The pilot's collective stick was also received.

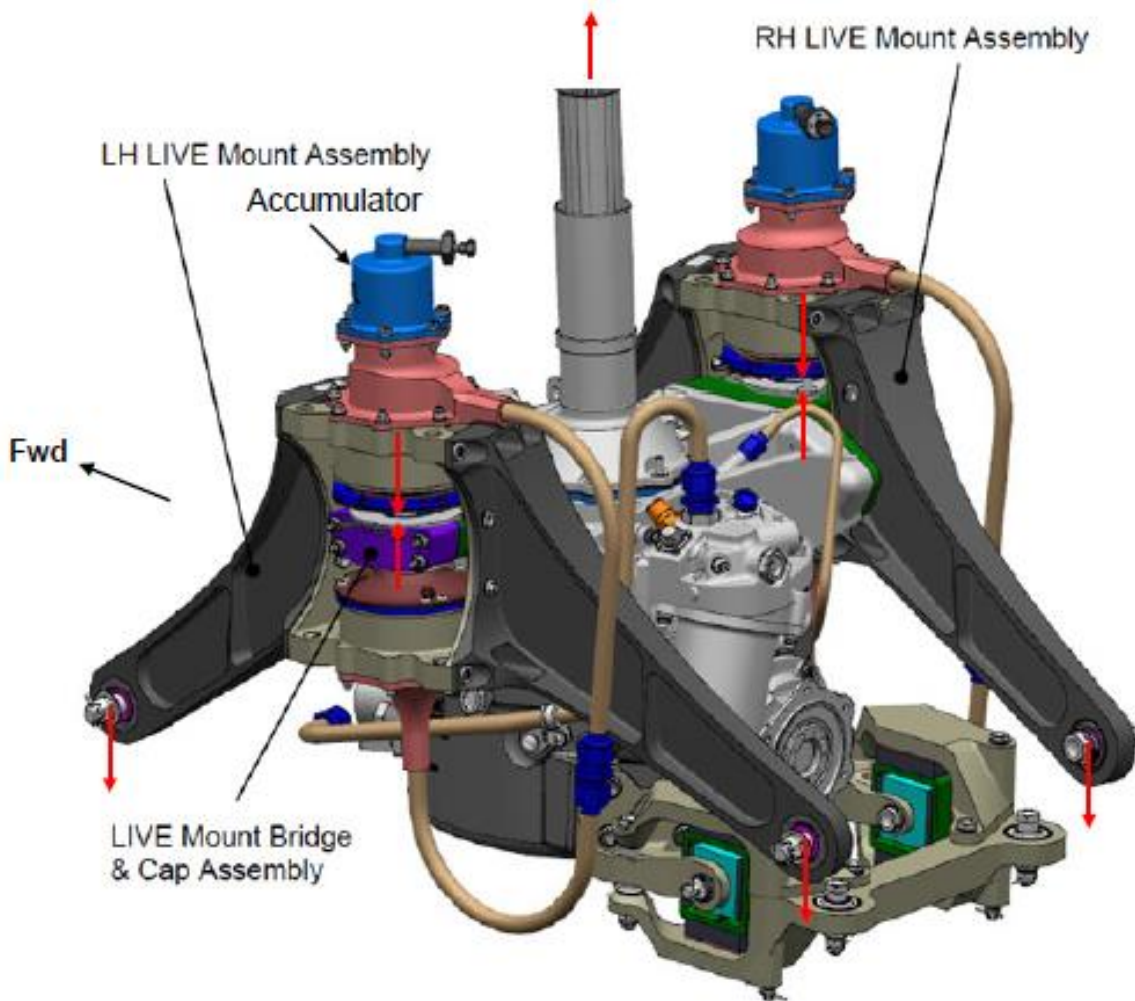
Figure 2: Illustration of the pylon support structure and main transmission. The fuselage attaches to the four corners of the LIVE mount arms (red arrows indicate load path – also see

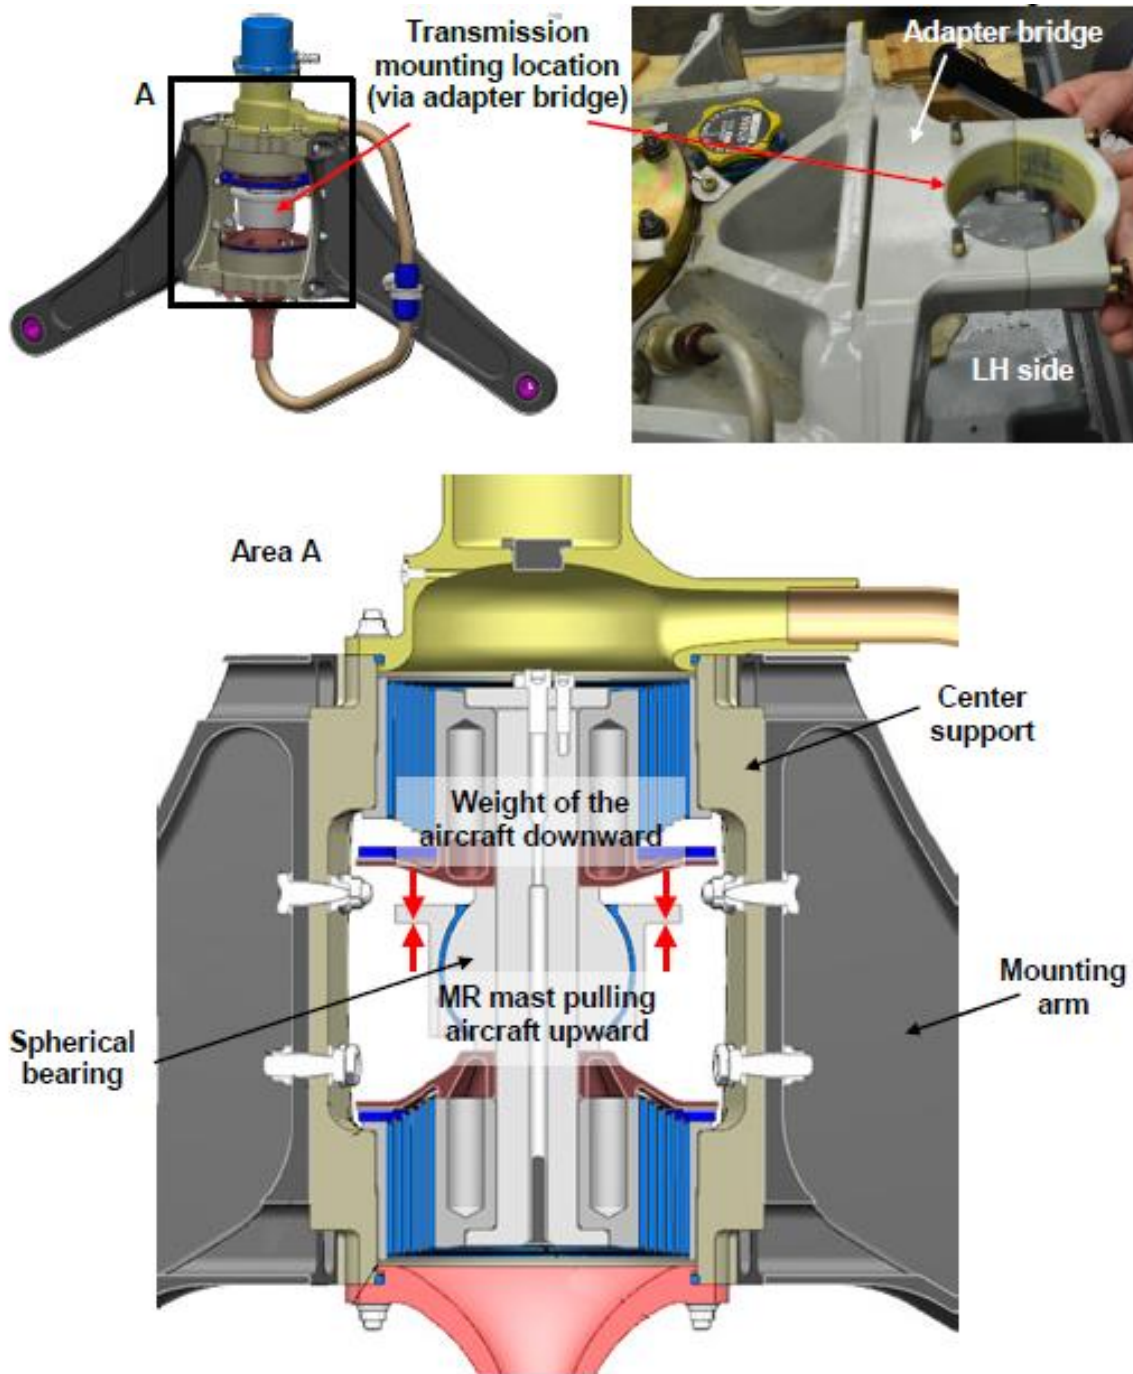
Figure 3: While in flight, the weight of the fuselage rests on the LIVE mount adapter bridge, putting the interface between the spherical bearing flange and adapter bridge in compression. Vertical vibrations are dampened with the load path going through the LIVE units.

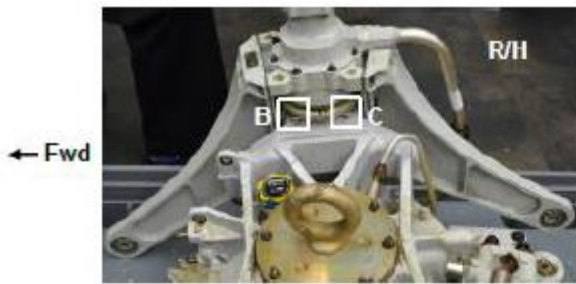
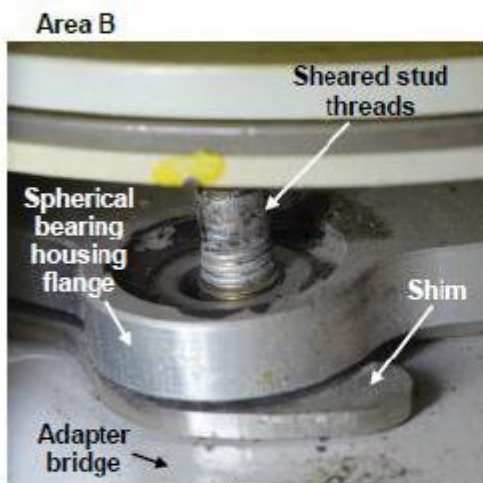
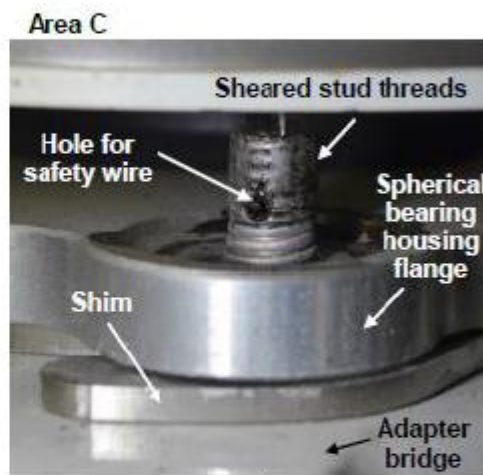
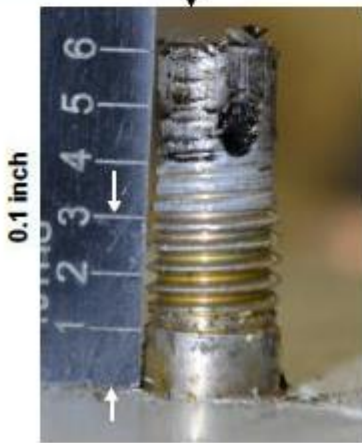
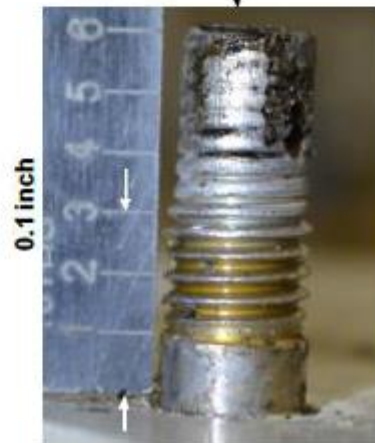
Figure 4: Top photo shows the right-hand LIVE mount assembly. Both adapter bridge studs had sheared threads as a result of the downward force from the impact.

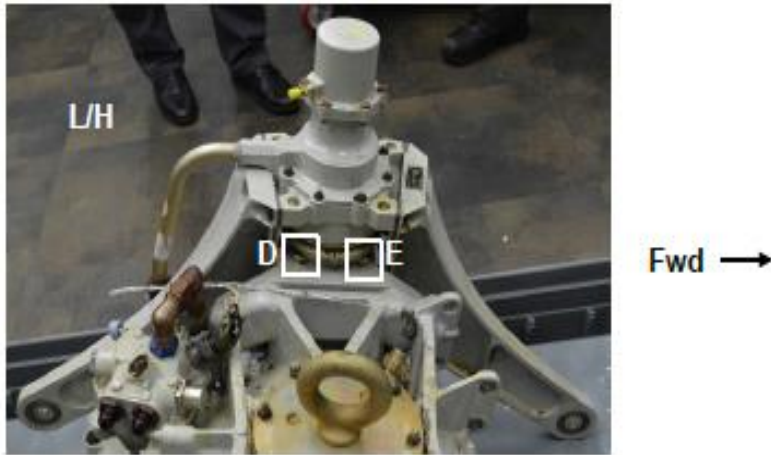
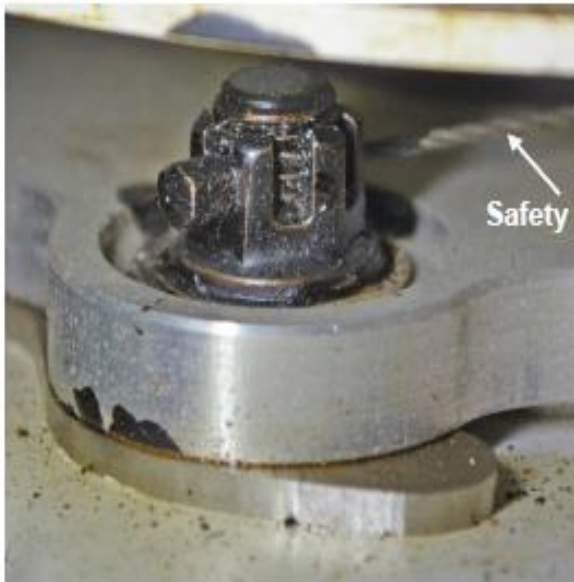
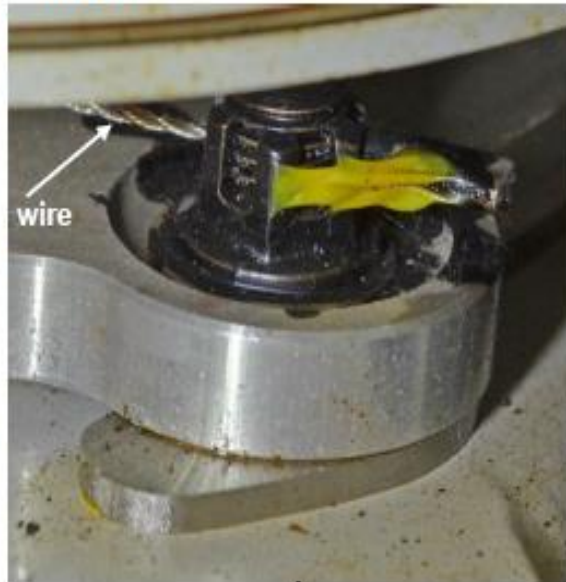
Figure 6: Views of the right-hand spherical bearing housing flange at the sheared stud thread locations. There was no wear on the spot faces, which indicated that the nuts were not loose.

Nut placed back into original position to show that the extent of the sheared stud threads on RH side (Fig. 4) was consistent with it not being excessively loose

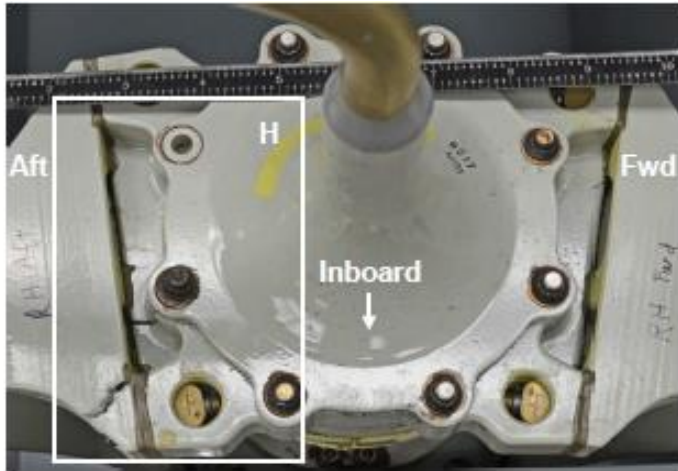
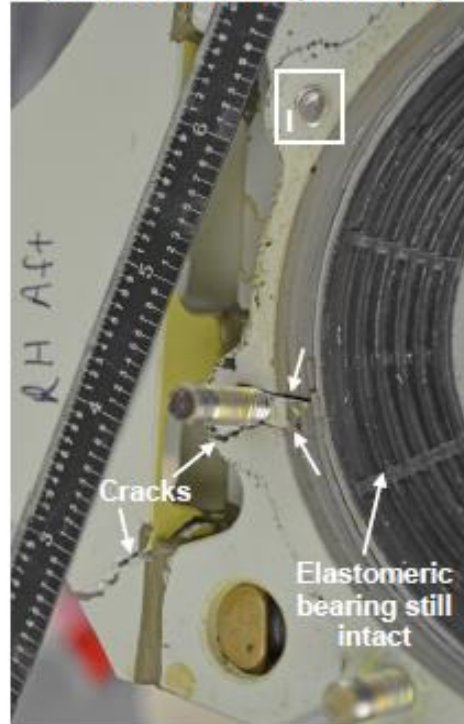
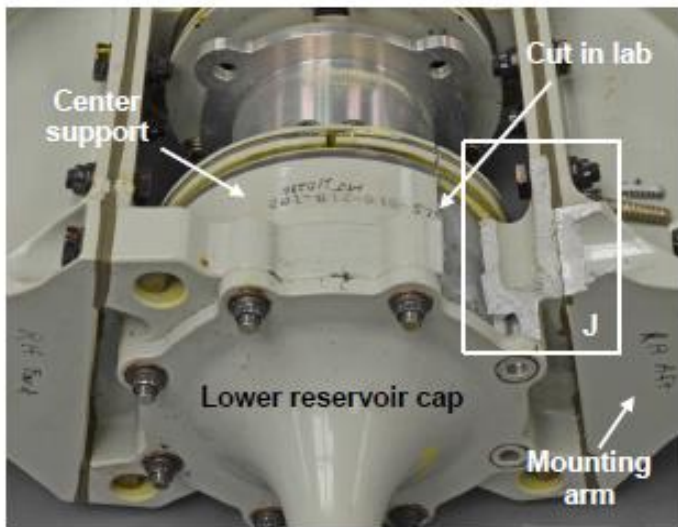
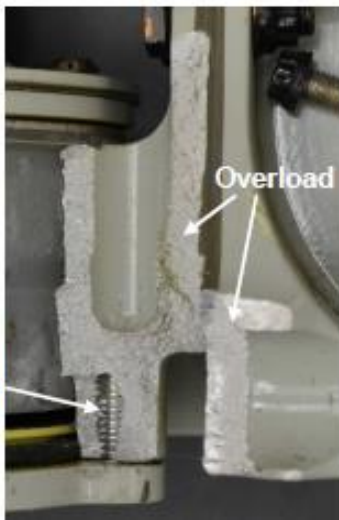
Shear overloaded stud

Stud fell out during sectioning

Figure 9: Views of the right-hand LIVE mount with overload cracks in the center support and the aft-inboard mounting arm attachment flange. The overload cracks were the result of the ground impact. The LIVE mount fluid had leaked out at the cracked center support.

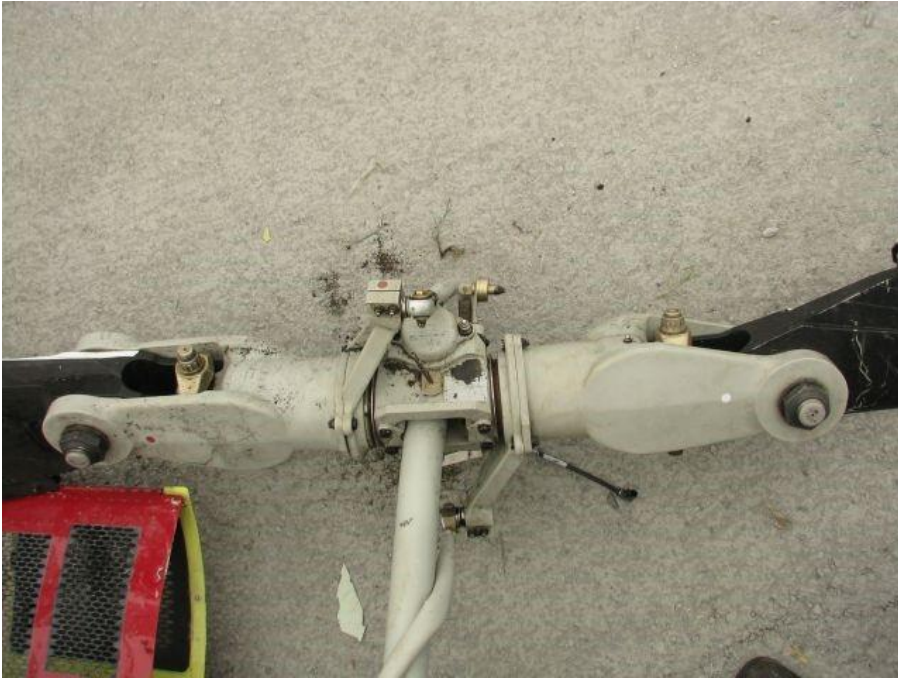
Photo 18

The main rotor hub remained attached to the mast splines (See Photo 18). Each main rotor blade grip remained installed on each yoke spindle, evidence that the Tension-Torsion (TT) straps between the grips (outboard) and the main rotor yoke (inboard) were intact. The grips for each blade exhibited over-rotation in the clockwise pitch direction consistent with impact forces. The Red blade pitch change link (PCL) fractured consistent with bending overload forces during impact near the center of the aluminum PCL (See Photo 19). The Red PCL top end remained connected to the Red grip and the bottom end to the red arm of the rotating outer ring swashplate. The White PCL was found wrapped around the mast but connections to the pitch horn on the top and to the swashplate on the bottom were intact (See Photo 20). The splined drive collar that provides drive from the mast to the swashplate through the drive link was disconnected from its mating mast splines consistent with impact forces (See Photo 21). Damage to the collar splines was consistent with impact forces. One of the bolts that holds the two collar halves together had partially stripped threads and the nut was missing consistent with impact forces (See Photo 22). The other collar nut and bolt were intact. The splined drive collar when connected to the mast provides rotational movement to the rotating outer ring swashplate. When the drive collar becomes disconnected from the mast while the mast continues to rotate (hence driving rotation of the swashplate will stop), PCLs may wrap around the mast and possibly fracture. The rotating outer ring swashplate rotated freely by hand.

Intact main rotor hub remained connected to mast assembly

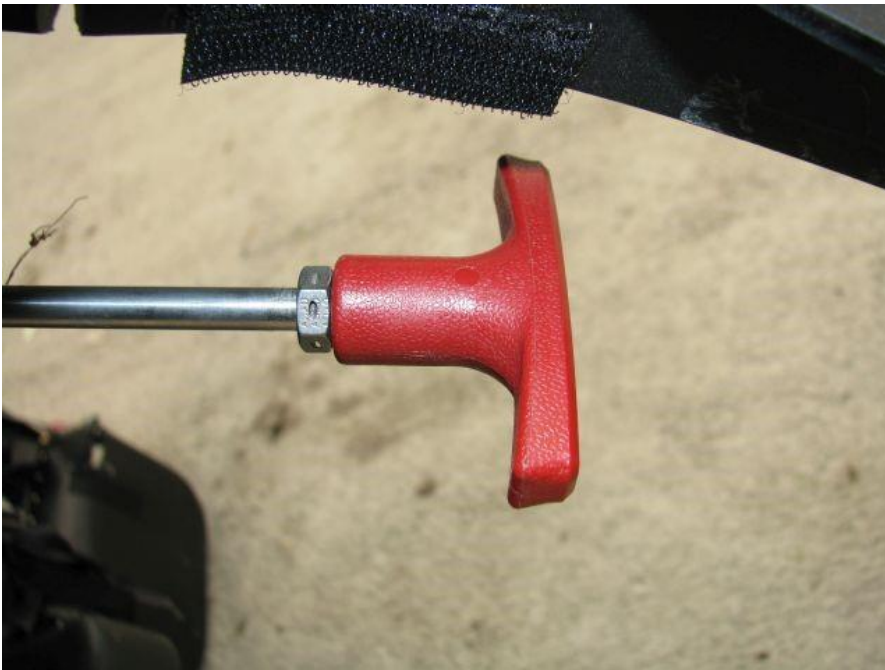
Photo 37

the cockpit handle to indicate that a hard contact from an object at impact caused the handle to move from On to Off (See Photo 37).

Emergency fuel shutoff handle was extended to Off position, but no markings on handle

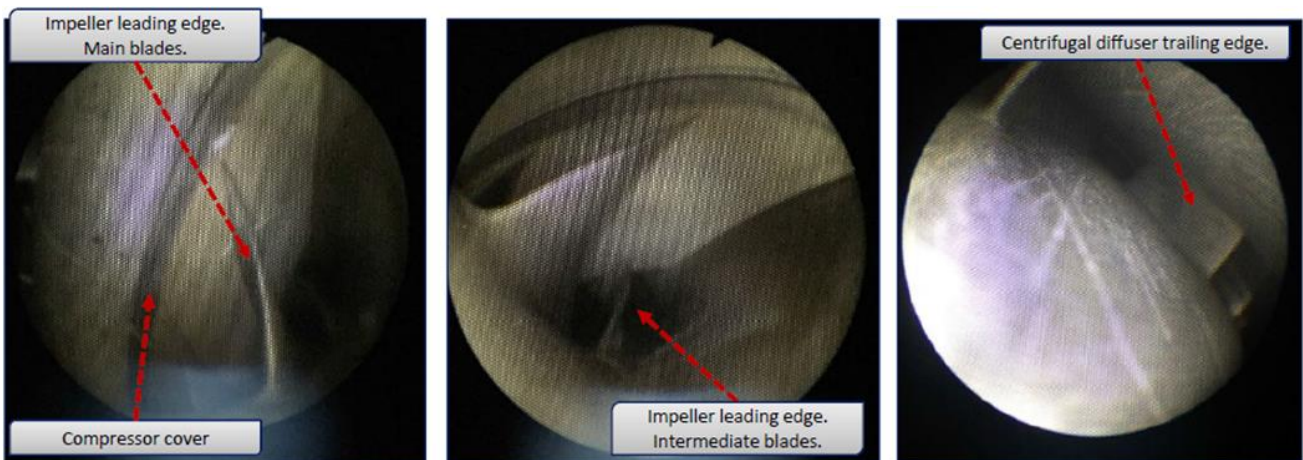
The impeller leading edges are found without any visible signs of damage, rub, erosion, nor FOD. The compressor cover does not present visible signs of rub in the inspected sectors.

The difference of color is normal due to the abradable coating in regard with the impeller blades. Centrifugal diffuser trailing edges are found without any visible signs of damage in the inspected sector.

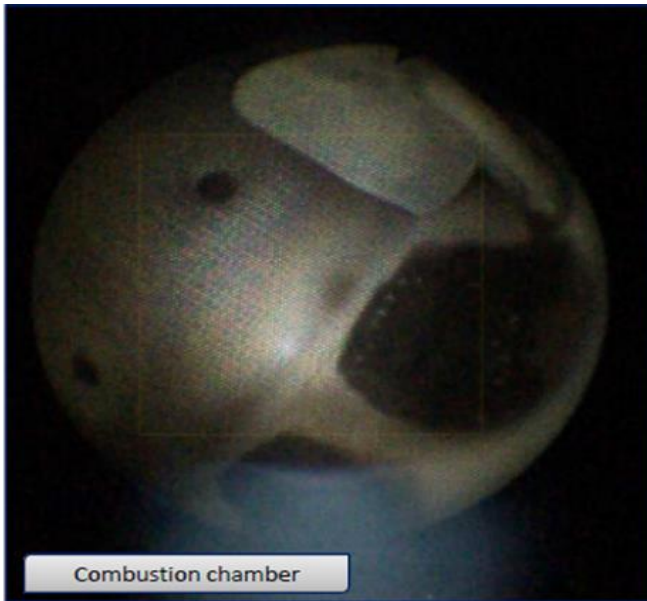
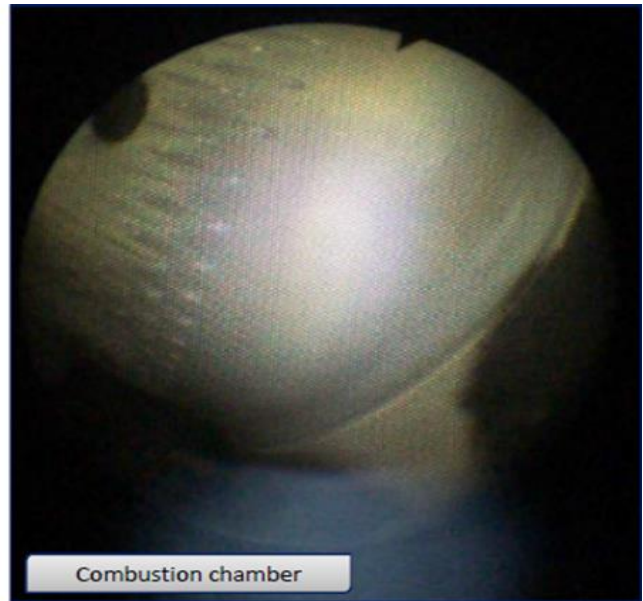
Module 02 : Combustion Chamber

The combustion chamber was found in good condition with no visible sign of damage in the inspected sector.

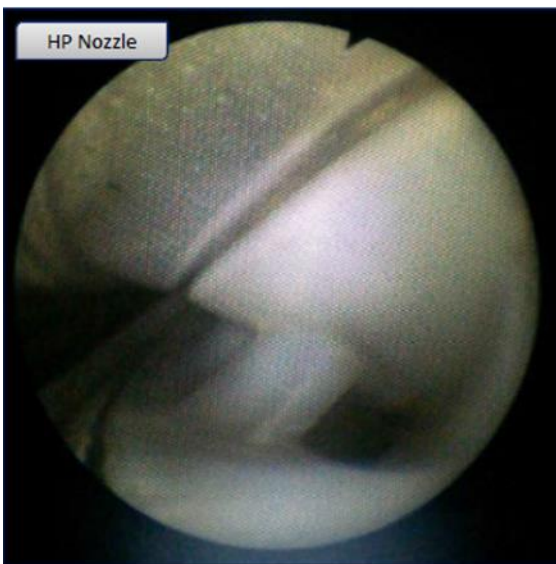
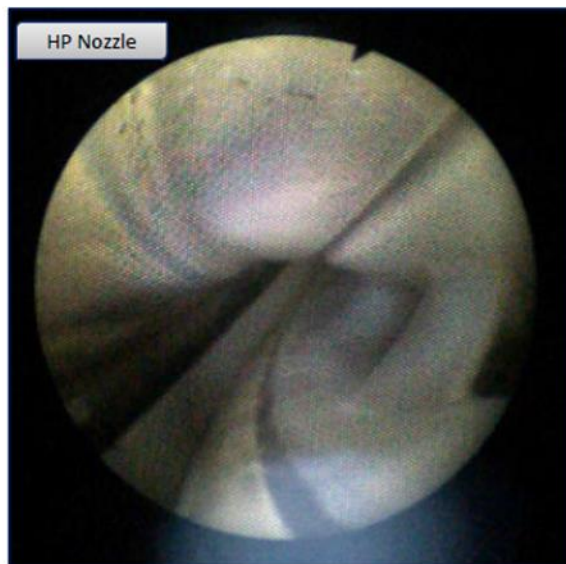
Module 02 : HP Turbine

The HP nozzle was found in good condition with no visible sign of damage in the inspected sector. The HP turbine blades were not accessible

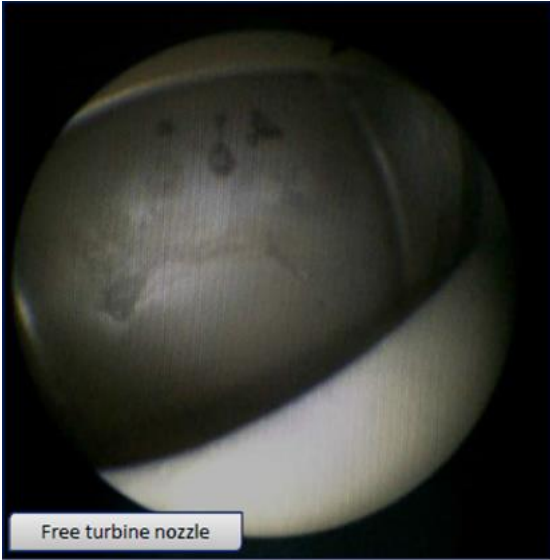
Free turbine nozzle

The PT nozzle was found in good condition with no visible sign of damage in the inspected sector. The power turbine blades were found in good condition with no visible sign of damage. A small liquid depot was found on the bottom of the casing (wreckage position).

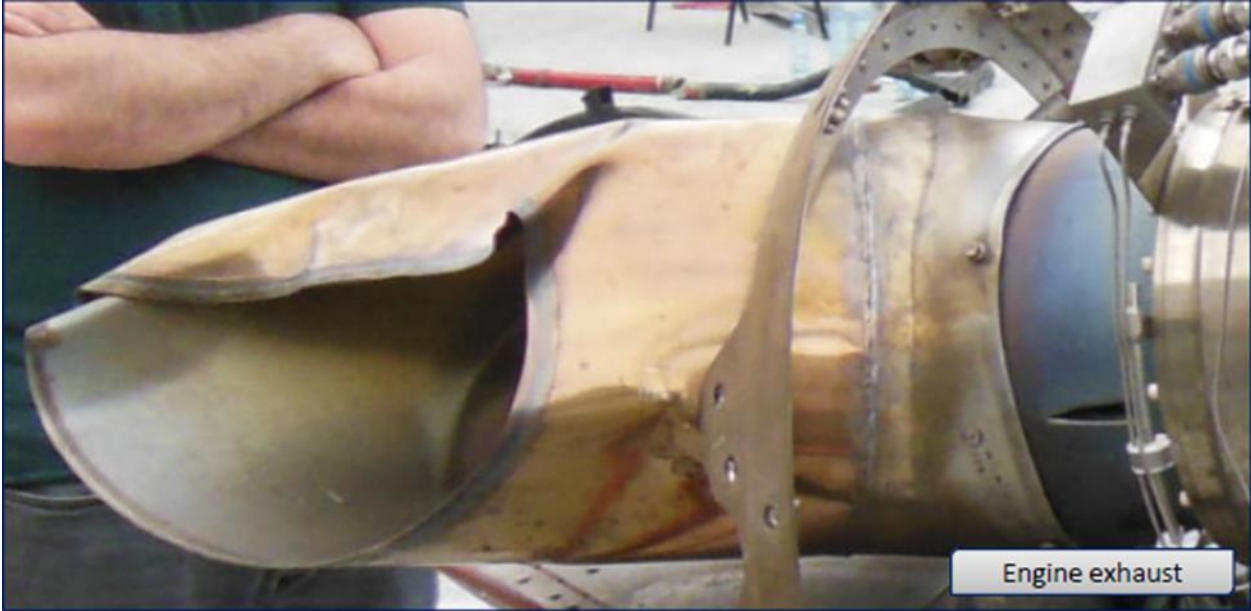
Engine exhaust

It was found damaged as a consequence of the crash.

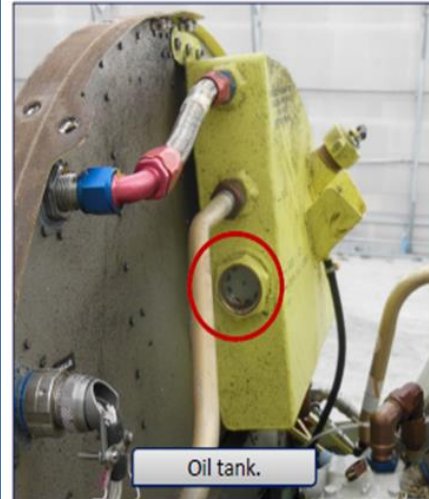
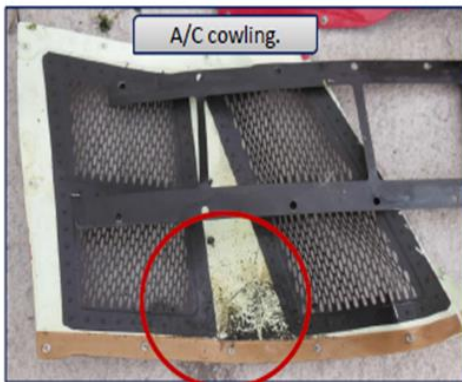
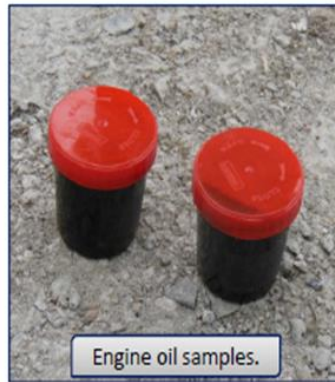
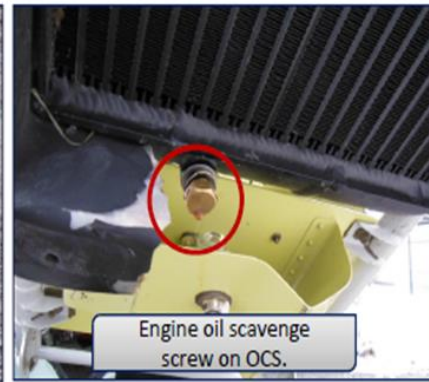
Dressing (pipes and harnesses) and A/C connections of systems Dressing (pipes and harnesses) and A/C connections of systems

- The oil tank is found empty.
- Two oil samples were taken from the Oil Cooling System scavenge and kept by the Georgian authorities for analysis.
- Traces of liquid leak that may be oil was found on A/C air entry cowlings.
- No other specific finding on pipes and connections.

- **Ignition** : no specific finding.
- **Harness & connectors** : no specific finding.
- **P3 picking** : no specific finding.

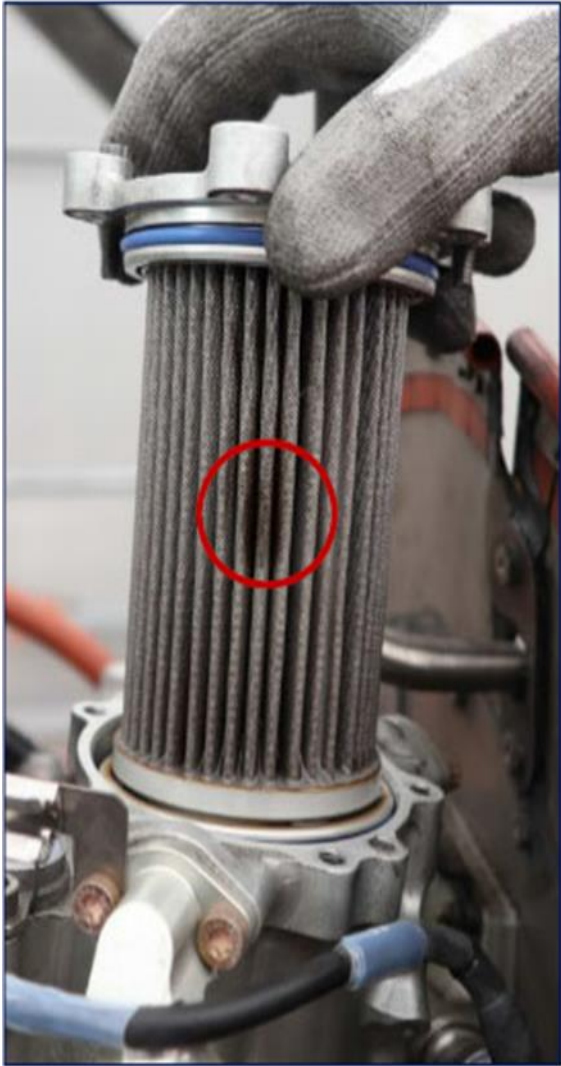
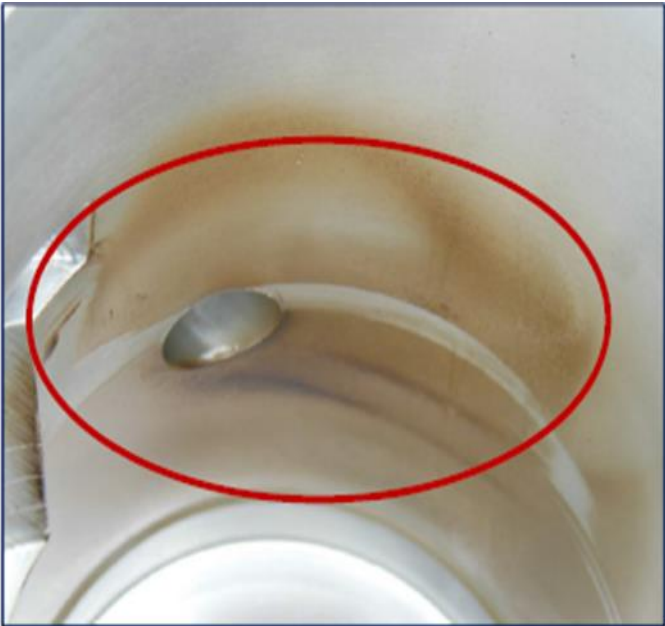
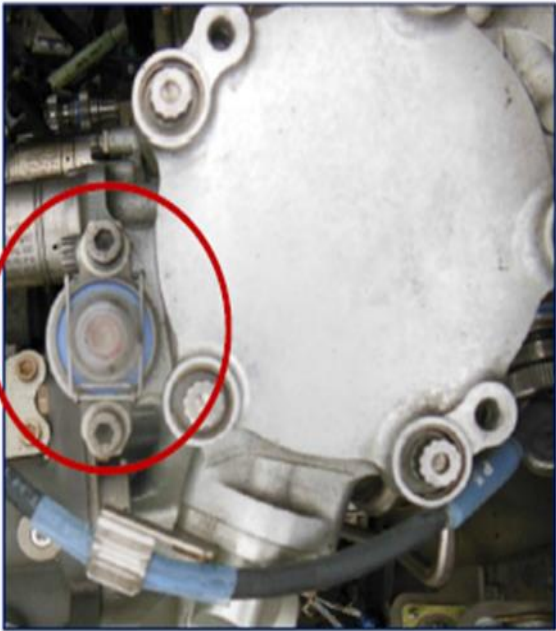
- Fuel filter

The fuel filter was checked and found clean. Traces of rusty depot is visible inside the fuel filter casing.

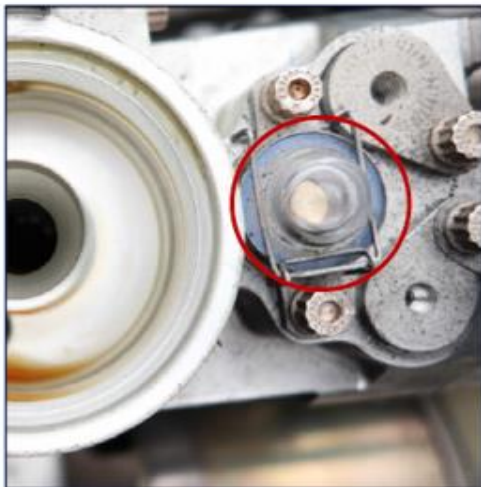
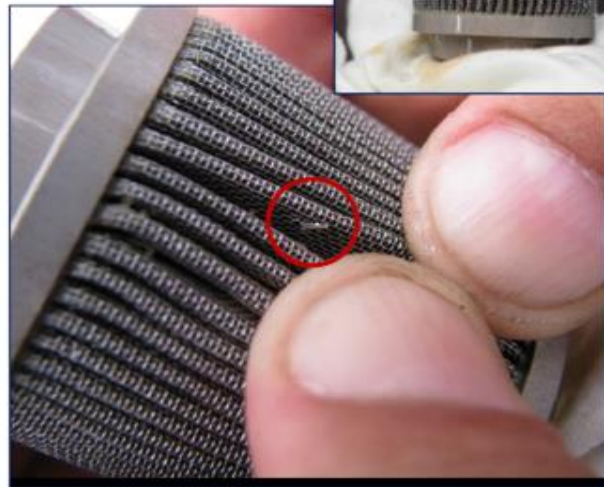
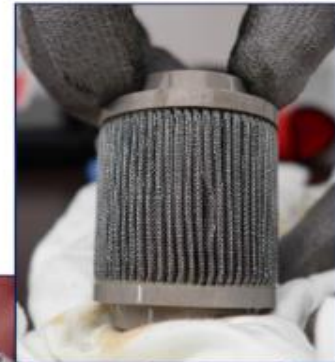
- **Oil filter**

The oil filter was checked and found polluted with one single particle.

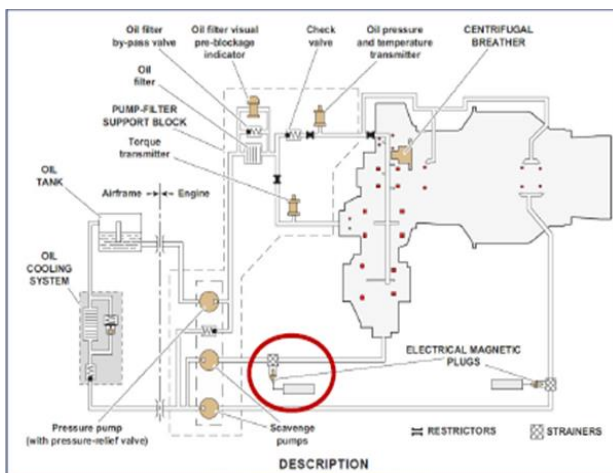
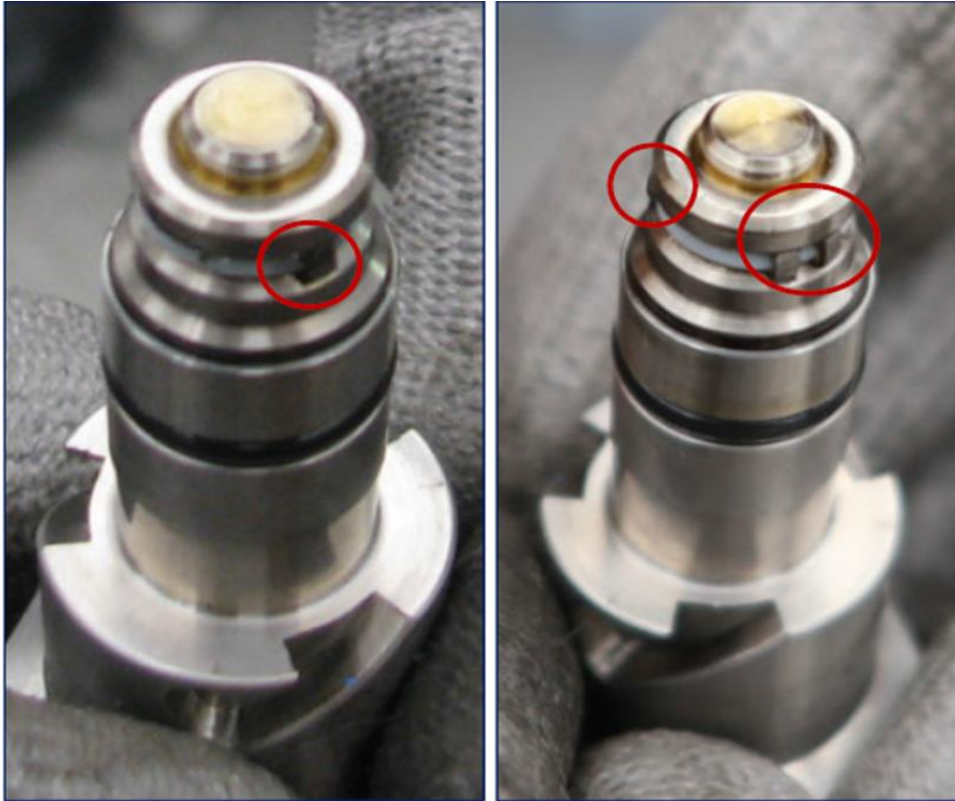
Electrical Magnetic Plugs : Module 01 scavenge line

Some metallic (03) parts (bearing tab type) are visible at the junction of the magnetic segment and the main body of the EMP.

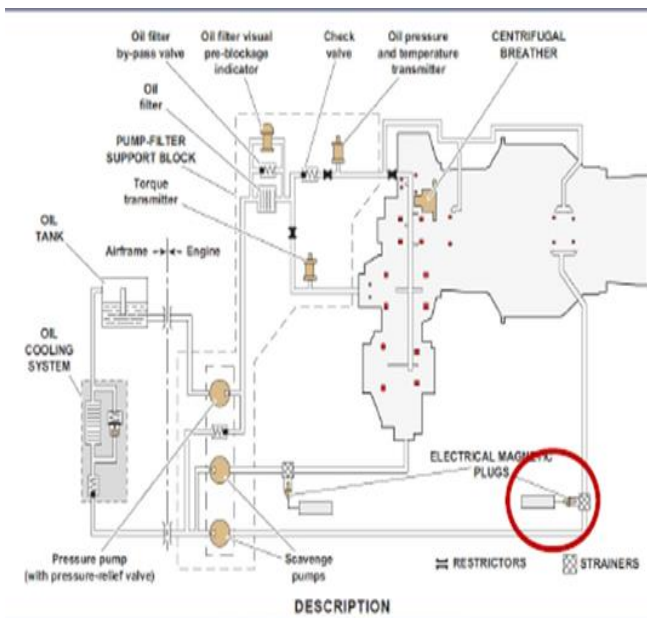
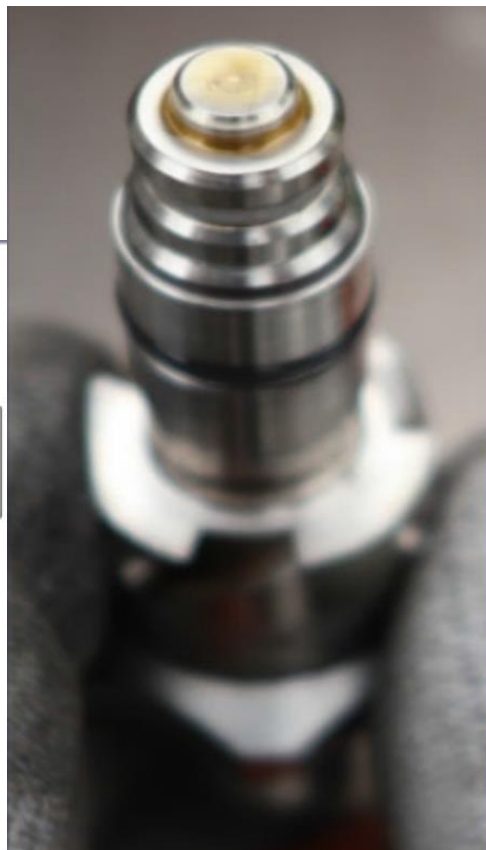
Electrical Magnetic Plugs : Module O2 scavenge line

This Module O2 EMP was found clean of any particle

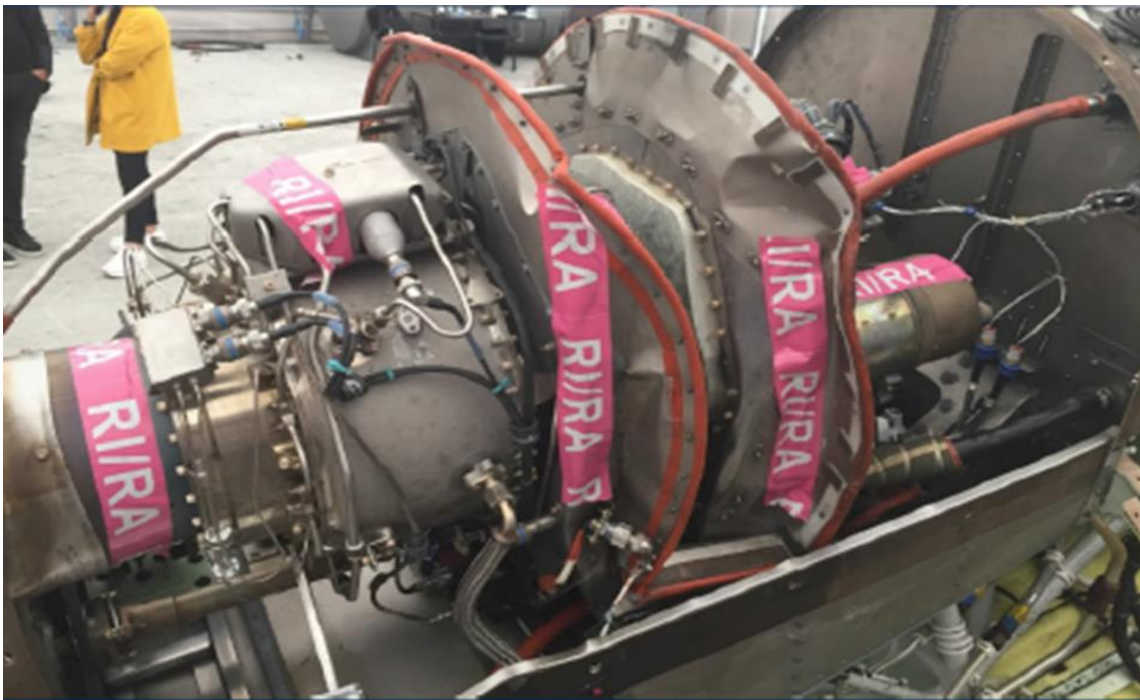
The engine was left on the aircraft and sealed under IIC and Georgian police supervision

The engine exam revealed that tab-type chips were found on the engine lower chip detector (See Photo 42) although no chips were observed on the rear upper chip detector. The Ng and Np turbines rotated freely by hand. The engine was later removed from the helicopter by “Aviator +” personnel and shipped to Safran Helicopter Engines facilities at France for future examination. Inspections of the engine, of the airpath and its rotating parts were performed, as well as checks and tests on the electrical magnetic plugs and on the igniters. The removal of the accessory gearbox (module M01) was then operated to control the state of the drive train.

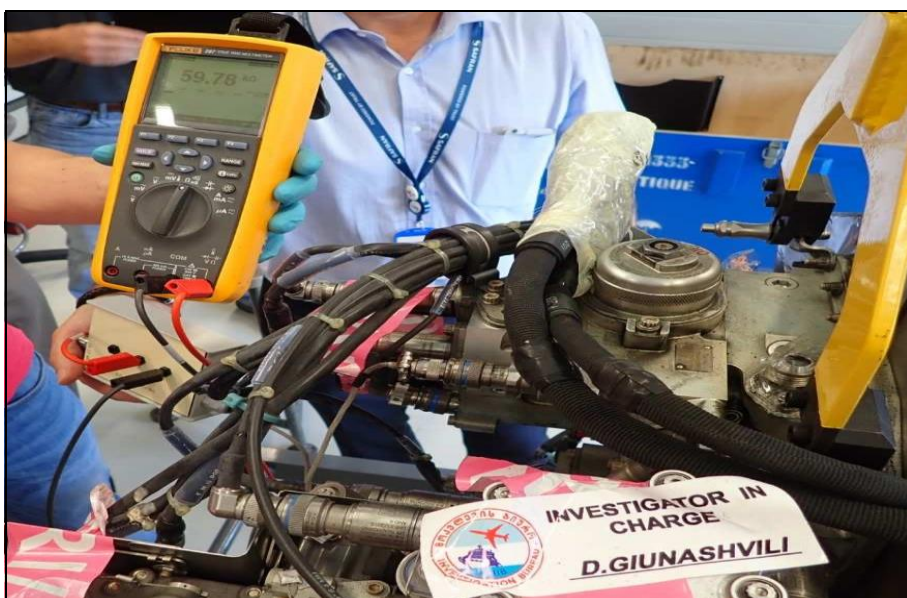
Therefore, no chip detection could have been made in this configuration by the EMP.

This result allowed to explain no chip detection was recorded by the avionics during the last flight.

Picture 5 : direct measurement of EMP Module 01 resistance through connector.

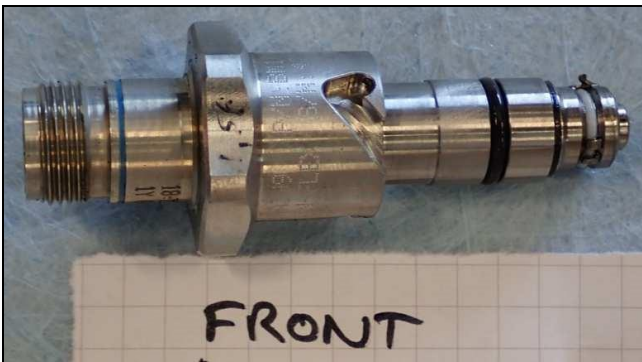
Module M01 EMP was removed from the engine and the presence of 4 chips of “bearing tab type” was detected between the two heads of the plug.

Picture 7 : Module M01 EMP with chip of “bearing tab type”.

An electrical continuity test was performed with the tabs left as they were found: the resistance measured (60kOhm) confirmed that, in the tabs position, no current goes between the two heads of the EMP.

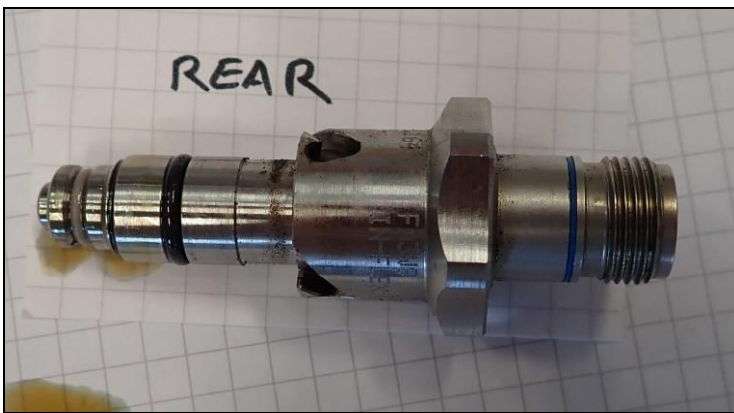
Module M02 EMP was then removed from the engine. After it was established that no chip was captured by this EMP, an electrical continuity test was performed: the resistance measured (60kOhm) indicated that the EMP functions were in accordance with the specification.

Picture 9 : Module M02 EMP is clean.

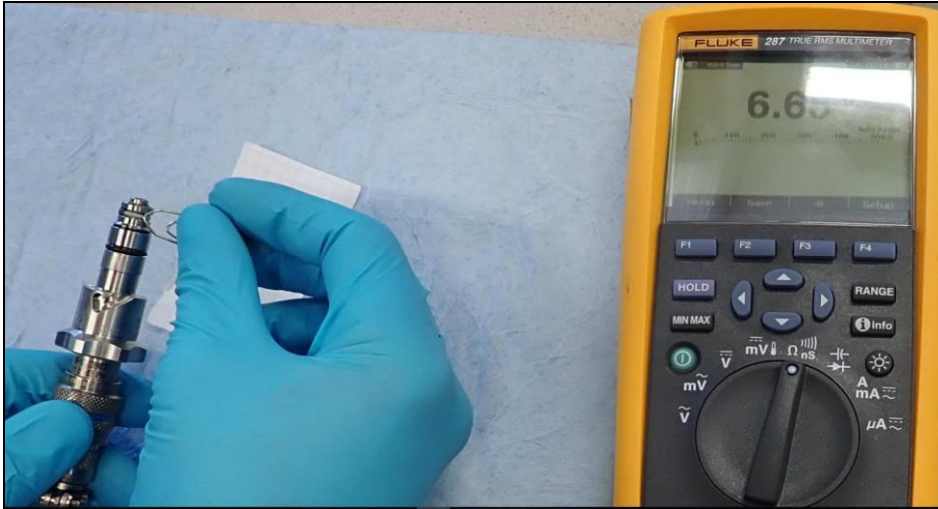
A resistance measured below 10 Ohms indicated that a current was going from one head to another and that both EMP's functions were in accordance with the specifications.

Picture 10 : deliberate contact between two heads of EMP of Module M01 - still with tabs on.

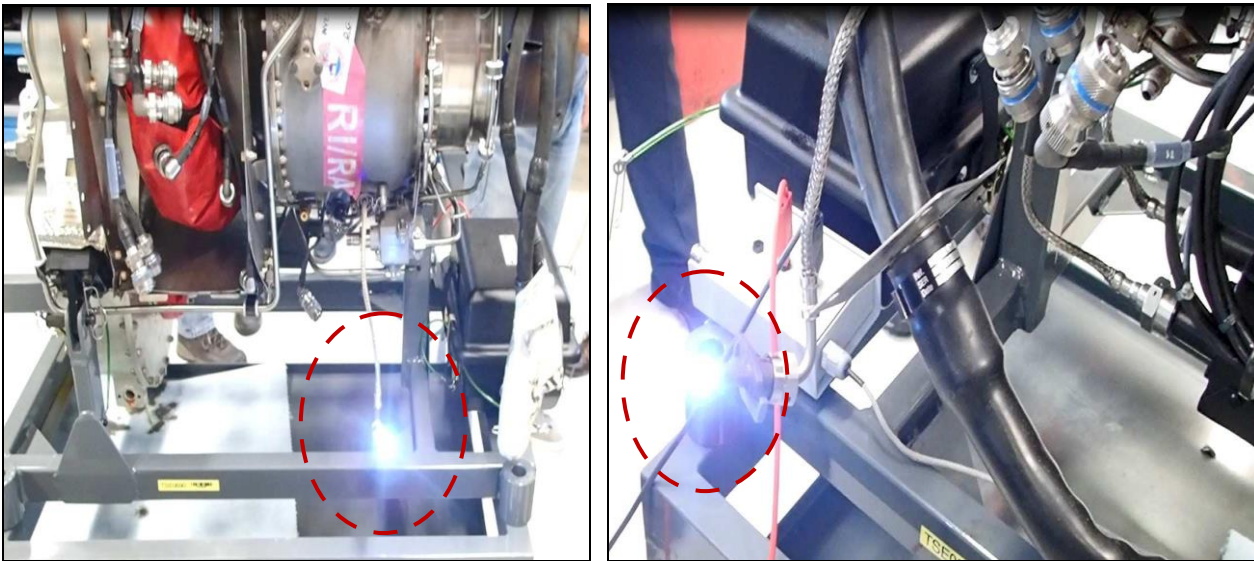
The start igniter test was requested during the investigation by the IIC. Both start igniters were found functioning as requested.

Pictures 11 & 12 : Left and Right Hand igniter test.

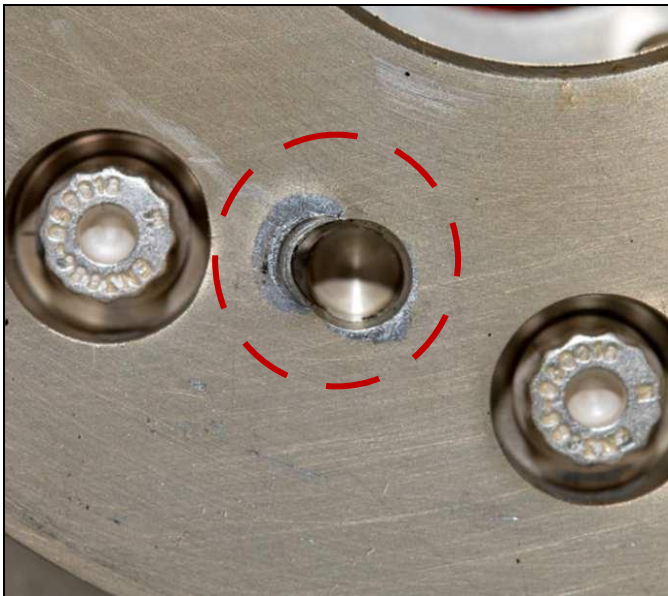
The HMU is removed from module M01. The positioning pin sets the angular position of the HMU on the module M01 casing. A masting of this positioning pin on the module M01 casing was detected. This statement was relevant with the induced metal beading and the ovalization of the drilling on the module M01 casing side. No other traces of displacement were found on the two cover flanges. These findings allow to conclude that the damage of the positioning pin was due to impact forces at the moment of the crash.

Picture 19 : casing side, ovalization and metal beading of the drilling of the HMU's positioning pin.

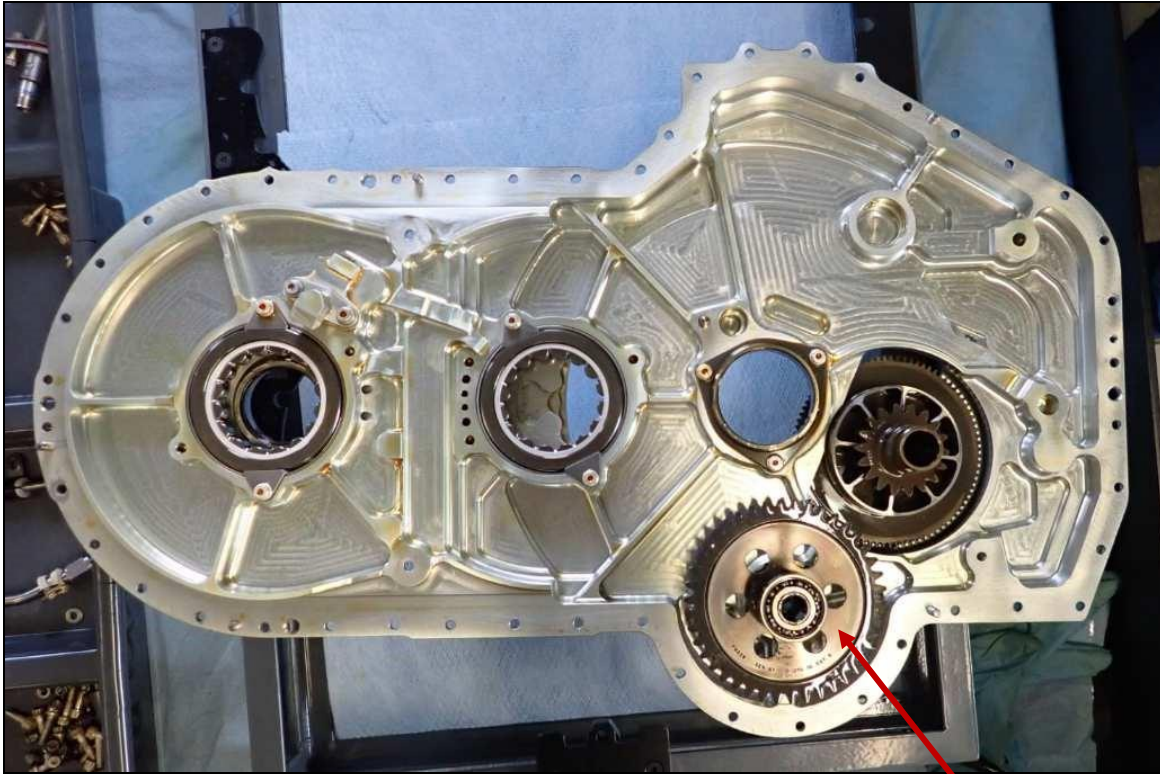
Once the front casing of module M01 was removed, an inspection of the gear train was visually performed. No visible damage was detected on any parts. A bearing tab was detected into one housing and was collected later by the IIC along with the HMU intermediate gear (port side).

Picture 24 : Module M01 gears, rear casing, front side side.
