**Ministry of Economy and Sustainable Development of Georgia
Civil Aviation and Maritime Transport Accident Incident
Investigation Bureau**

**Final Report on accident to Bell 505 helicopter in Kazbegi municipality,
Georgia on 6 June 2019**

Helicopter type	BELL-505
Nationality and registration marks	4L- ADJ
Operator	“Aviator+” LLC
Time and date of the accident	10:57 (local time) 06.06.2019
Accident location	“Kazbegi” municipality settlement “Stepantsminda” (Georgia).
Geographical coordinates	N 42°38' 59'' E 44°38' 49''

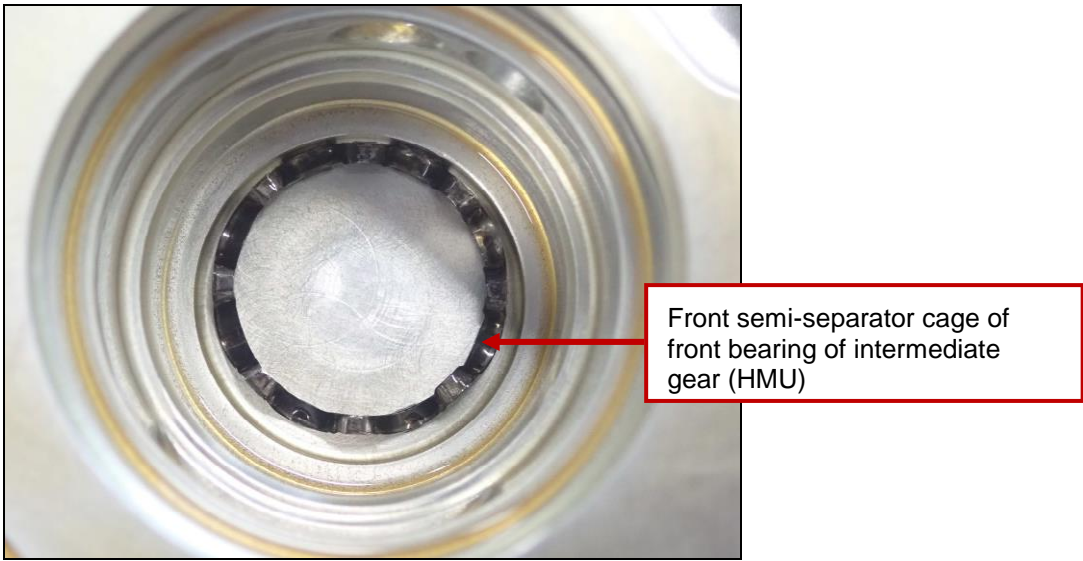
Front semi-separator cage of front bearing of intermediate gear (HMU)

Picture 28 : one of the semi-separator cage is left into the housing of the front bearing of the intermediate gear. Considering the loss of bearing tabs, this is an expected statement once the gear is removed.

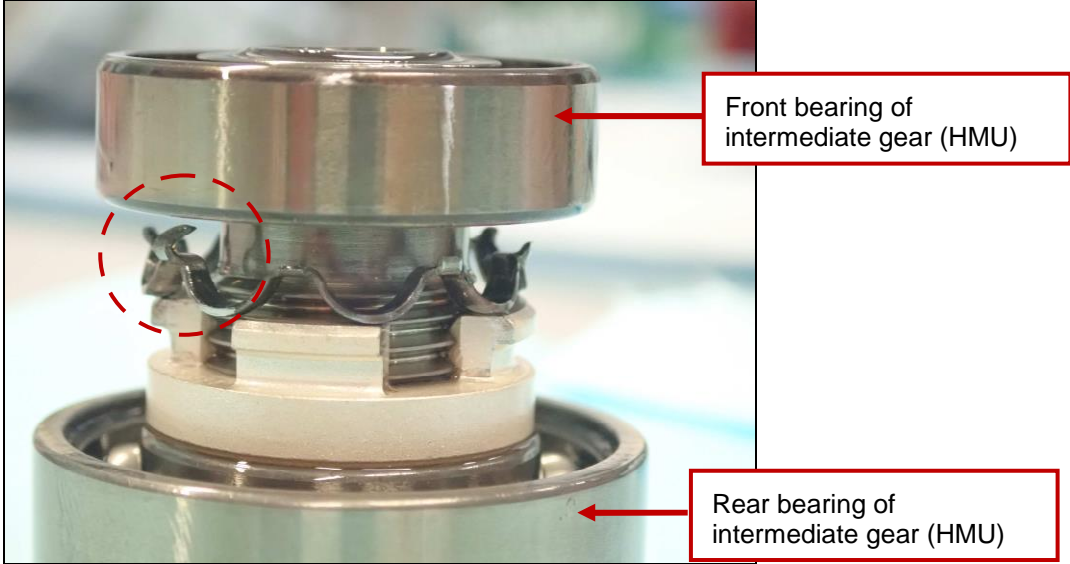
Picture 29 : the rear semi-separator cage with the only tab that did not brake.

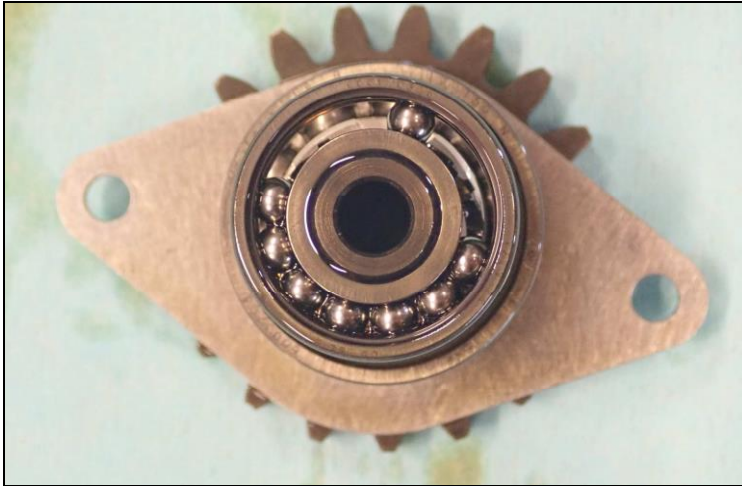
Picture 30 : the front bearing of the HMU's intermediate gear : no ball was missing.

The loss of 7 of the 8 “bearing tabs” was then established:

- One was still set on the semi-separator cage.
- As previously quoted in, four tabs are recovered on module M01 electrical magnetic plug.
- One is recovered into the intermediate gear housing.
- 2 tabs are missing.

On addition, no visible damage was noticed on the 8 balls (none missing) nor on the races of the front bearing.

In the new bearing design, the separator cage is now riveted and not stamped. Indeed, this former manufacturing process was introducing indications of folded material that was leading to a stress concentration, therefore to a crack initiation and eventually to a fatigue rupture of the stamped metallic parts of the semi separator cage, then called “tabs”.

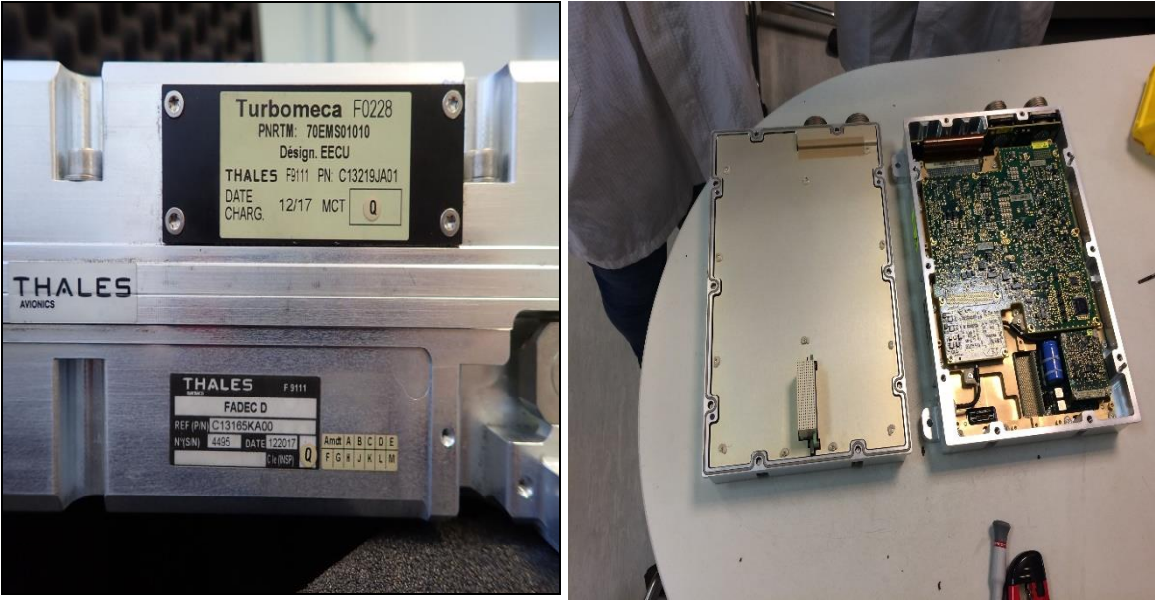
Picture 3 : EECU reference and part number. Thales sealing is unsealed since the examination at BEA.

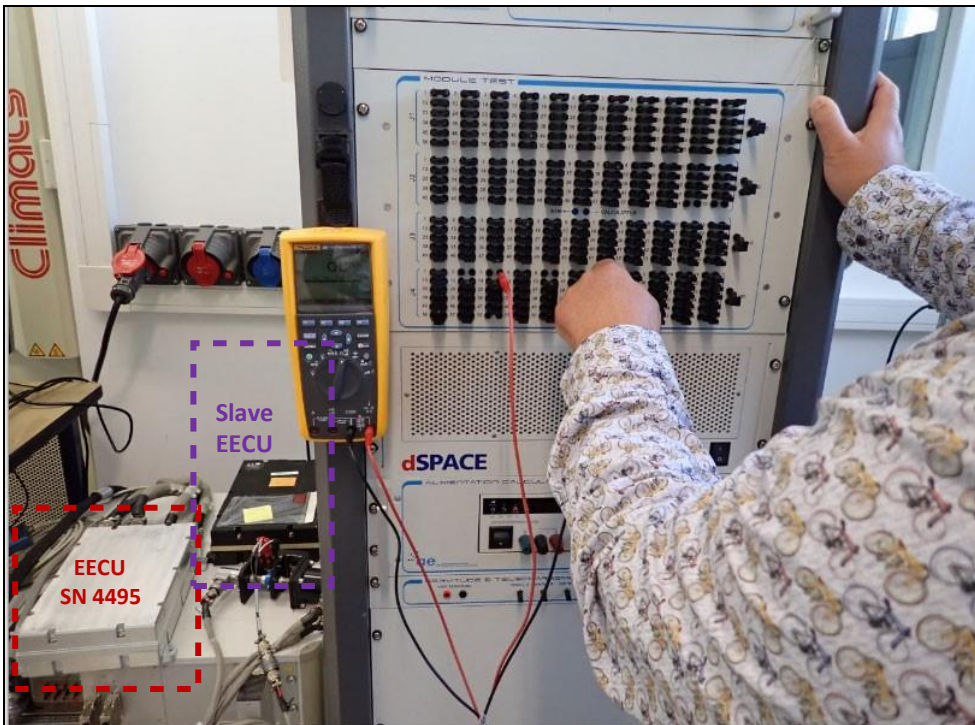
Prior to downloading any information, electrical checks were performed on the EECU’s connectors to look for potential internal damage. The electrical checks results were satisfactory and the download went ahead.

Picture 4 : EECU SN4495 connected on electronic test bay and on-going continuity check.

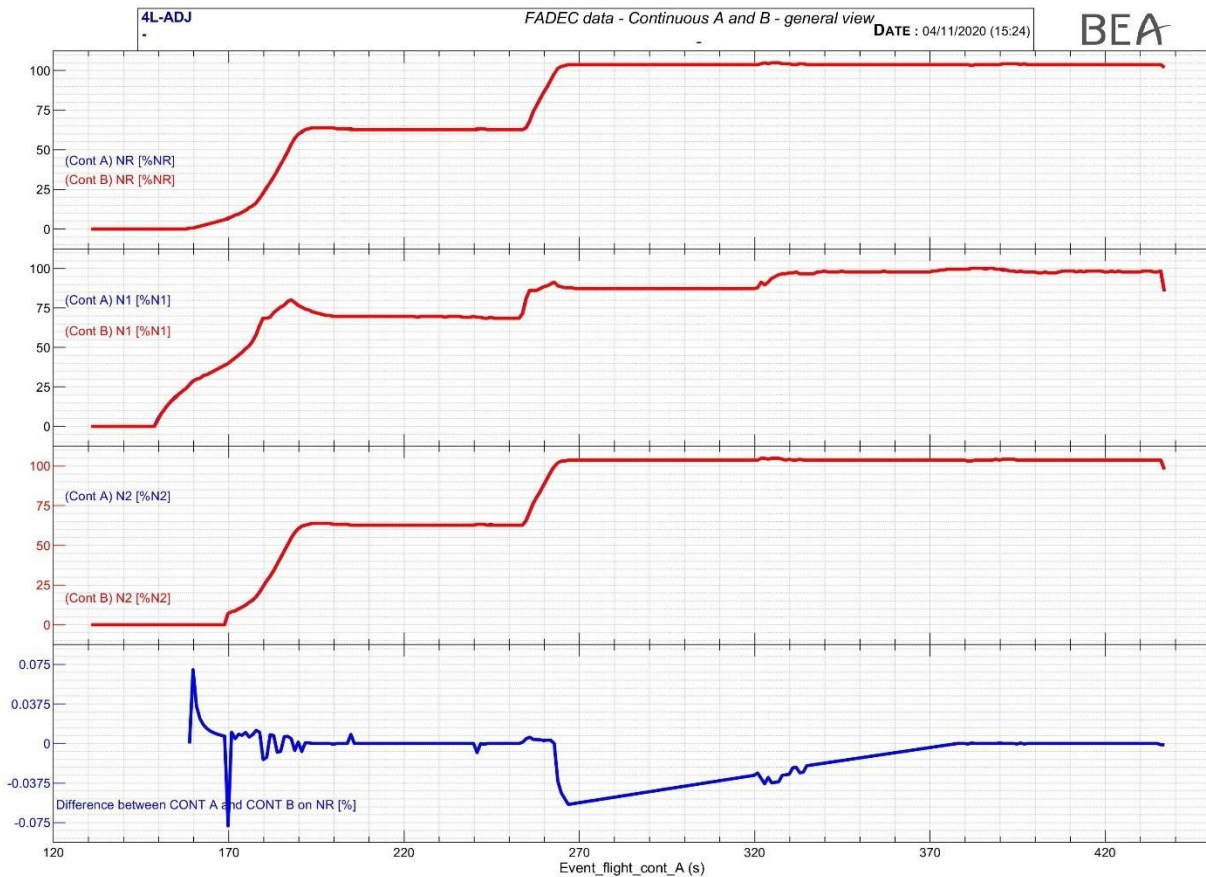
The EECU continuous recordings from channel A and from channel B were compared: the recorded values from channel A and from channel B were consistent with each other. Figure 1 below shows an example of this consistency (see Appendix 1 for the comparison of the relevant parameters).

Figure 1: Example of values consistency between channel A and channel B

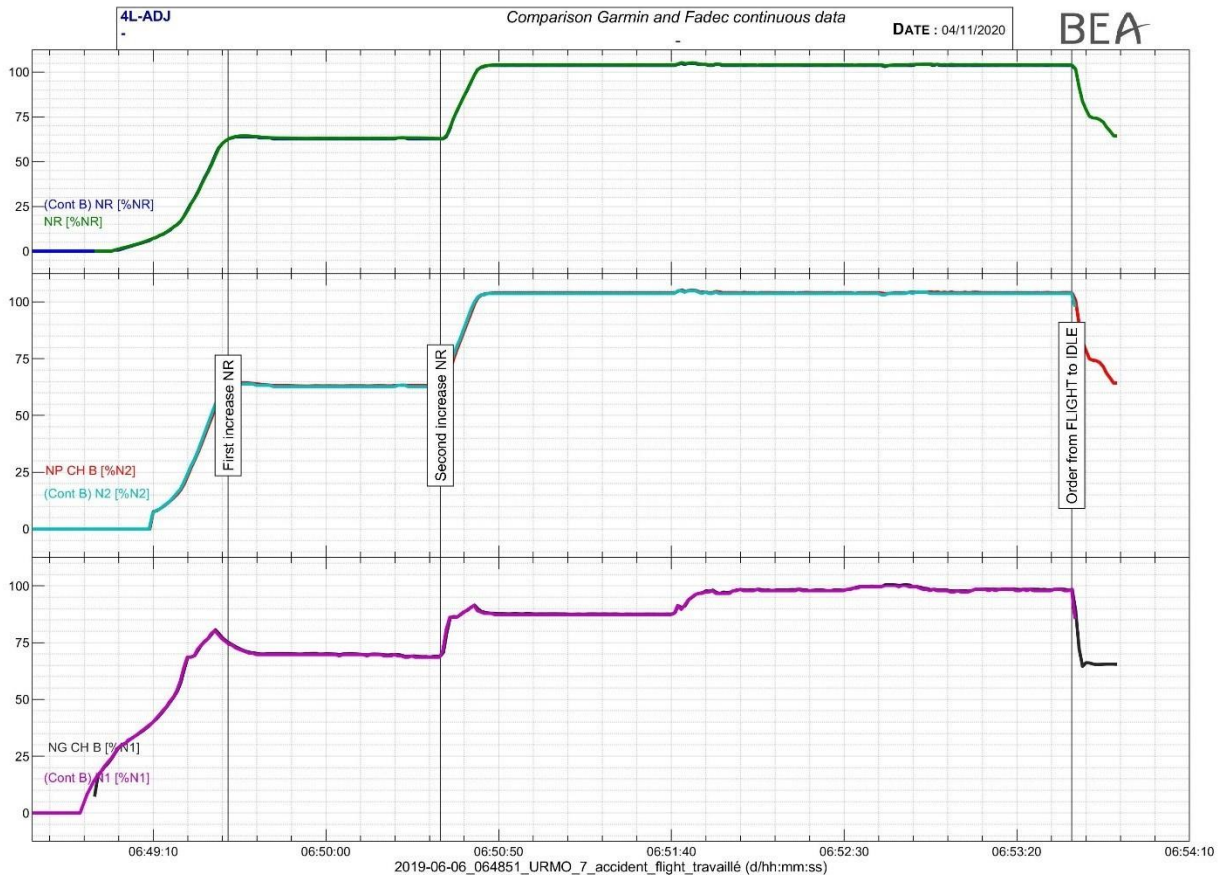
EECU time (s) + 24380 (s) = Garmin UTC time.

This synchronization was validated with the start of the reduction in NR, N1 and N2, which is the third event displayed on the figure below. As the sample rate of the two sets of data is 1s, the synchronization of the two sets of data is precise within 2 seconds.

Figure 2: Synchronisation of EECU time and Garmin time

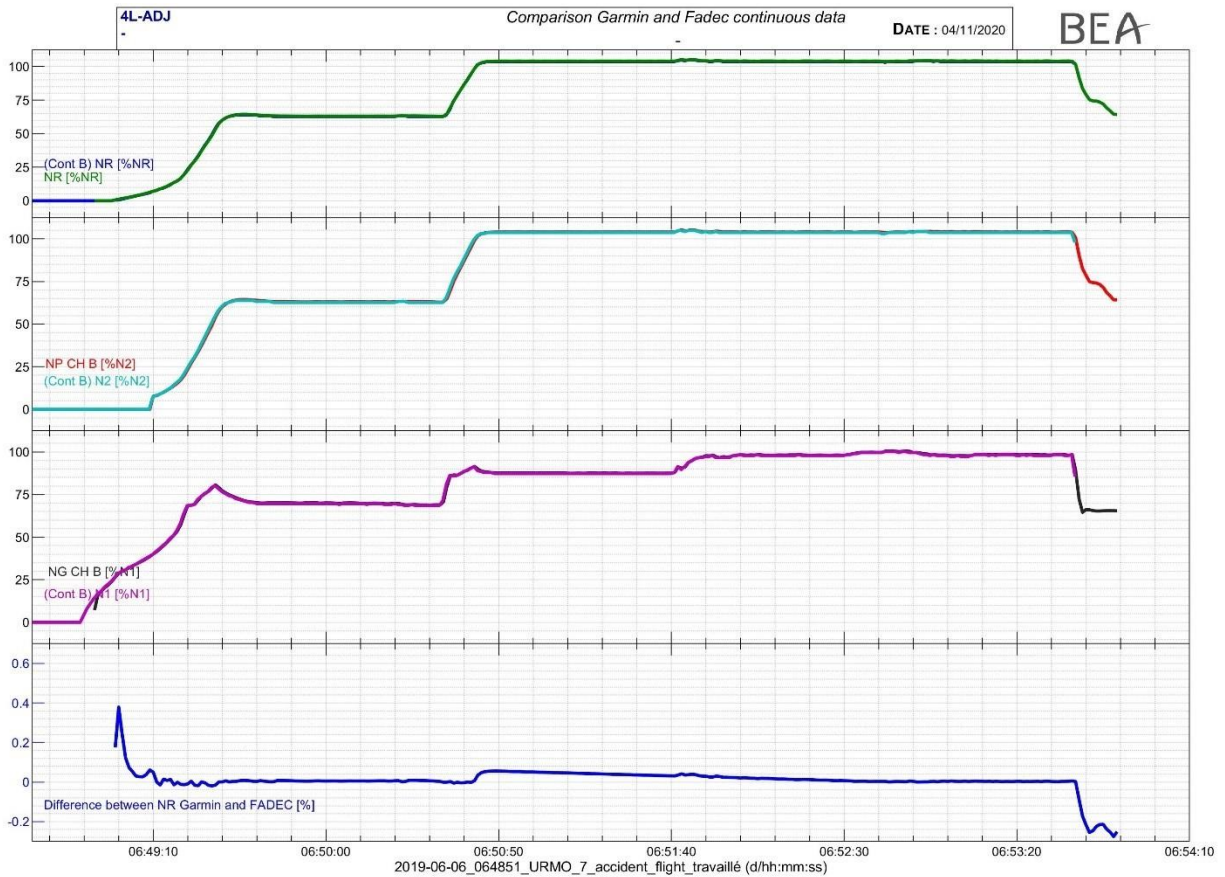
A comparison between these two sets of data (EECU and Garmin) shown that, on common intervals, the data was consistent. Figure below shows some engine parameters data coming from the EECU channel

B and from the Garmin. The difference between NR coming from both sets of data is negligible until the impact with the ground.

Figure 3: Example of comparison between the Garmin and the EECU recorded data

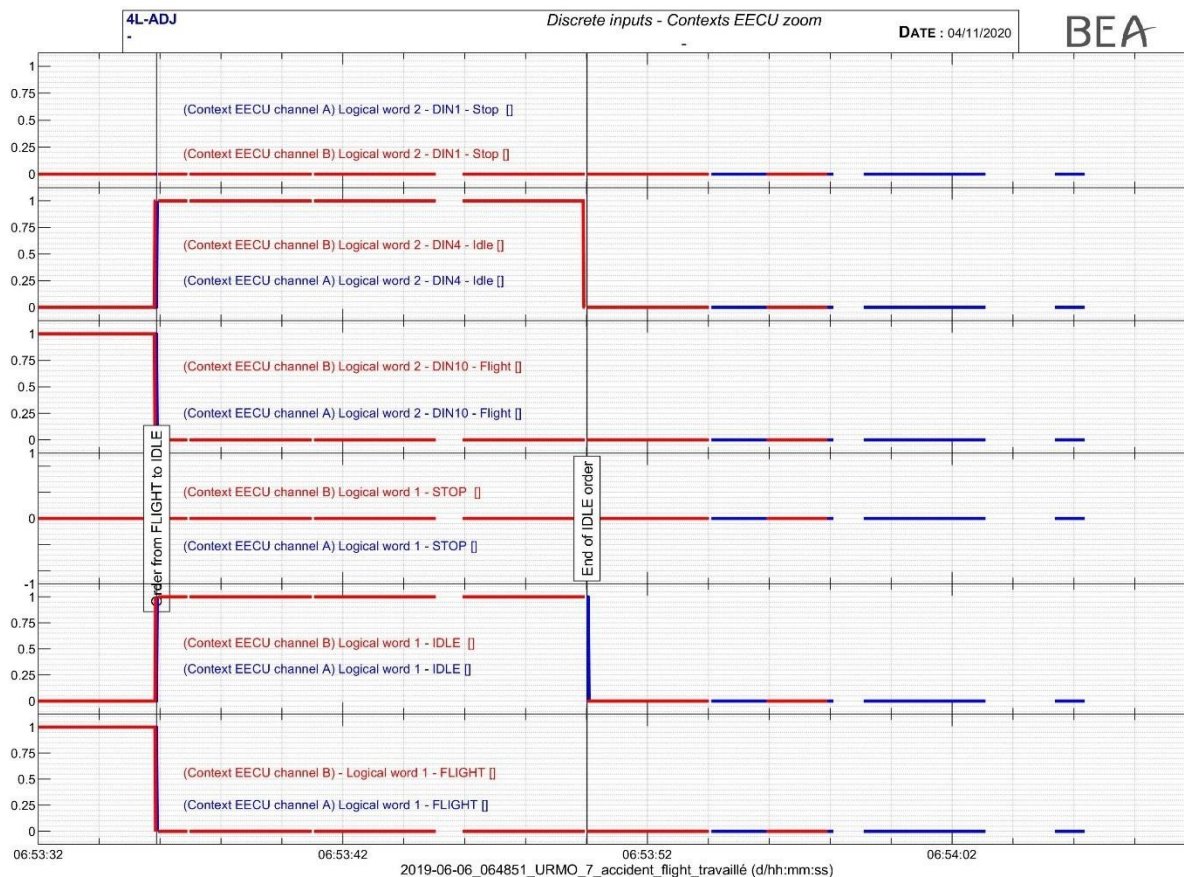
- An order from FLIGHT to IDLE was taken into account by the EECU at 06:53:35.88
 - A control status from FLIGHT to IDLE was returned to the avionics at 06:53:35.9
 - The timeframe between the reception of the order and the update of the control status was 20 ms, which is within the manufacturer’s tolerance.

At 06:53:50,02, logical word 1 switched from IDLE to RUN-UP, and an engine shut-off authorization was sent to the avionics. This authorization informs the pilot that conditions are met to shut the engine down.

Figure 4: example of discrete inputs comparison

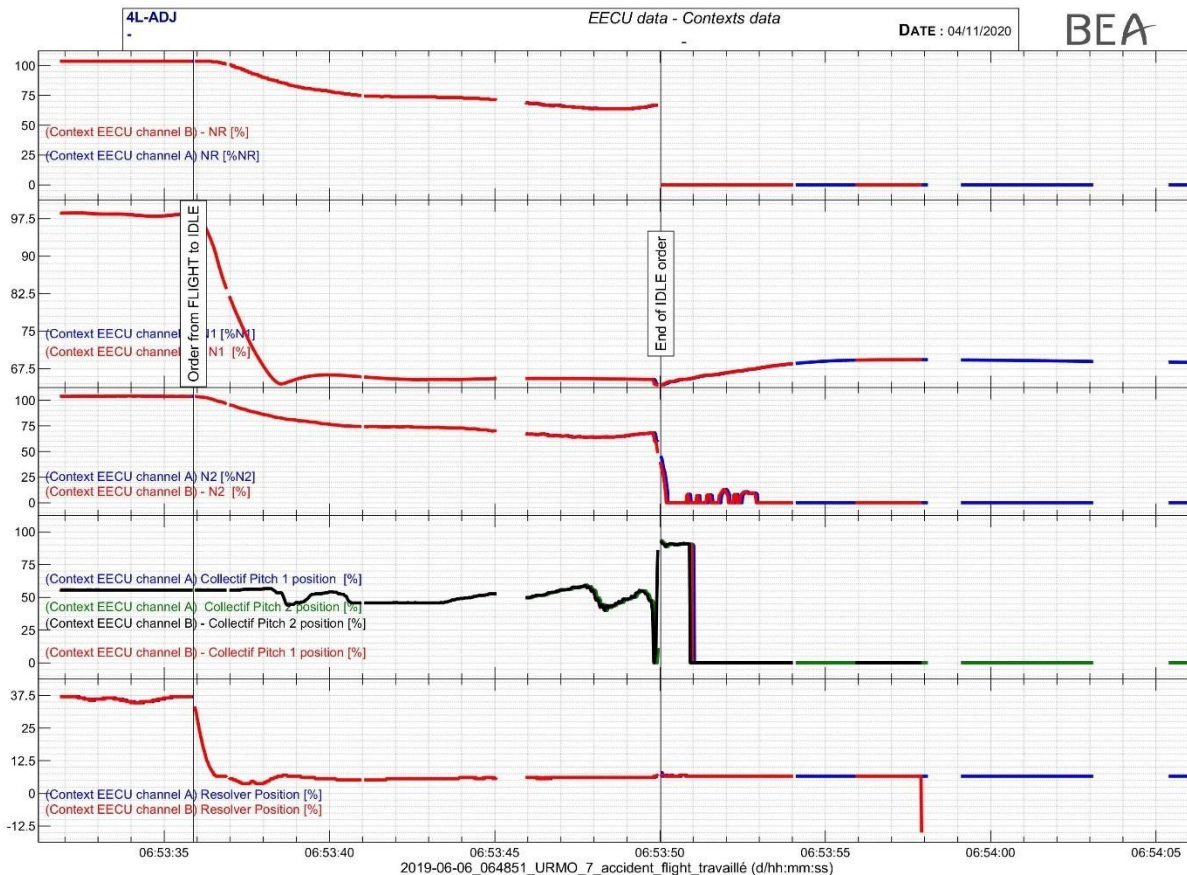
Figure 5 : Contextual data for both channels of the EECU

Reminder At around 06:53:35.9, the logical word 2 switched from FLIGHT to IDLE and the logical word 1 acknowledged this change within 20 ms.

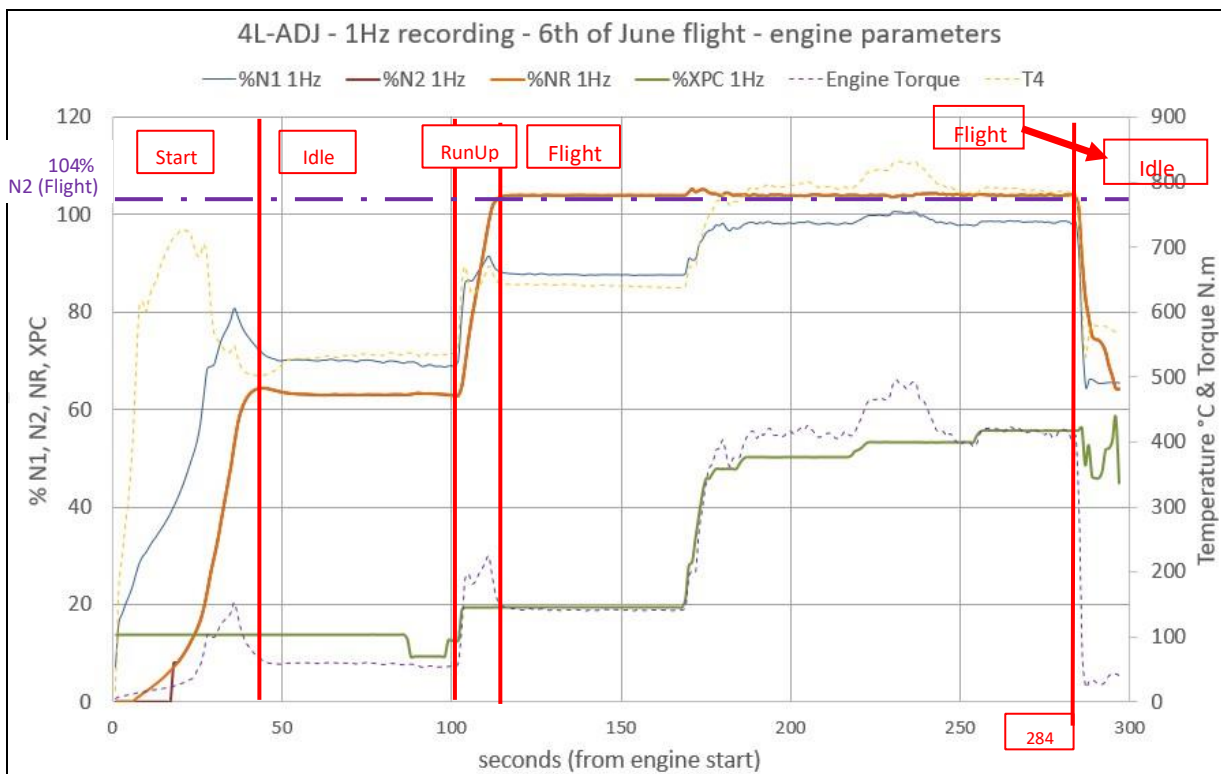
- engine parameters were consistent with an engine operation from start to idle, and from idle to flight where the N2 rating is 104%.
- at 284 seconds after the engine started, the N1, N2, NR suddenly started to drop. This statement was in accordance with the change of state from flight to idle mode recorded in the logical word 2

Chart 1 : Engine parameters – 1Hz – from engine start to end of recording

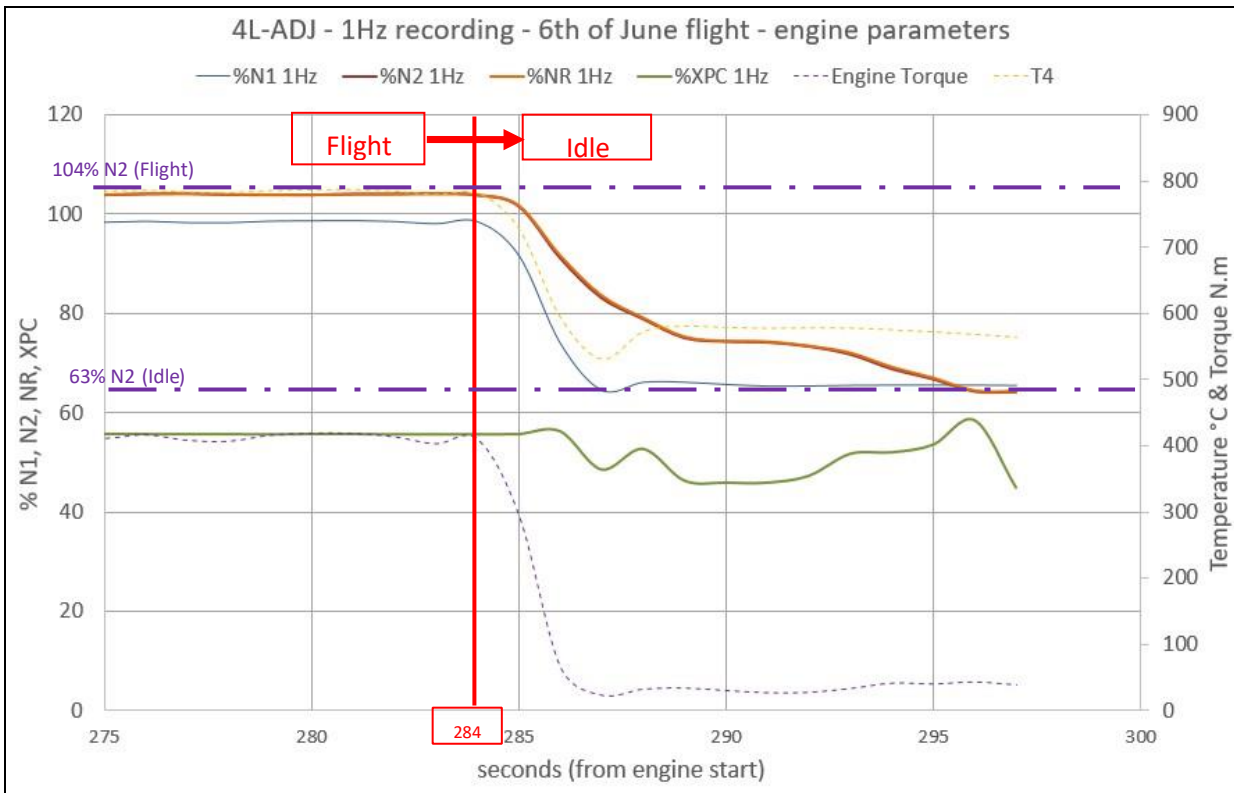
- all engines parameters were consistent with an idle mode rating (Chart 2; N2(idle) = 63%) \square NR and N2 were synchronized.
- XPC (collective pitch position) was always higher than 46%.

Chart 2 : Engine parameters – 1Hz – zoom on the last 25 seconds of continuous recording
